**Derryarogue Bog**

**Cutaway Bog Decommissioning and  
Rehabilitation Plan**

**2023**

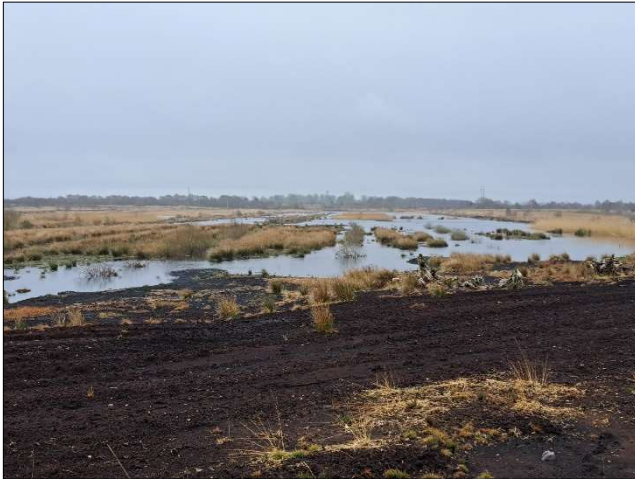
<p><i>Wetland with <i>Phragmites australis</i> reedbed community (pPhrag) in the NW of Derryarogue.</i></p>	<p><i>Wetland/open water at the SW corner of the northern lobe of Derryarogue.</i></p>

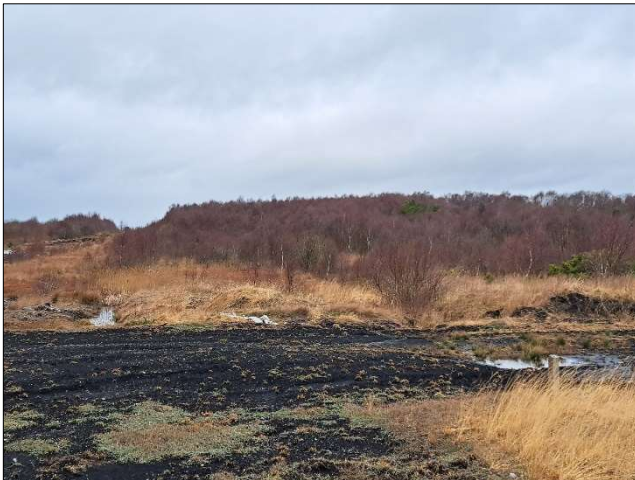
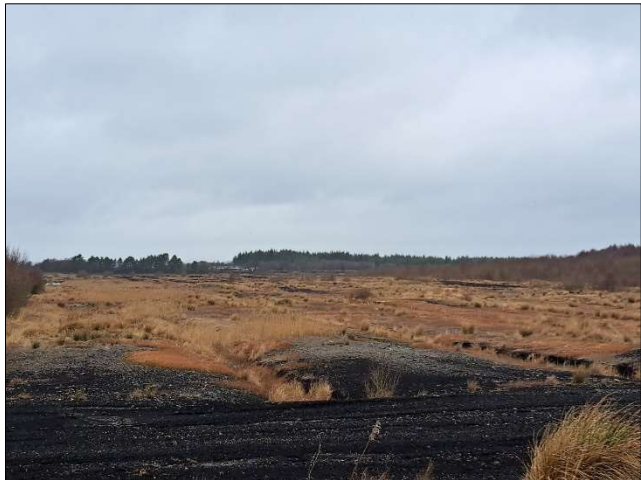
<p><i>Mature Birch woodland (BirWD) in the northern lobe of Derryarogue with pioneer <i>Molinia caerulea</i>-dominated community and bare peat in the foreground.</i></p>	<p><i>Bare peat and pioneer vegetation in the SW of the northern lobe.</i></p>

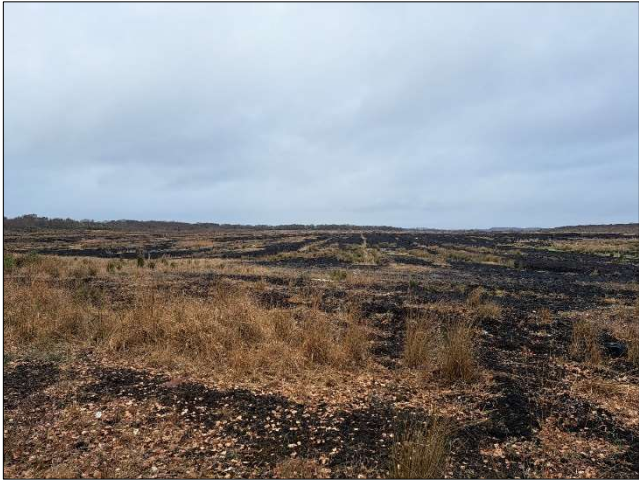
<p><i>Cutover dominated by bare peat and pioneer vegetation to the south of the southern lobe.</i></p>

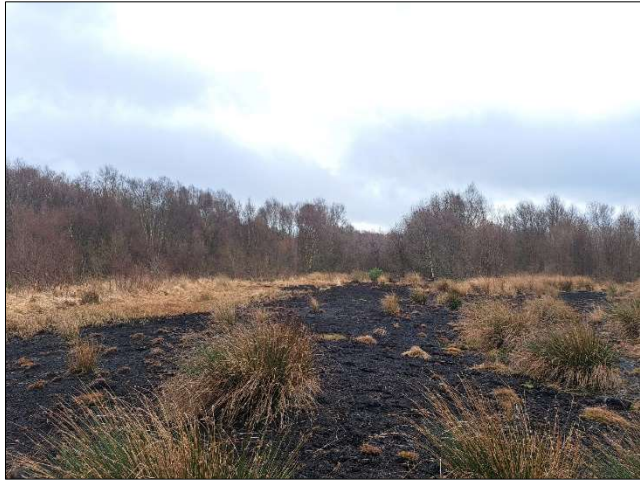
<p><i>Cutover dominated by bare peat and pioneer vegetation with Birch woodland (BirWD) in the background, to the east of the southern lobe.</i></p>

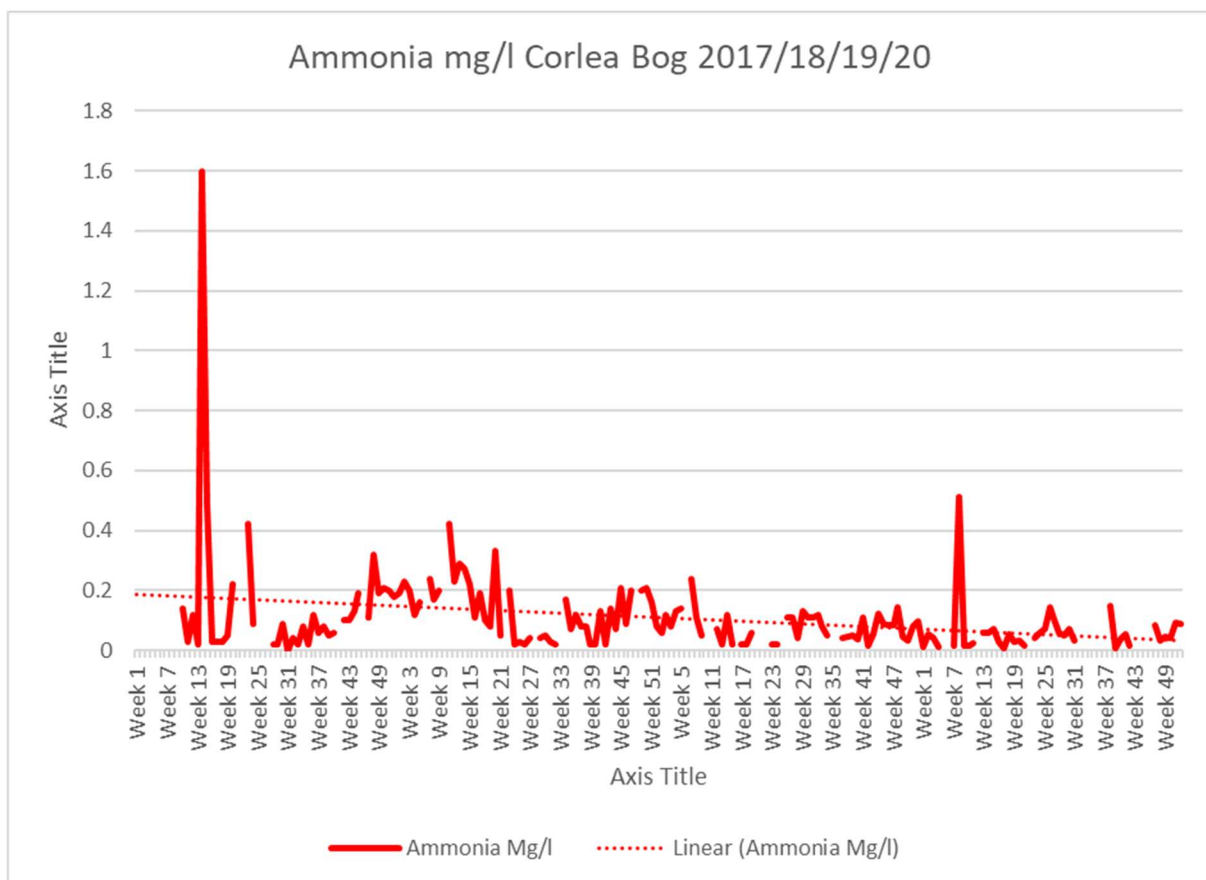
**Figure 7.1.** Ammonia levels over the period 2015-2019 at Longfordpass and the period 2017-2020 at Corlea.

Similarly monitoring of surface water ammonia emissions from a Corlea bog in Mountdillon over the past 4 yrs. post cessation of peat extraction with ongoing rehabilitation, indicate downward trends.

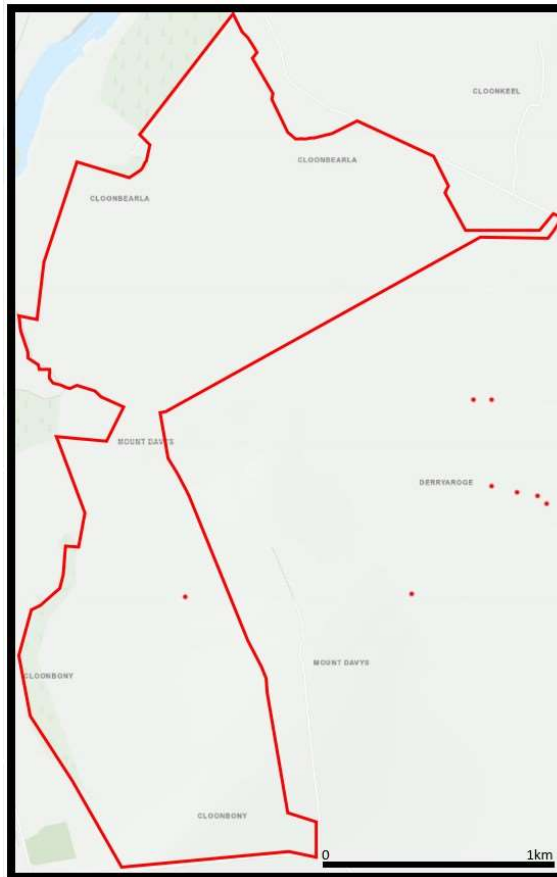
Fig. 3. Derryarogue Bog, Co. Longford, detail of the Sites and Monuments Record. The proposed rehabilitation area is outlined with the red line.

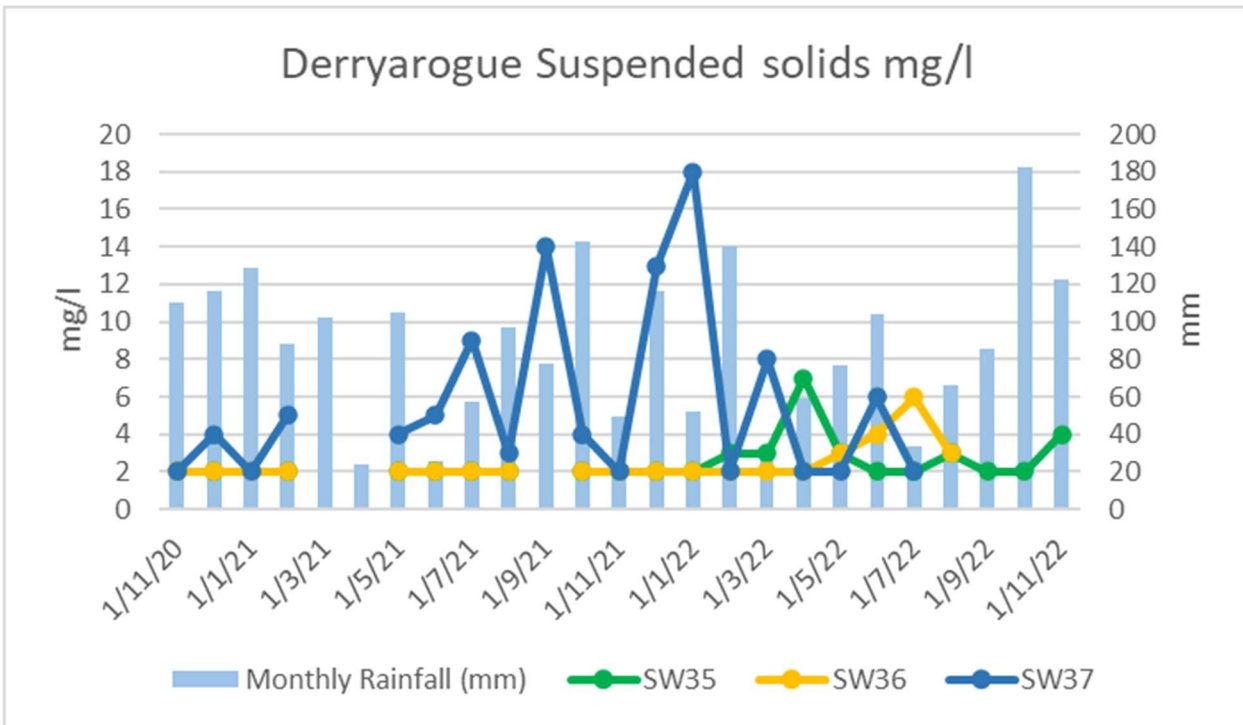
Plate 0-1 Derryarogue suspended solids sampling results

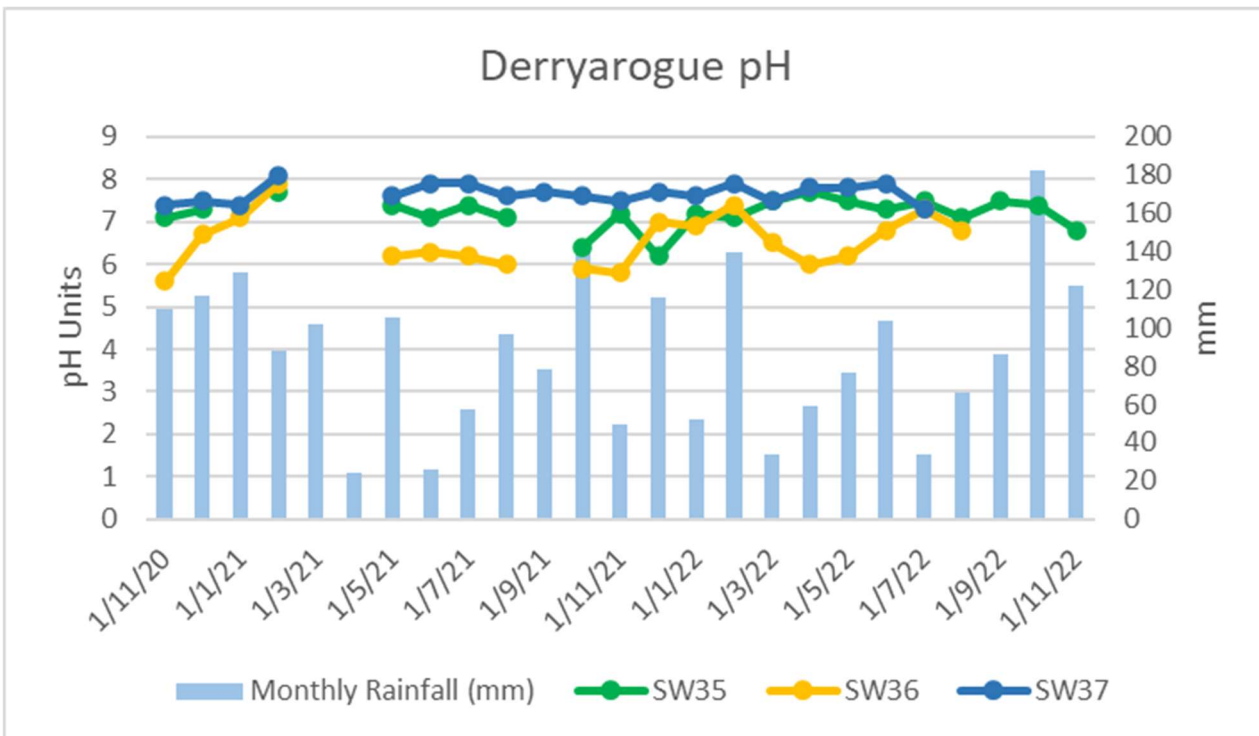
Plate 0-2 Derryarogue pH sampling results
