Article 6 (3) Appropriate Assessment Screening Report

Corlea Bog, Co. Longford,
Decommissioning and
Rehabilitation Plan 2023

Project Title: **Corlea Bog, Co. Longford, Decommissioning and Rehabilitation Plan 2023.**

Document Title: **Appropriate Assessment Screening Report**

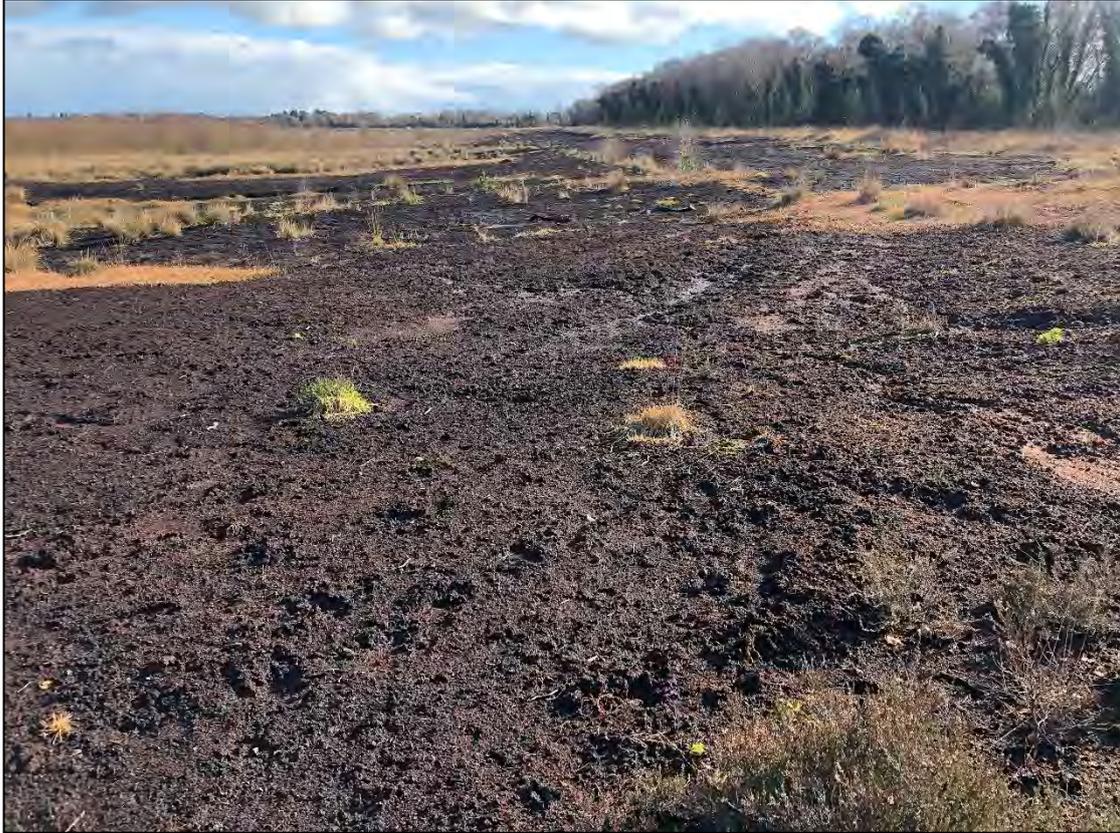
Plate 2-1 An area of Cutover Bog (PB4) present to the north of the site, with pioneer species of Ling Heather (*Calluna vulgaris*), Rush (*Juncus spp*) and Cottongrass (*Eriophorum angustifolium*).

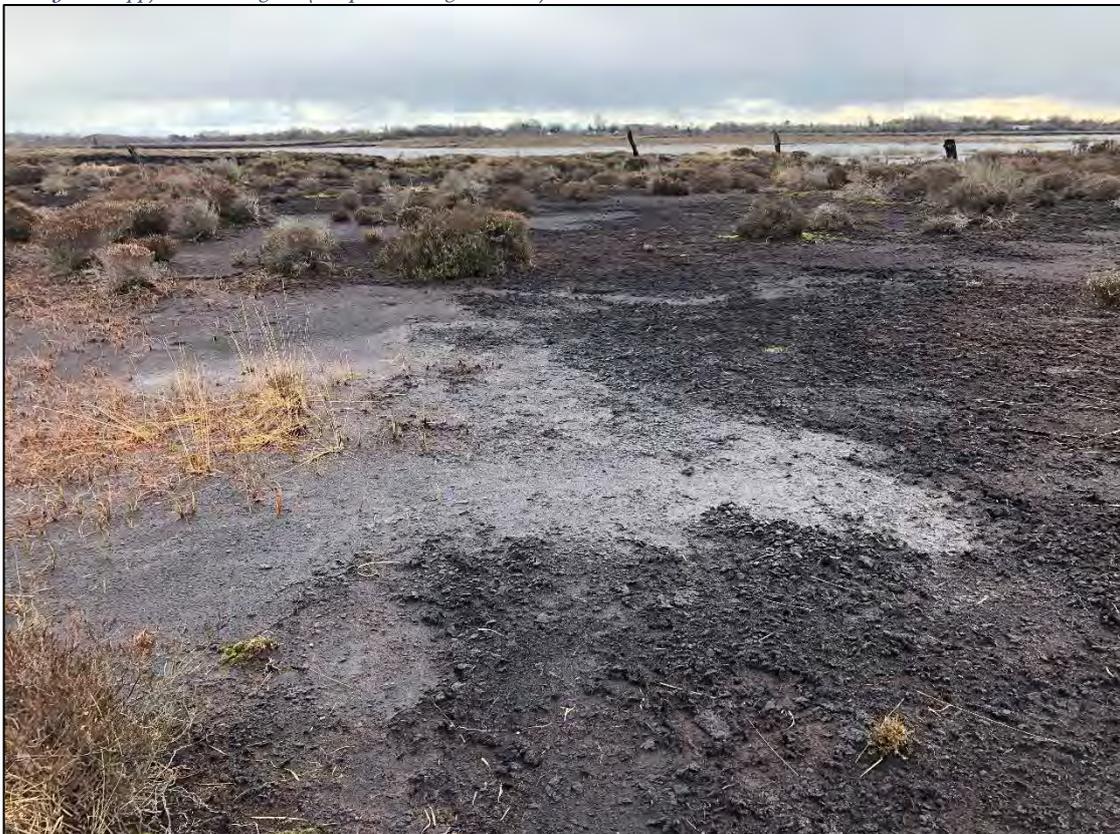
Plate 2-2 An area of Cutover Bog (PB4) present to the east of the site, with Pioneer Ling Heather (*Calluna vulgaris*).

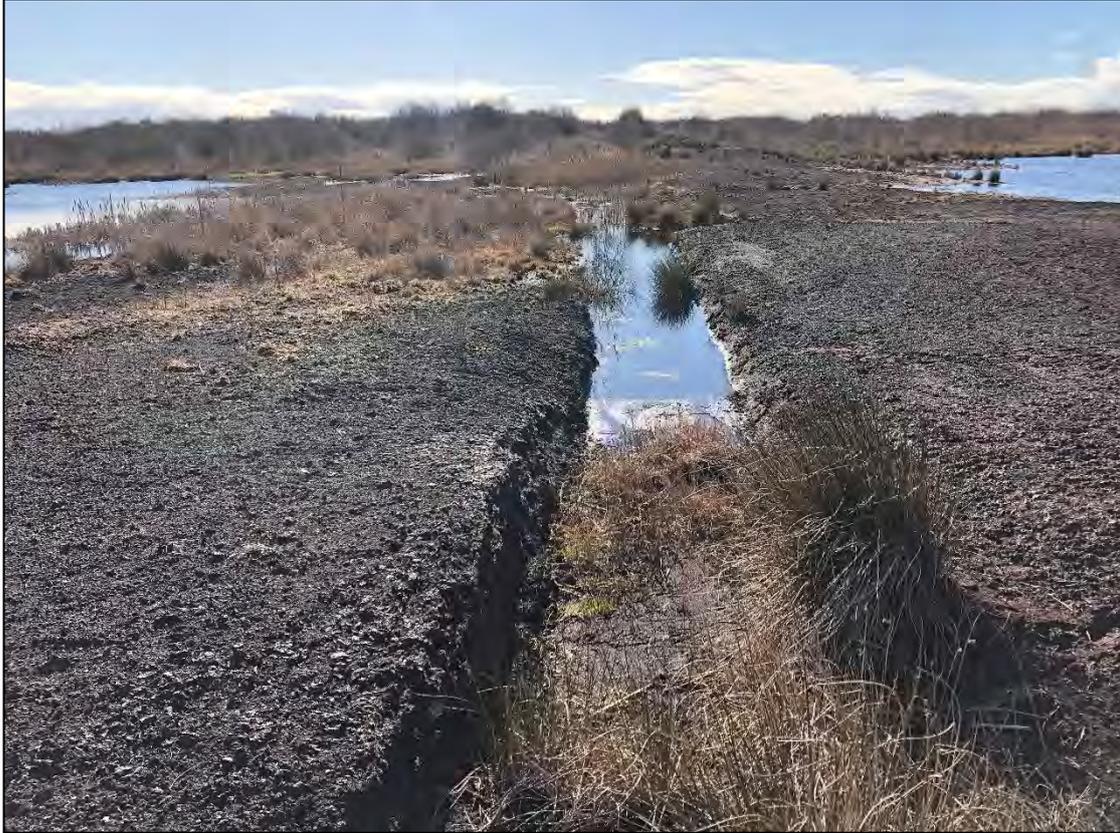
Plate 2-3 Drainage Ditch (FW4) present to the east of the site, with wetland habitats evident to the top left and right corners of this plate.

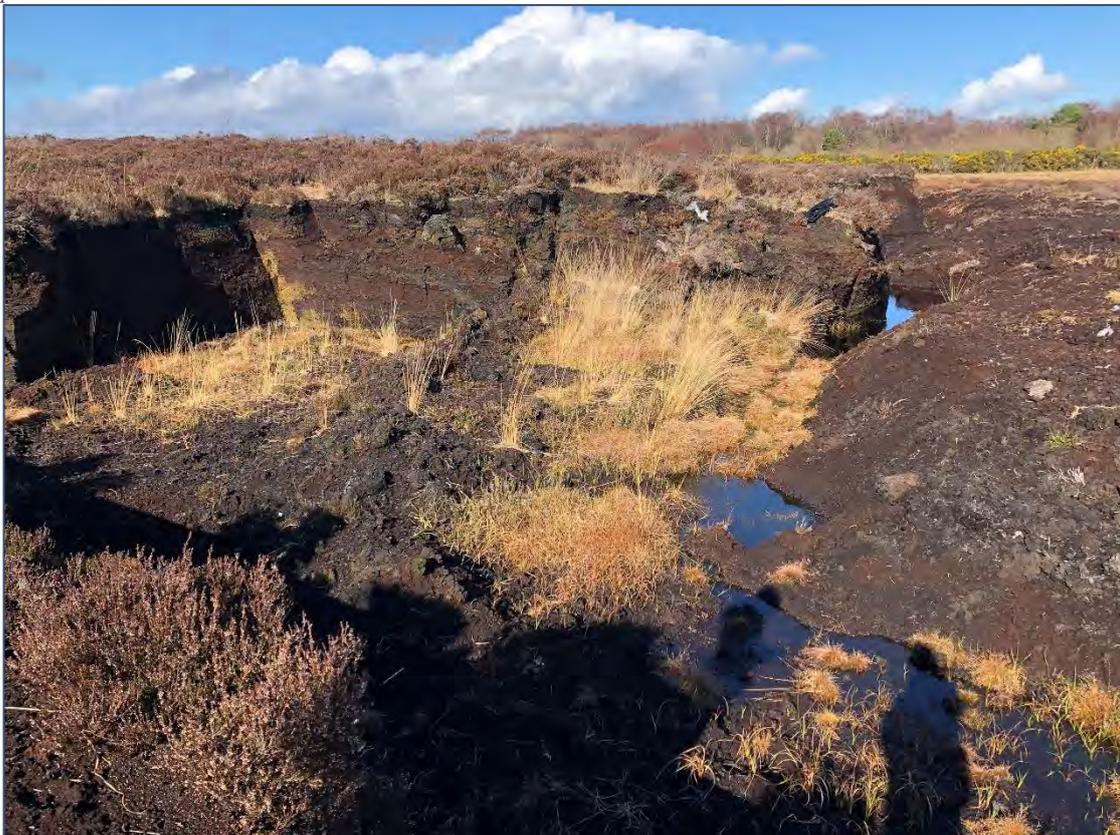
Plate 2-4 An area of cutover bog (PB4) present to the east of the site, with Ling Heather (*Calluna vulgaris*) and Cottongrass (*Eriophorum angustifolium*).

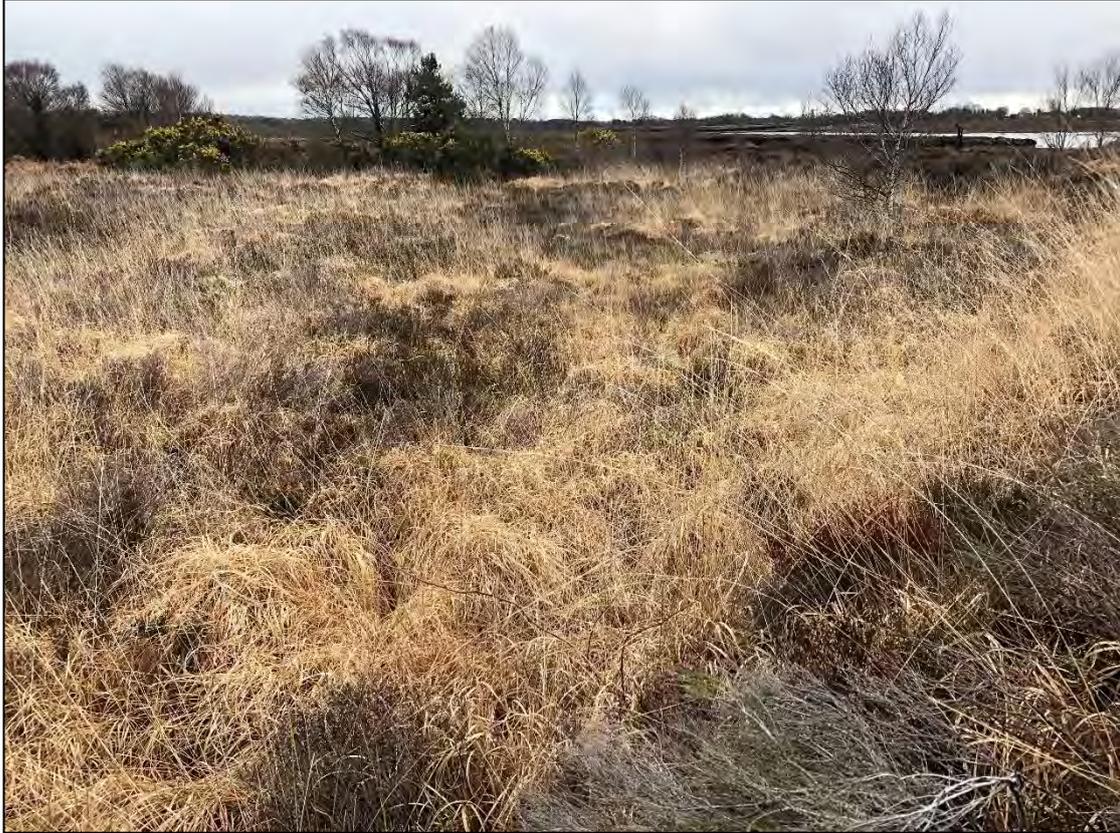
Plate 2-5 An area of Cutover bog dominated by Purple Moor Grass (*Molinia caerulea*), with species of Cotton Grass (*Eriophorum angustifolium*), Ling Heather (*Calluna vulgaris*), Rush (*Juncus spp*), and Gorse (*Ulex spp*) to the east of the site.

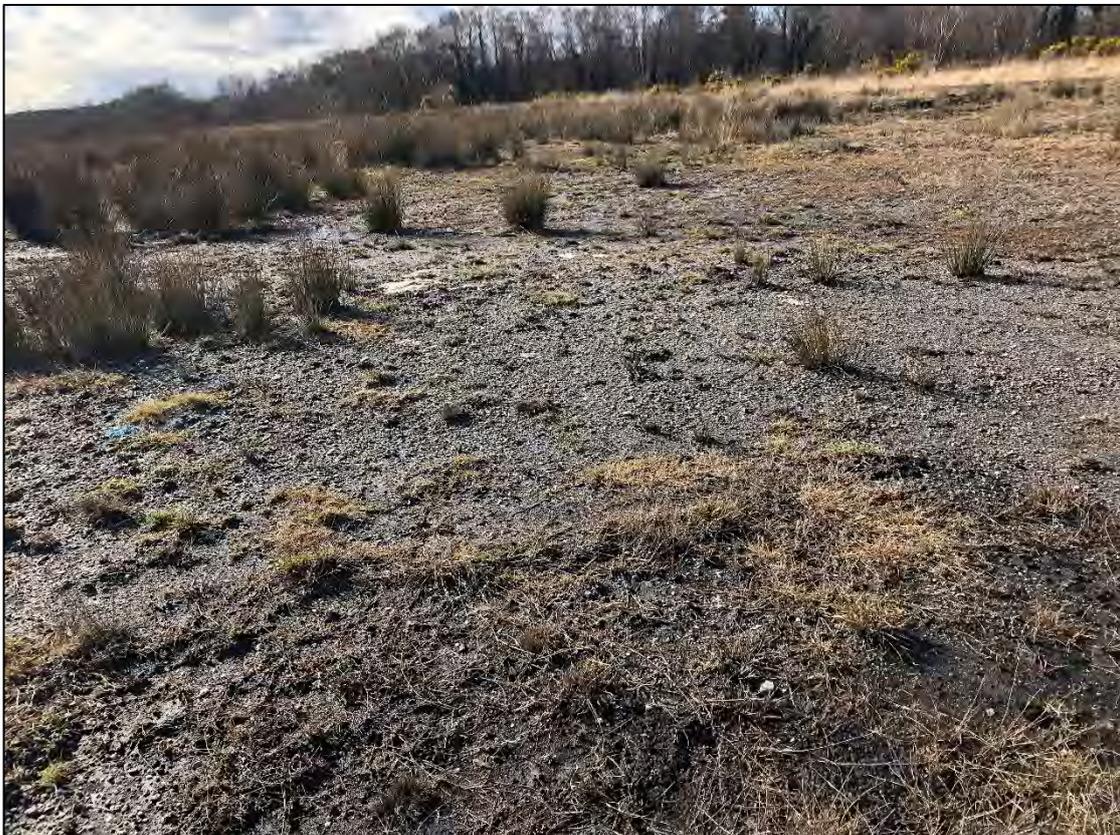
Plate 2-6 An Area of cutover bog (PB4) present to the north of the site, with exposed gravel.

<i>Plate 2-6 An Area of cutover bog (PB4) present to the north of the site, with exposed gravel</i>	<i>19</i>

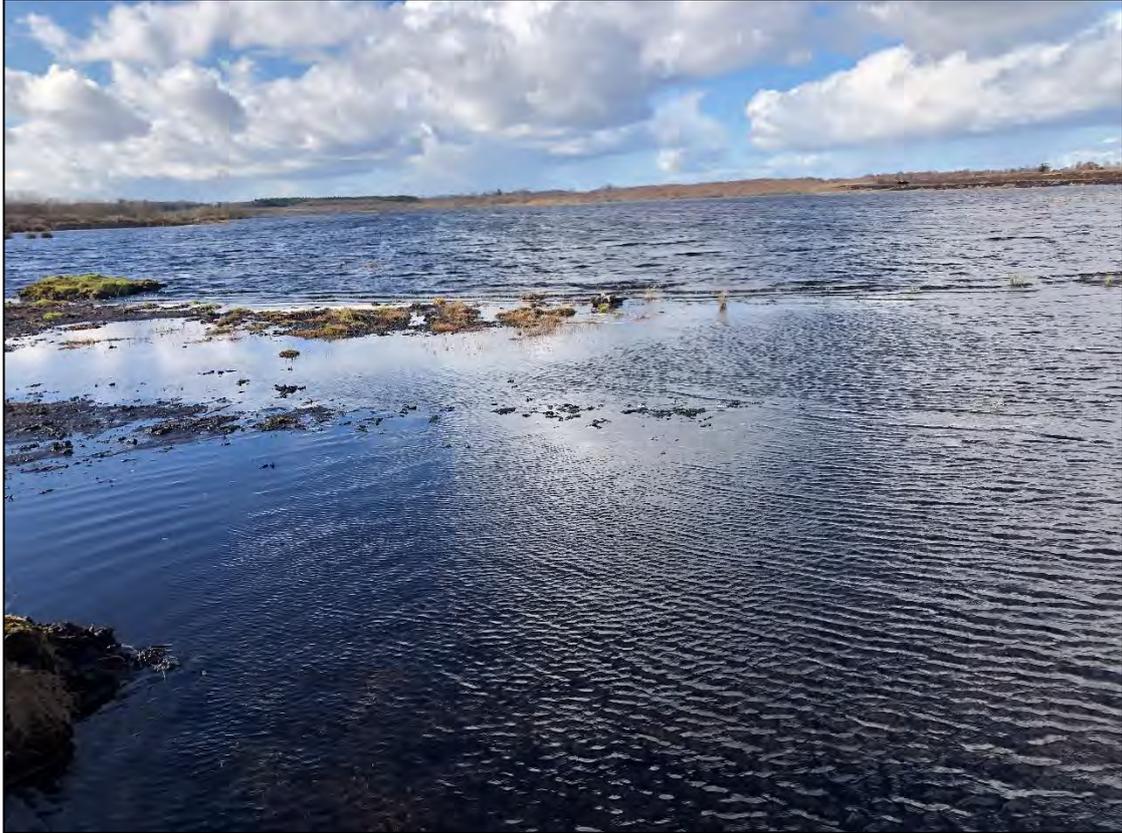
Plate 2-7 A large area of open water present to the western parcel of the site.

Plate 2-7 A large area of open water present to the western parcel of the site. 20

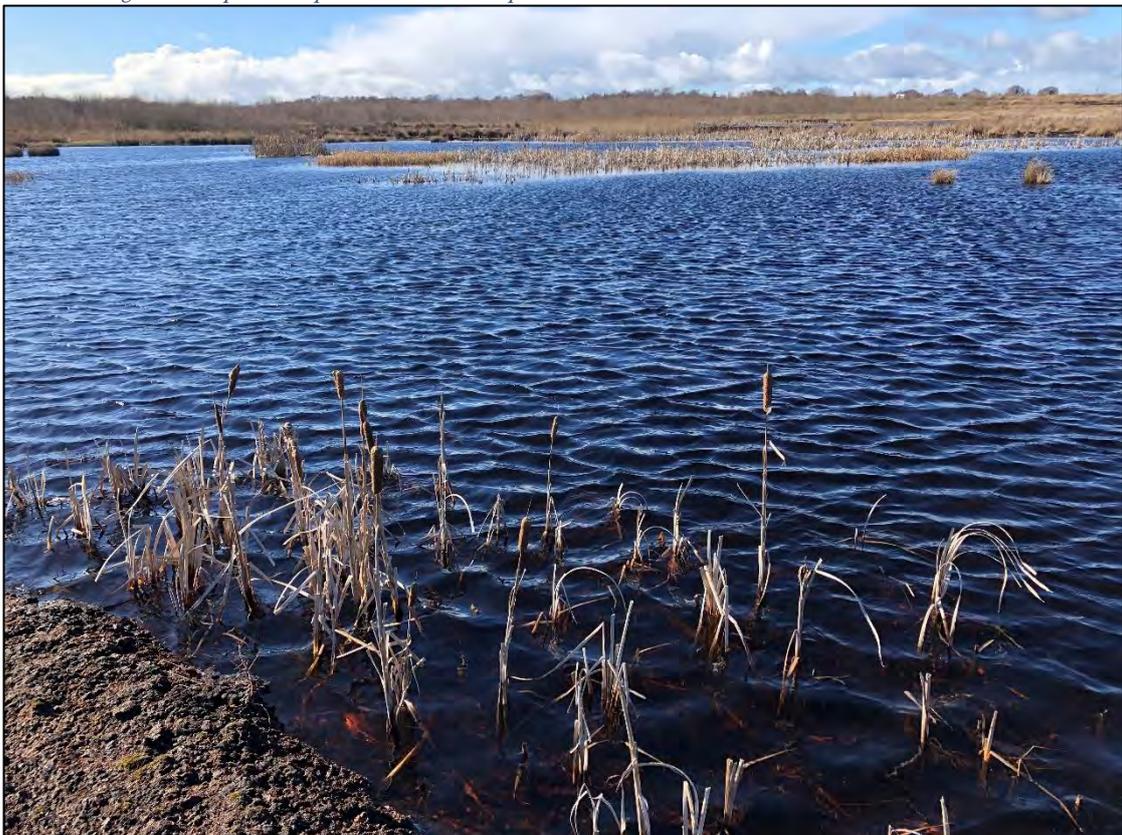
Plate 2-8 An area of open water present to the east of the site, with species of Rush (*Juncus spp*) and Bulrush (*Typha latifolia*),

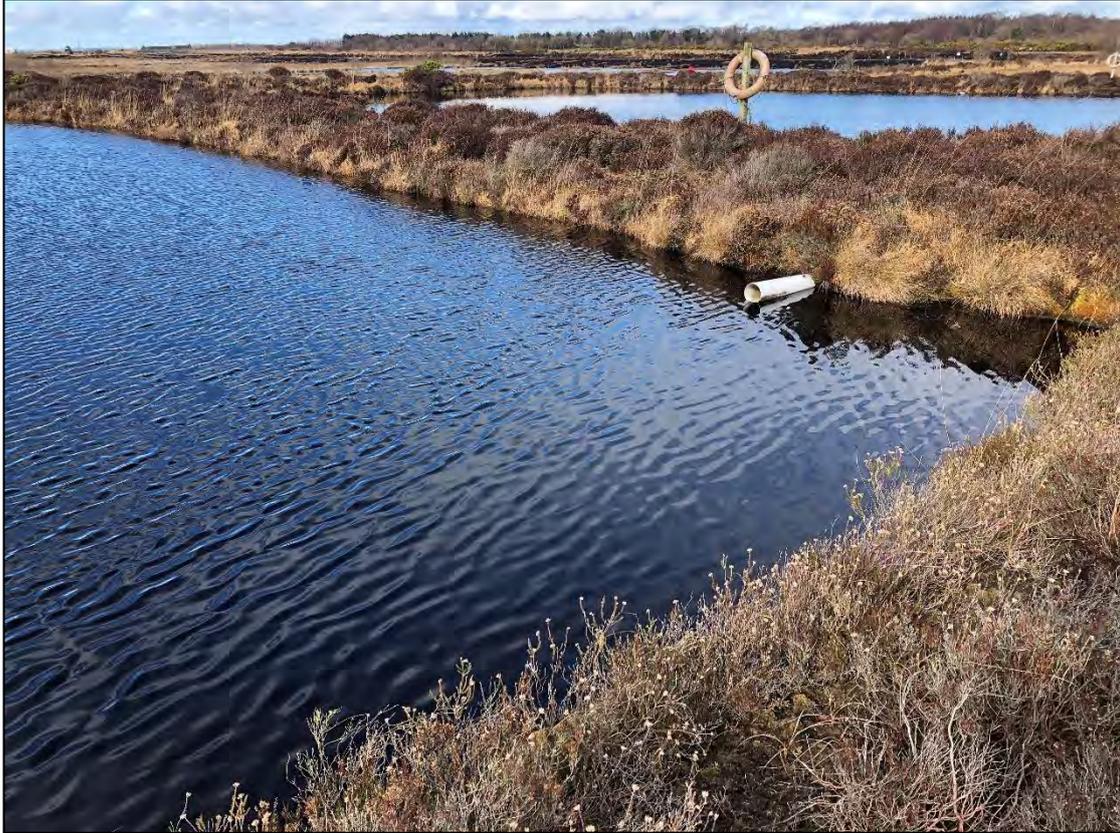
Plate 2-9 An area of open water present to the east of the site.

Plate 2-9 An area of open water present to the east of the site..... 21

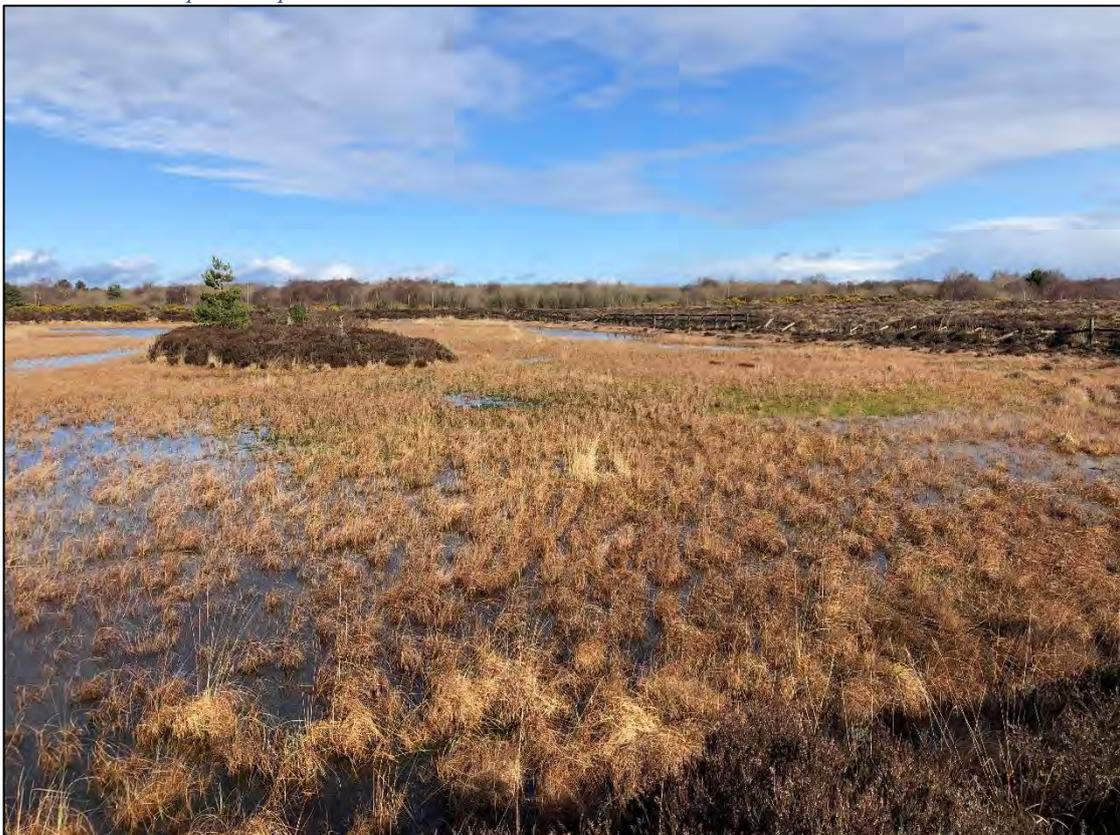
Plate 2-10 Cutover Bog (PB4) dominated by Purple Moor-grass (*Molinia caerulea*), and Cottongrass (*Eriophorum angustifolium*) present to the east of the site, adjacent to open pools of water.

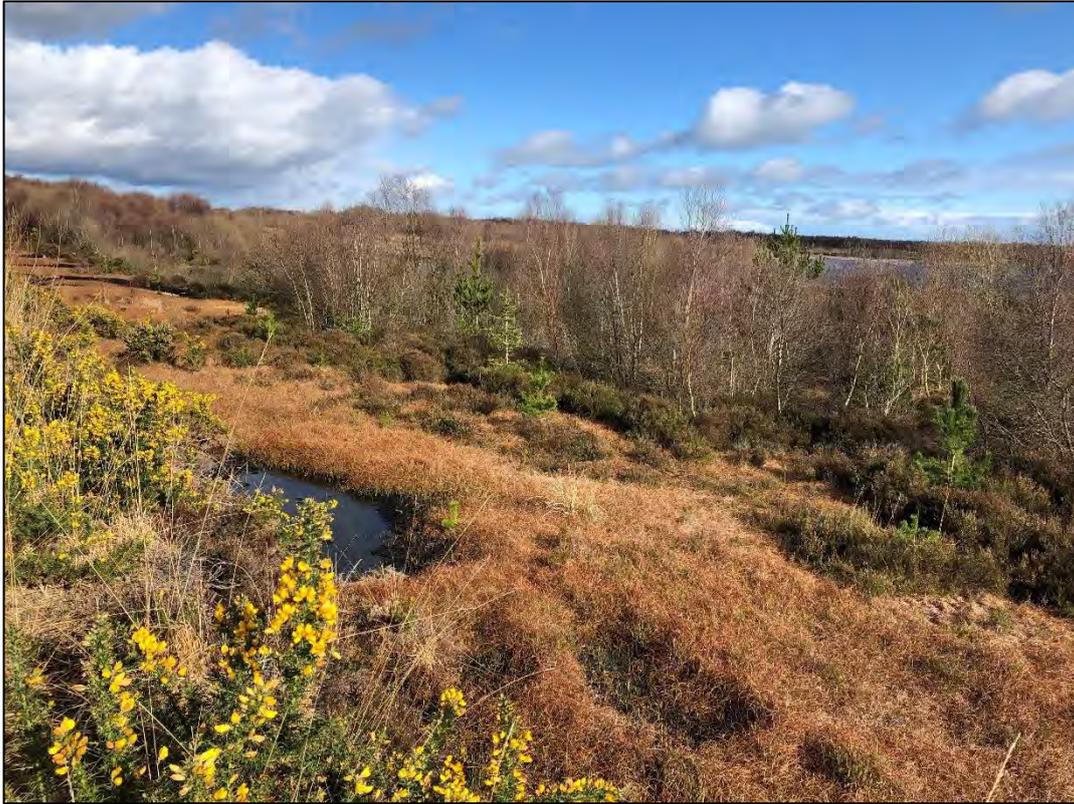
Plate 2-11 Poor Fen (PF2) habitat present to the north of the site, adjacent to the wetland habitat dominated by Cottongrass (*Eriophorum angustifolium*), Gorse (*Ulex spp*), Ling Heather (*Calluna vulgaris*), and Immature Woodland (WS2) of Pine (*Pinus spp*) and Downy Birch (*Betula pubescens*).

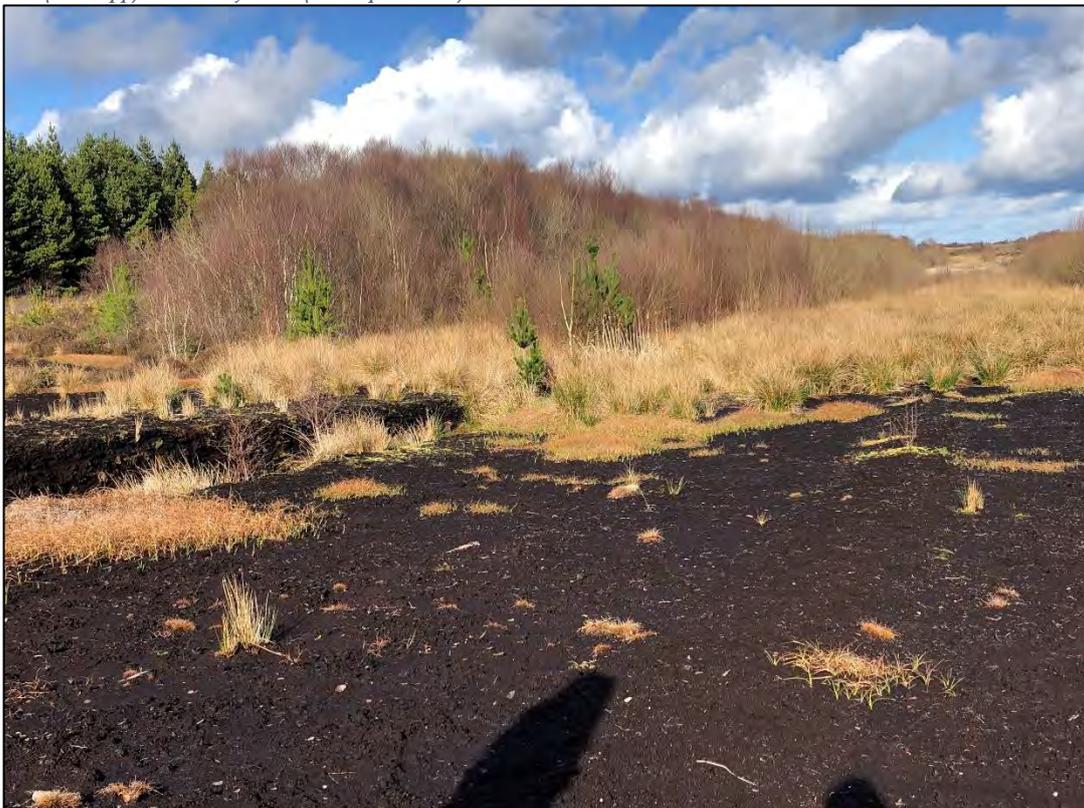
Plate 2-12 Poor Fen (PF2) habitat present to the northwest of the site on cutover bog dominated by Soft Rush (*Juncus effusus*), Cottongrass (*Eriophorum angustifolium*), Immature Woodland (WS2) of Pine (*Pinus spp*) and Downy Birch (*Betula pubescens*).

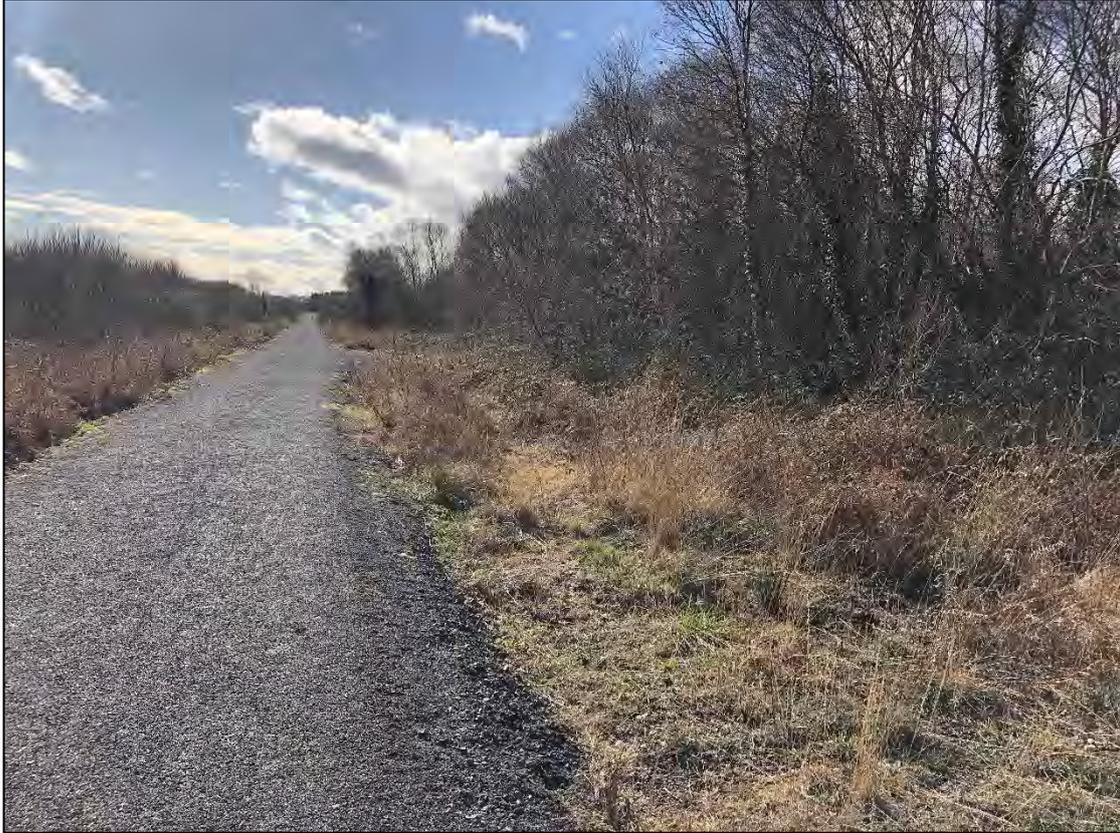
Plate 2-13 Treeline (WL2) with transitional Scrub (WS1) present to the margins of the amenity track (BL3) to the north of the site with species of Gorse (*Ulex spp*), Bramble (*Rubus spp*), Downy Birch (*Betula pebescens*), Bracken (*Pteridium aquilinum*), and Ivy (*Hedera spp*).

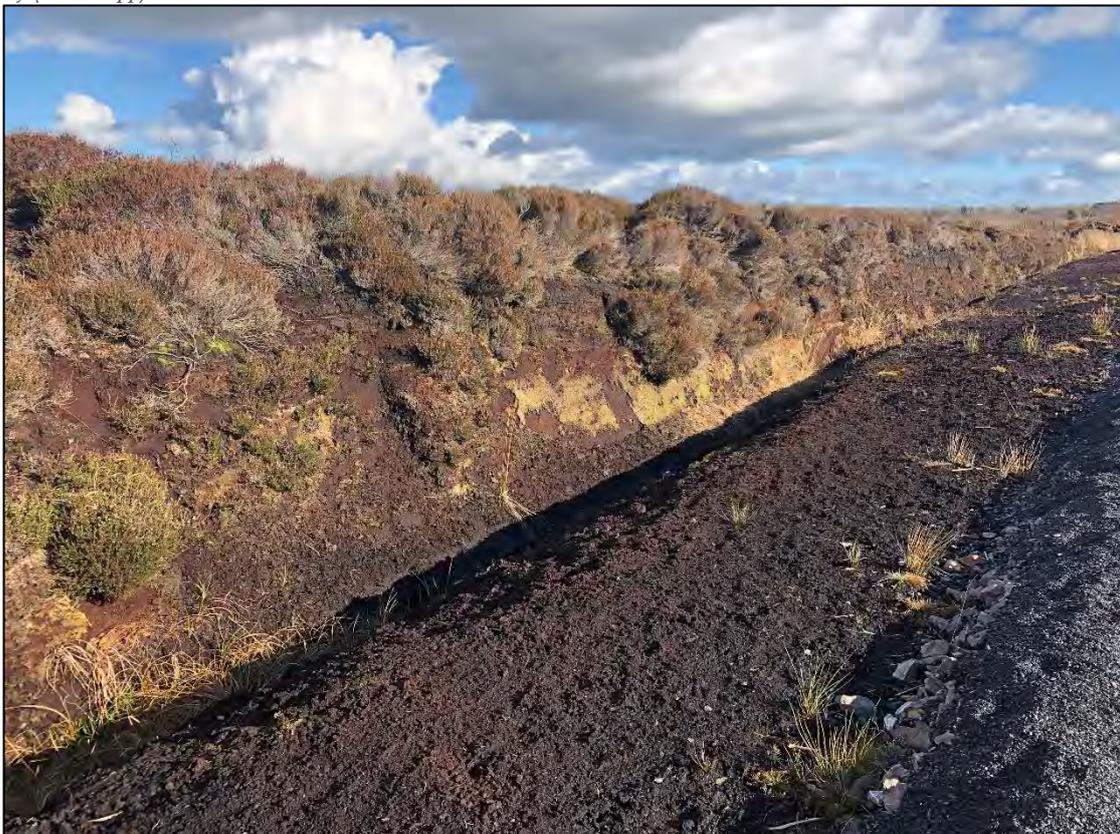
Plate 2-14 Degraded Raised Bog (PB1) in poor condition to west margins of the site, dominated by Ling Heather (*Calluna vulgaris*).

Plate 2-14 Degraded Raised Bog (PB1) in poor condition to west margins of the site, dominated by Ling Heather (*Calluna vulgaris*)..... 23

Areas of degraded **Raised Bog (PB1)** are present to the south, east and west margins of the site. These areas are dominated by Ling Heather (*Calluna vulgaris*). Other species recorded on these uncut margins include Purple Moor Grass (*Molinia caerulea*), Cross Leaved Heath (*Erica tetralix*), Deergrass (*Trichophorum caespitosum*), Bracken (*Pteridium aquilinum*), and *Sphagnum spp*.

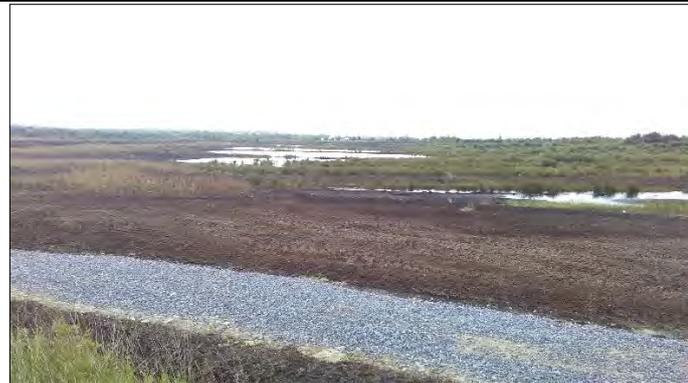
Bare peat along the headlands with the new track at the north-east basin.

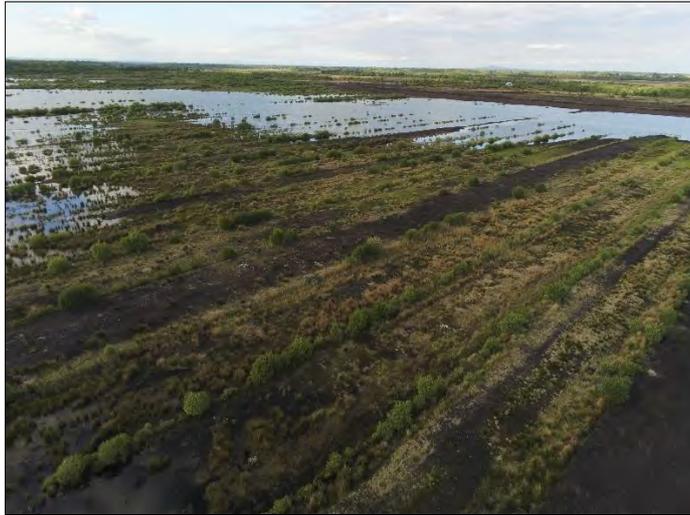
Southern margin – drier cutaway (2020).

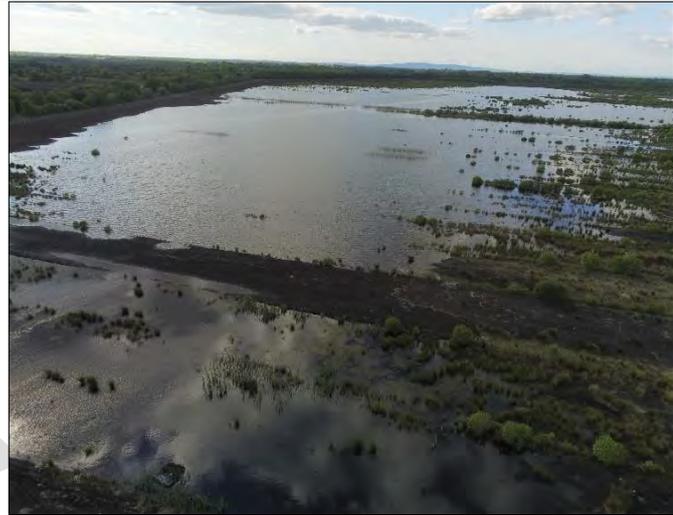
Eastern wetland (2020).

Wetlands have developed in the main basins with large areas of standing water and a mosaic of wetland vegetation with patches of developing Reedbeds (Common Reed and Reedmace) and poor fen (pioneering *Juncus effusus* and *Carex rostrata*). These wetlands attract breeding and wintering water-birds. The wetlands are fringed with bare peat and colonising vegetation.

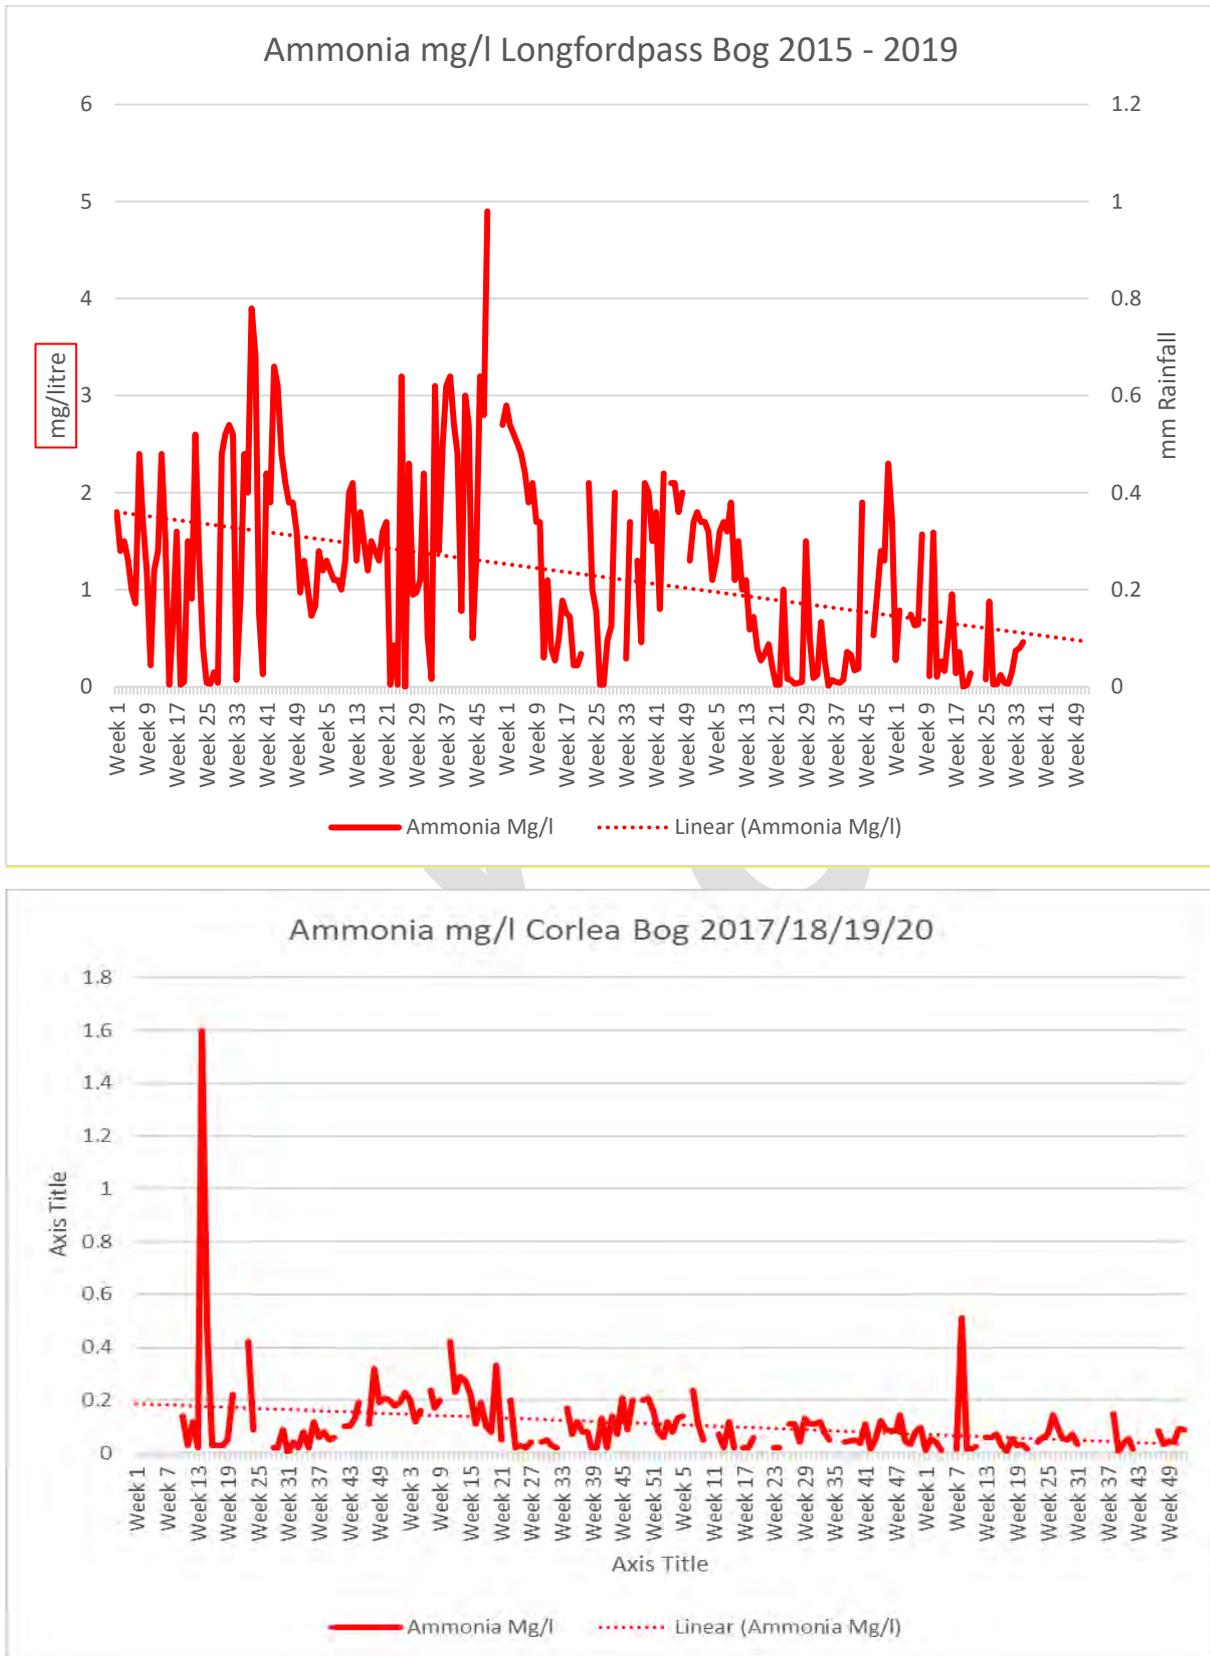
Figure 7.1. Ammonia levels over the period 2015-2019/2020 at Longfordpass and Corlea.

Similarly monitoring of surface water ammonia emissions from Corlea bog in Moundillon over the past 3 years, post cessation of peat extraction with ongoing rehabilitation, indicate downward trends. Following commencement, and as the monthly monitoring program at Corlea continues in 2022 during the rehabilitation

works and data from the 2021 monitoring program is compiled, further trending will be produced to verify any ongoing trends.
