Bord na Móna

Killashee bog

**Cutaway Bog Decommissioning and
Rehabilitation Plan
2023**

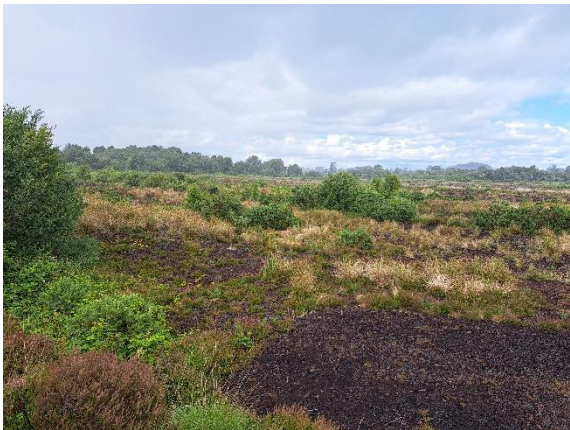
Table 1: Photos of Habitats at Killashee bog.

| Photos of Habitats at Killashee (2023) | |
|---|---|
| <p><i>Bare peat with pioneer dry heath forming to the south of Killashee.</i></p> | <p><i>Willow and Gorse Scrub to the north of the site.</i></p> |
