## **Article 6 (3) Appropriate Assessment Screening Report**

Lisclogher West Bog, Co.  
Westmeath,  
Decommissioning and  
Rehabilitation Plan 2023.

Project Title: **Lisclogher West Bog, Co. Westmeath, Decommissioning and Rehabilitation Plan 2023.**

Document Title: **Appropriate Assessment Screening Report**

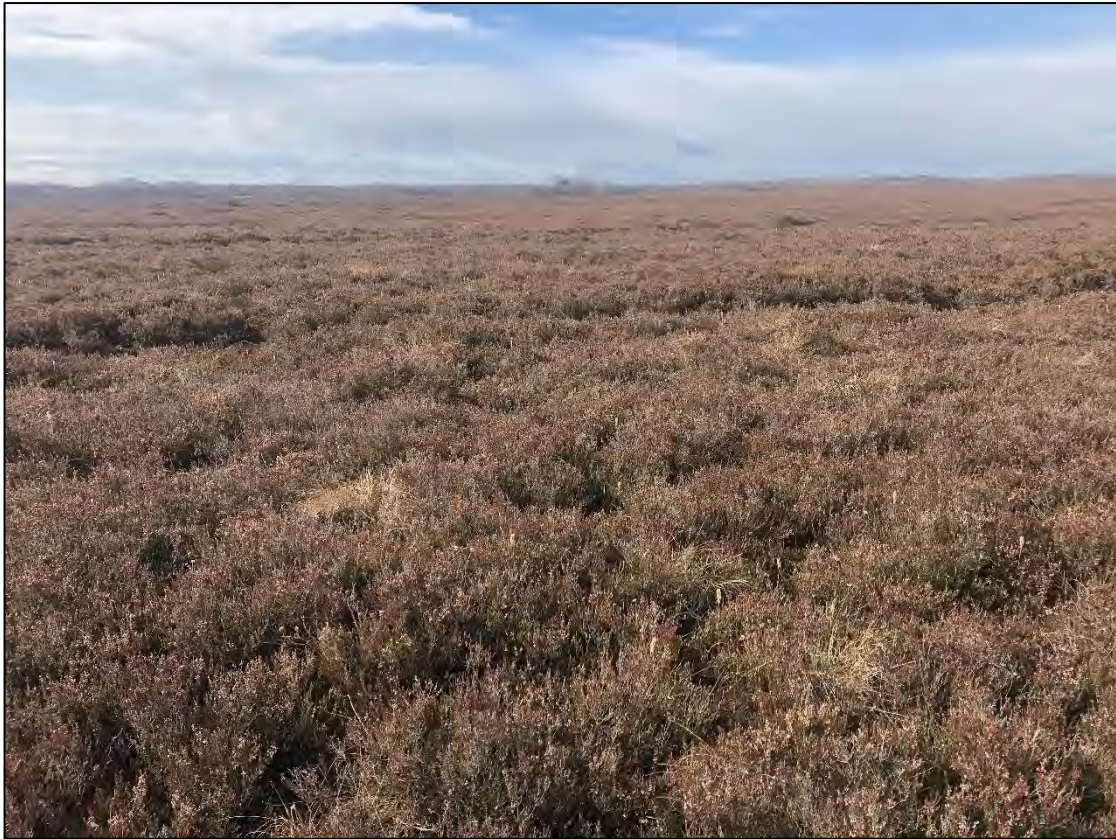
Plate 2-1 Raised Bog (PB1) in poor condition to the east of the site, dominated by Ling Heather (*Calluna vulgaris*) and species of Cross-leaved Heath (*Erica tetralix*), Deergrass (*Trichophorum cespitosum*), Hares Tail Cotton grass (*Eriophorum vaginatum*), Common Cottongrass (*Eriophorum angustifolium*), Reindeer Lichen (*Cadonia portentosa*), and *Sphagnum* spp.

The most dominant habitat recorded on Lislogher West Bog is **Raised Bog (PB1)** in poor condition, subject to artificial drainage, present throughout the site. (See plates 2.1 and 2.2). These areas are dominated by Ling Heather (*Calluna vulgaris*). Other species recorded include Purple Moor Grass (*Molinia caerulea*), Cross-leaved Heath (*Erica tertalix*), Deergrass (*Trichophorum cespitosum*), Hares Tail Cotton grass (*Eriophorum vaginatum*), Common Cottongrass (*Eriophorum angustifolium*), Reindeer Lichen (*Cladonia portentosa*), and *Sphagnum spp.* An area of burnt raised bog in poor condition to the southwest of the site was burnt in 2008, now dominated by pioneer Ling Heather (*Calluna vulgaris*), Purple Moor-grass (*Molinia caerulea*), and Common Cottongrass (*Eriophorum angustifolium*) (Plate 2.3), with species of Sitka Spruce (*Picea sitchensis*), Bracken (*Pteridium aquilinum*) and Gorse (*Ulex europaeus*) also recorded. Various trees still display evidence of burning in this area (plate 2.4). **Drainage ditches (FW4)** are present throughout the site (Plate 2.5).

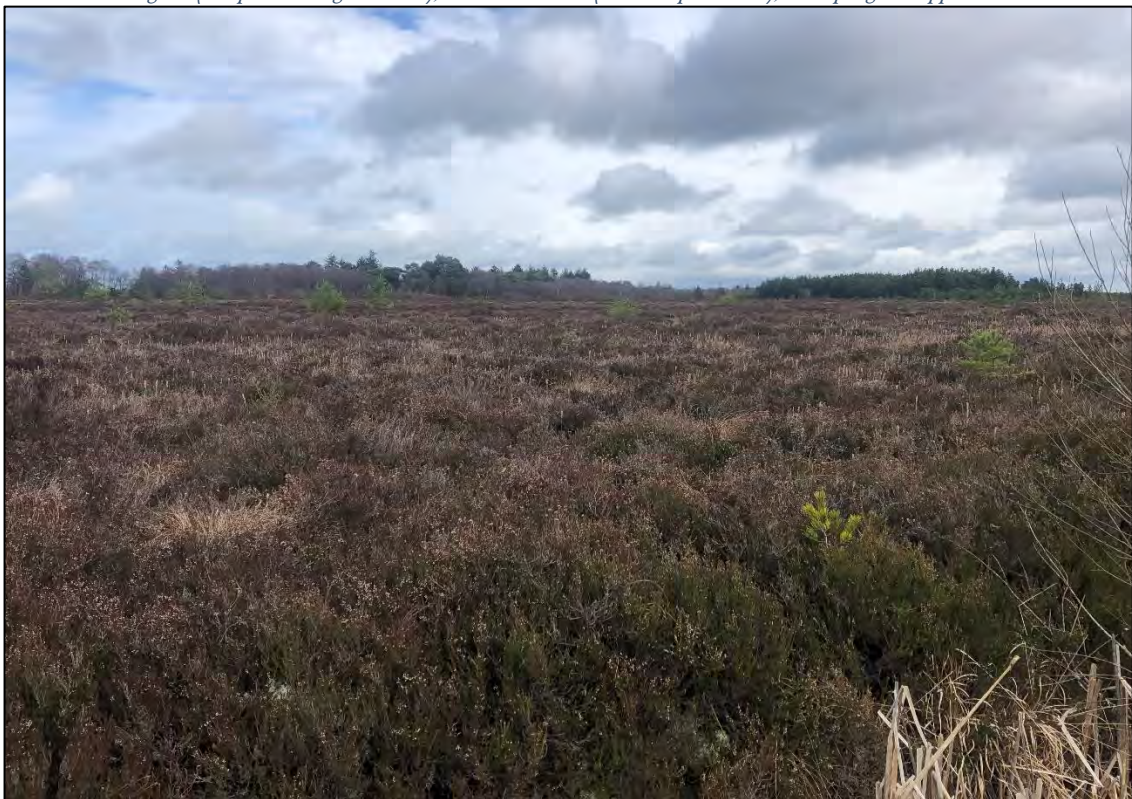
Plate 2-2 Raised Bog (PB1) in poor condition to the southwest of the site dominated by Ling Heather (*Calluna vulgaris*) and species of Cross-leaved Heath (*Erica tetralix*), Deergrass (*Trichophorum cespitosum*), Hares Tail Cotton grass (*Eriophorum vaginatum*), Common Cottongrass (*Eriophorum angustifolium*), Reindeer Lichen (*Cladonia portentosa*), *Sphagnum* spp, and *Conifer* spp saplings.

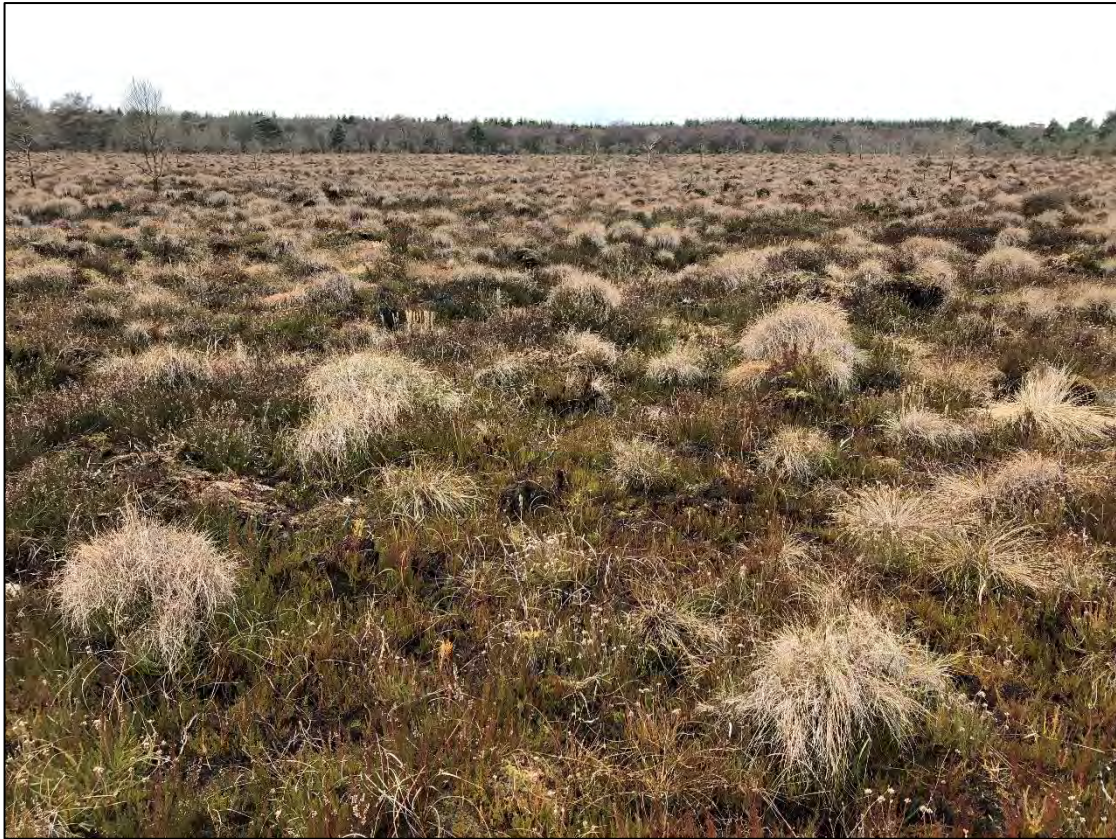
Plate 2-3 An area of degraded burnt Raised Bog (PB1) to the southwest of the site, dominated by pioneer Ling Heather (*Calluna vulgaris*), Purple Moor-grass (*Molinia caerulea*) and Common Cottongrass (*Eriophorum angustifolium*).

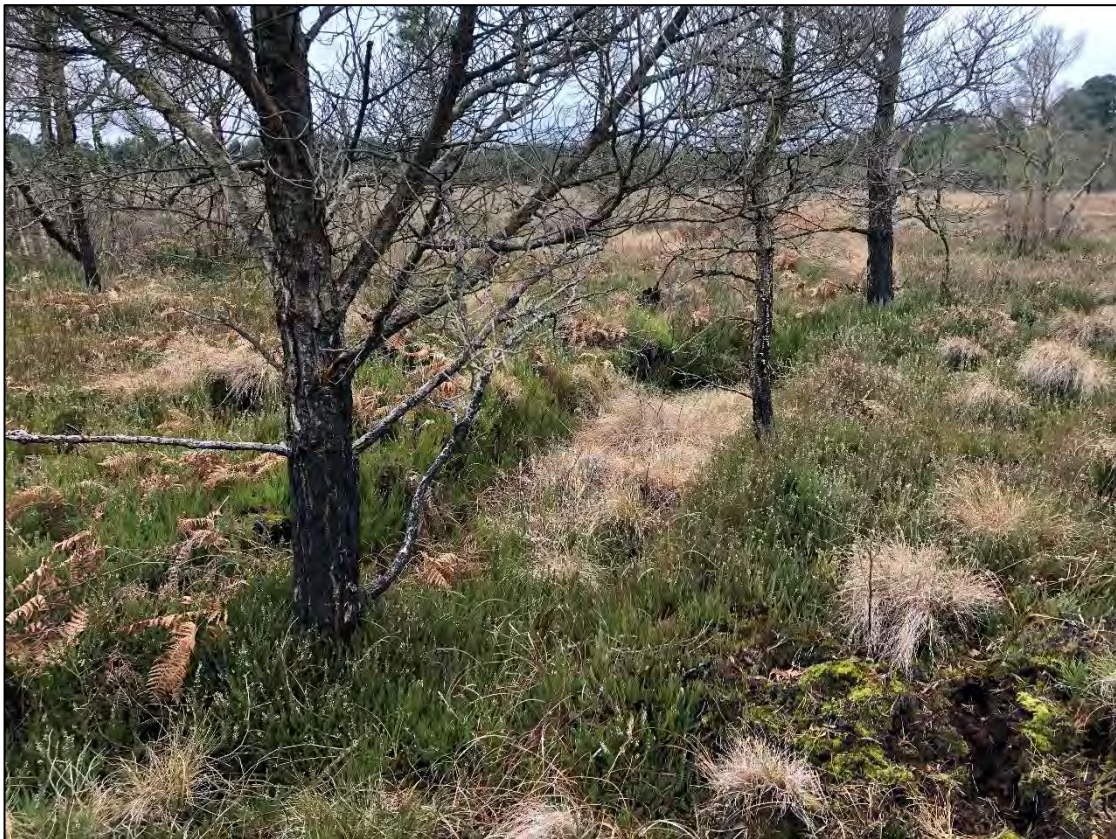
Plate 2-4 An area of burnt degraded Raised Bog (PB1) to the southwest of the site, with evidence of burning on trees recorded.

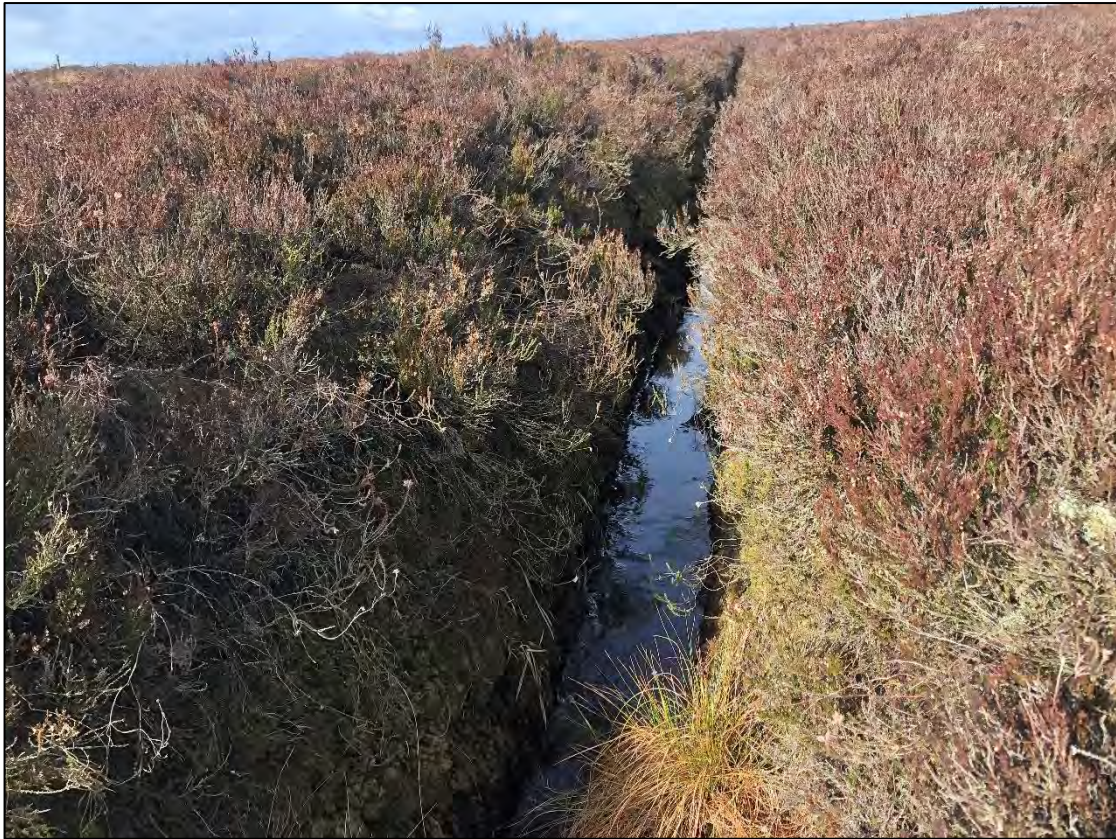
Plate 2-5 Drainage Ditches (FW4) present throughout the site.

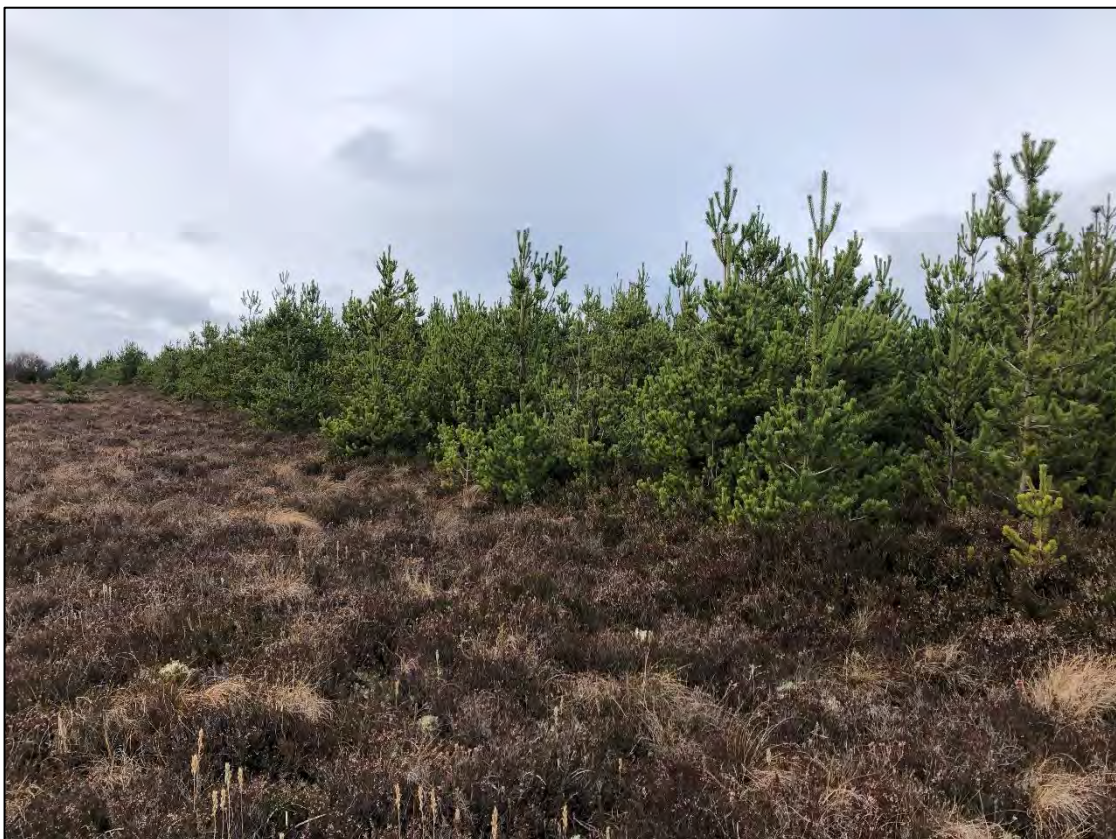
Plate 2-6 Conifer Plantation (WD4) dominated by Young Lodgepole Pine (*Pinus contorta*) present to the north of the site, managed by Coillte.

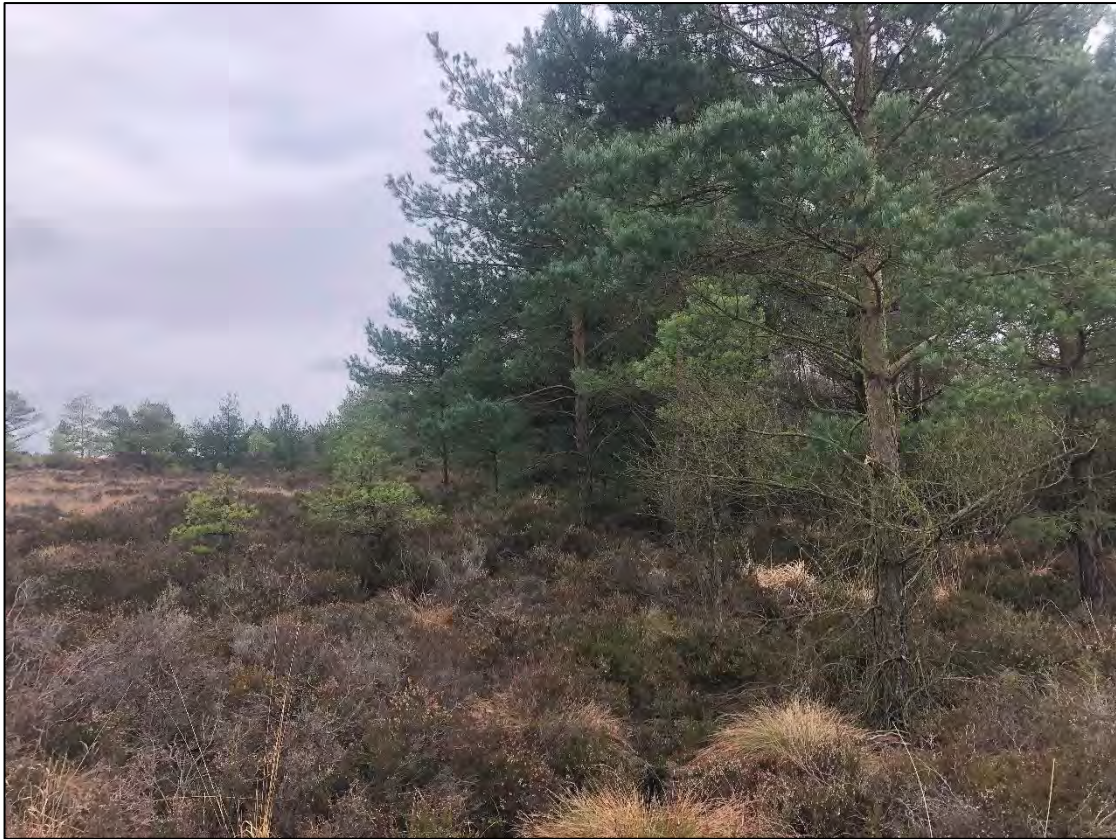
Plate 2-7 Conifer Plantation (WD4) dominated by Lodgepole Pine (*Pinus contorta*) present to the south of the site, managed by Coillte.

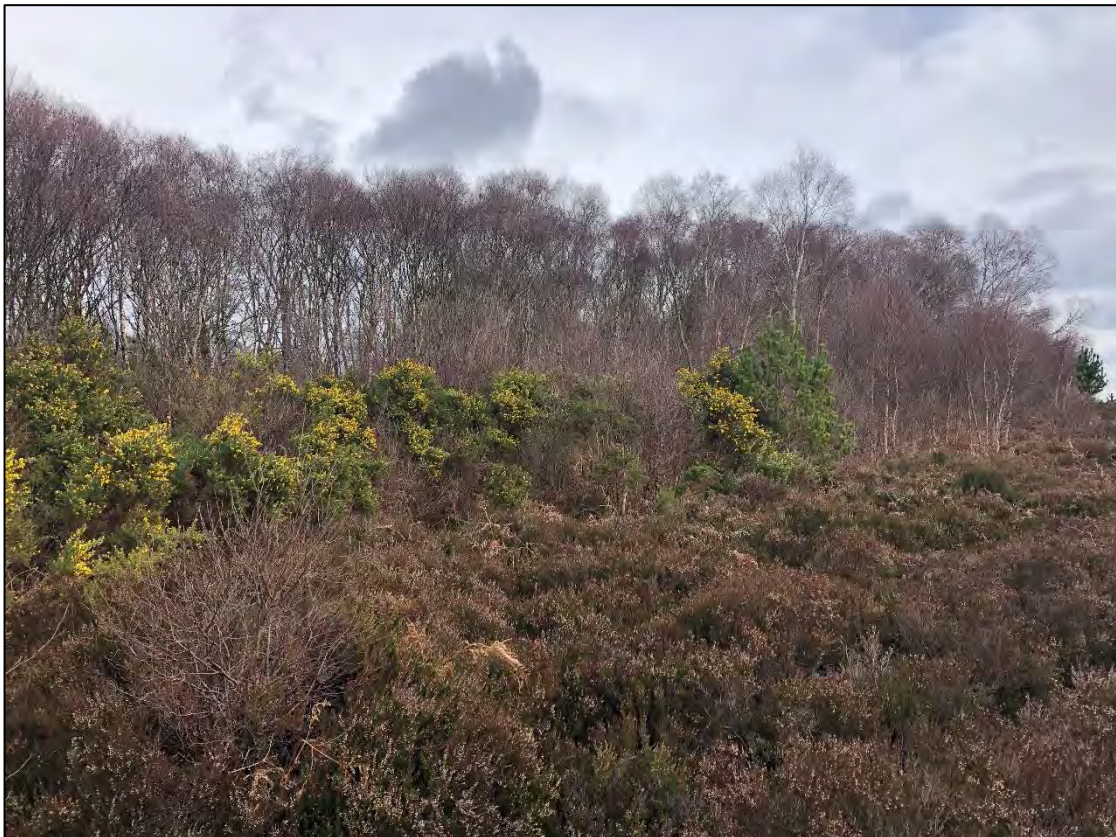
Plate 2-8 Oak-Birch- Holly Woodland (WN1) dominated by Downy Birch (*Betula pubescens*) present to the north and northeast sections of the site, with species of Gorse (*Ulex europaeus*), Bracken (*Pteridium aquilinum*), and young conifer saplings.

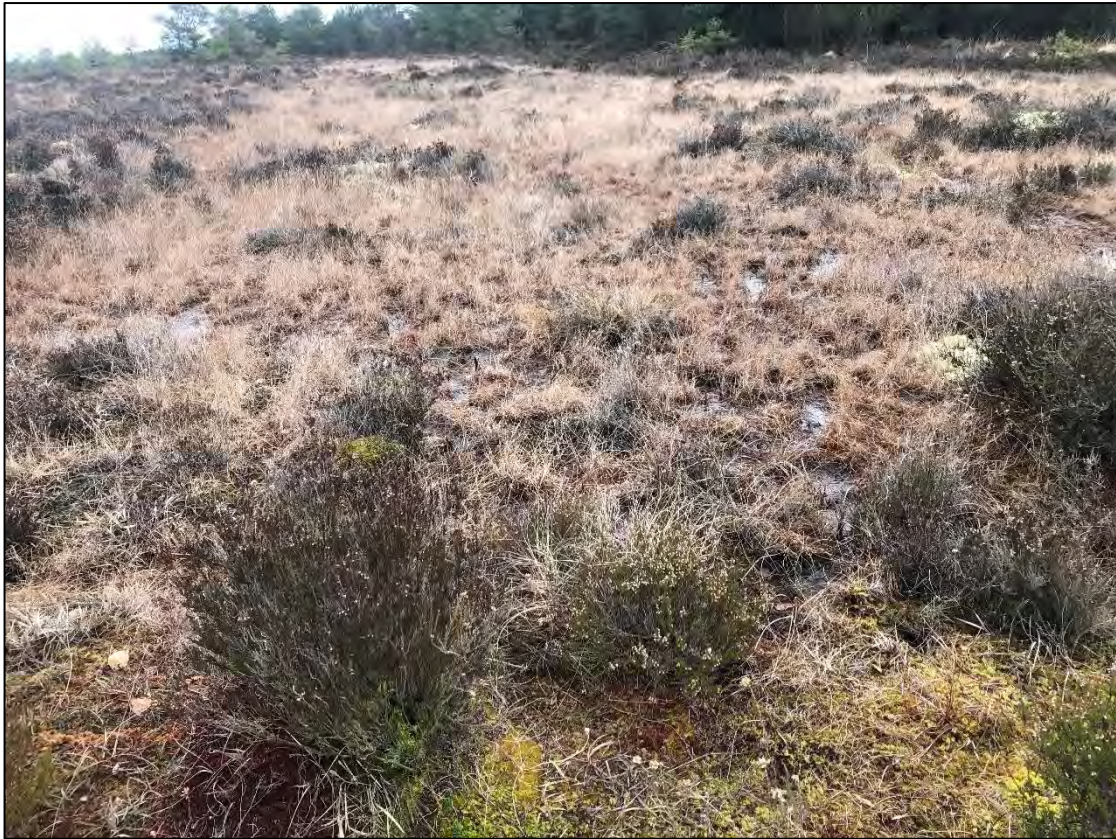
Plate 2-9 Poor Fen and flush (PF2) present to the south of the site, with species of Ling Heather (*Calluna vulgaris*), *Sphagnum* spp, Purple Moor grass (*Molinia caerulea*), Reindeer Lichen (*Cladonia portentosa*), and Common Cottongrass (*Eriophorum angustifolium*)

A flush occurs in the western section of the bog, situated within the drained basin of Martinstown Lough. The outer margins of the flush are classified as inactive, due to low *Sphagnum* cover. The former basin of the lake is still evident, and the lowest section is quite wet and quaking, with higher *Sphagnum* cover. This area conforms to active flush and sub-central ecotope and is considered Annex I “*Active Raised Bog*”.

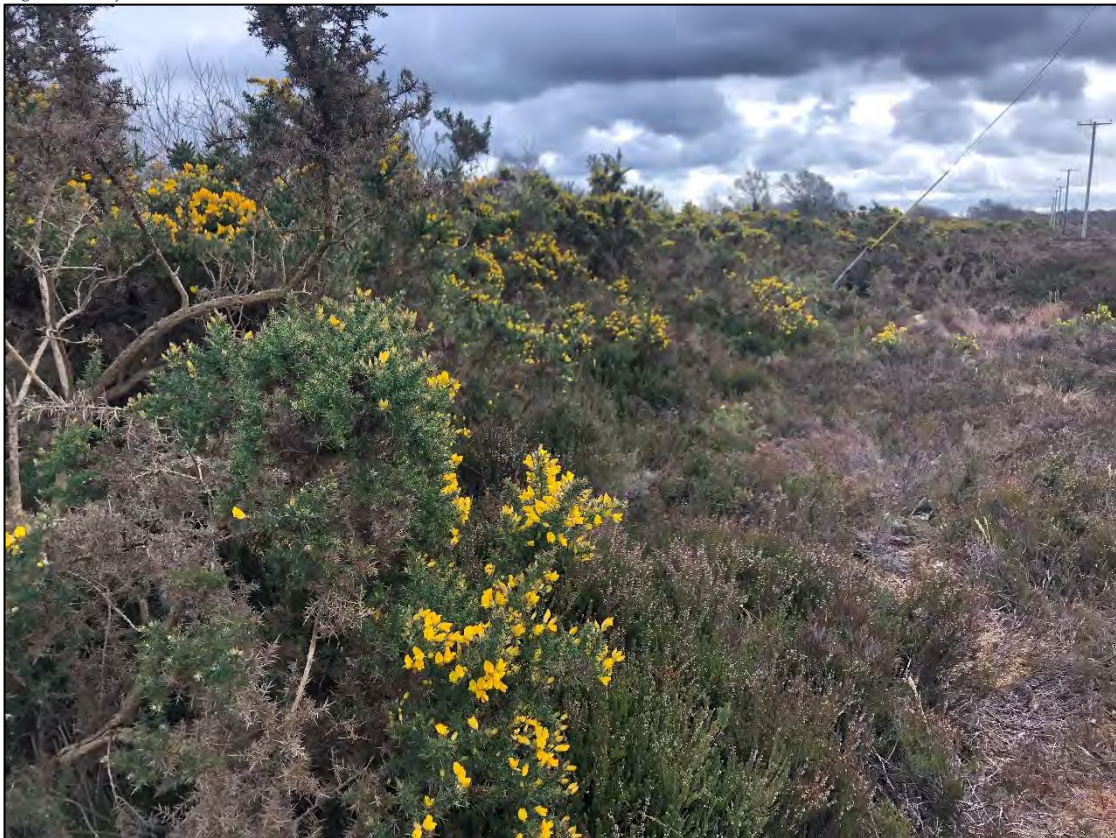
Plate 2-10 Scrub (WS1) dominated by Gorse (*Ulex europaeus*) present to the eastern boundary of the site.

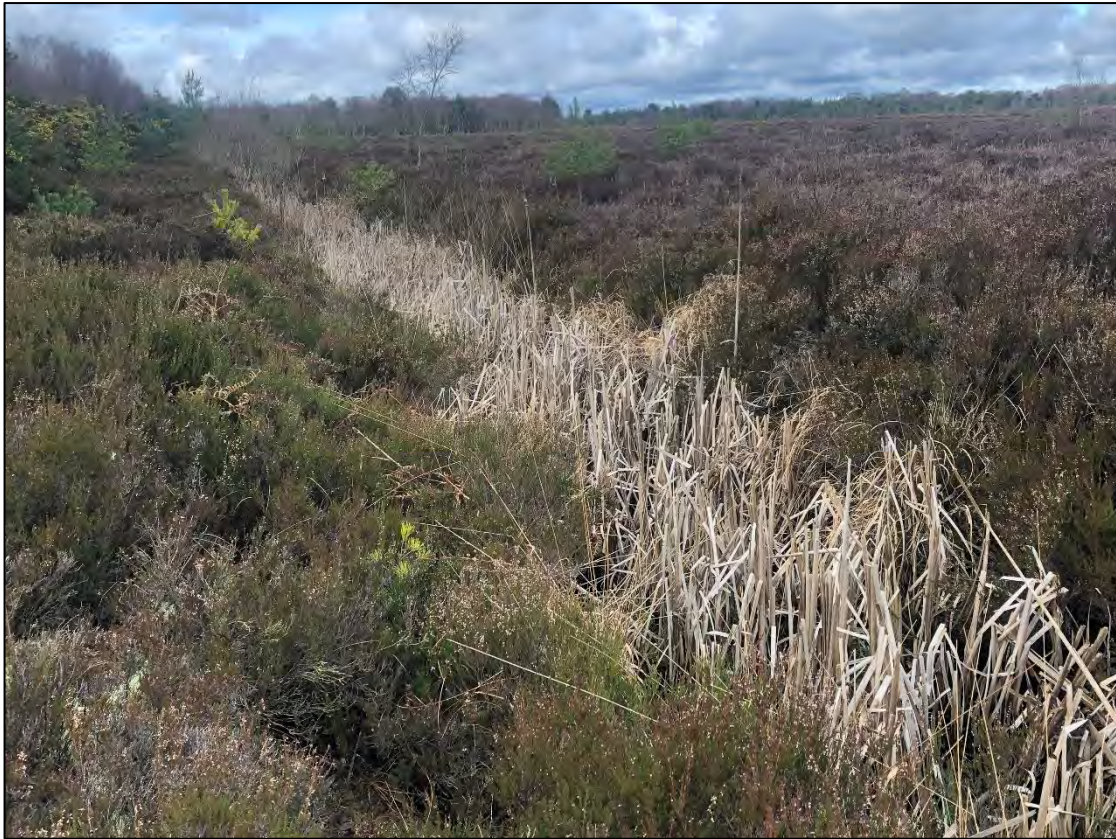
*Plate 2-11 The Bolandstown Stream classified as Depositing Stream/River (FW2) flows to the southern margin of the site, in a south-easterly direction.*

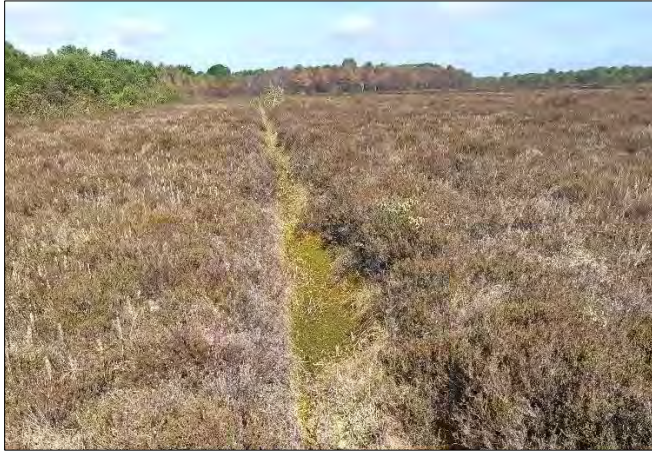
*Plate 3.1 Example of drainage ditches occurring within Lisclogher West, supporting Sphagnum mosses (May 2020).*

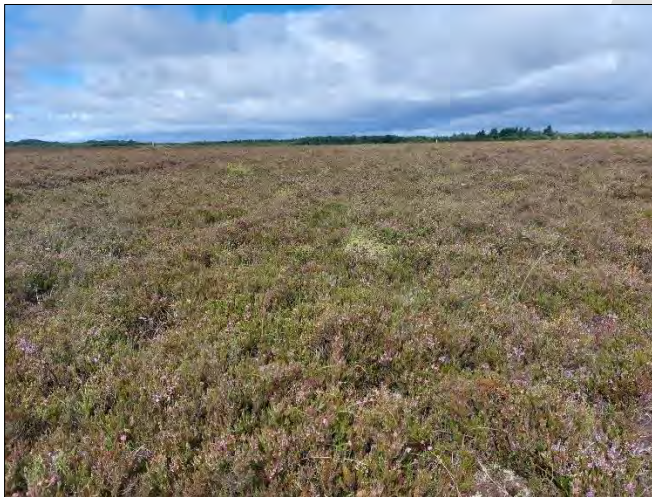
*Plate 3.3 Example of degraded/dry heather Lisclogher West bog (August 2022).*

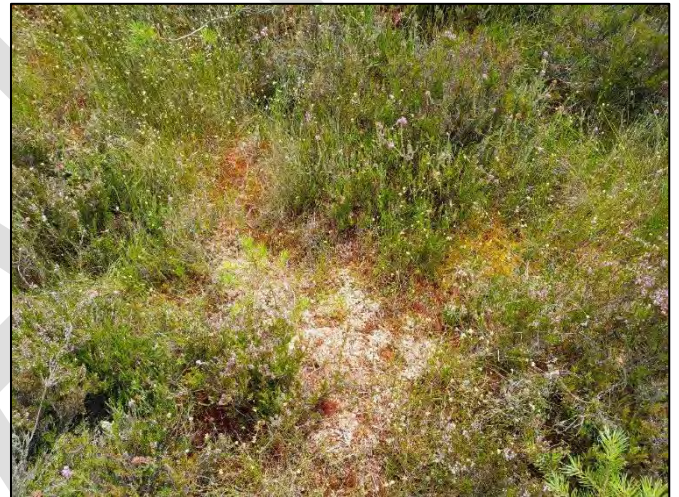
*Plate 3.4 Sub-central ecotope located in the active flush in the western section of the bog, formed in the basin of a former lake. (August 2022).*
