Bord na Móna

Lisclogher West Bog

**Cutaway Bog Decommissioning and
Rehabilitation Plan**

2023

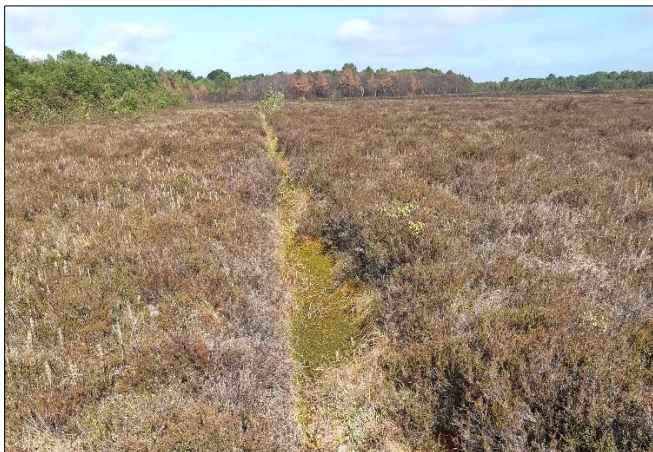
Plate 3.1 Example of drainage ditches occurring within Lisclogher West, supporting Sphagnum mosses (May 2020).

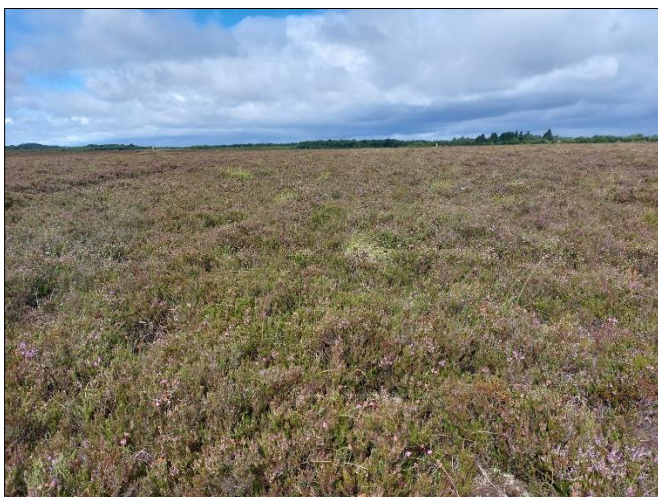
Plate 3.3 Example of degraded/dry heather Lisclogher West bog (August 2022).

The majority of the bog does not have a well-developed micro-topography, lacking pools and hummocks. It is generally uniform, dominated by low heather, lacking *Sphagnum* mosses and is firm and dry underfoot. The western section of the bog, south of the road had a more natural raised bog topography including hummocks, and pools, although it had been recently burned.

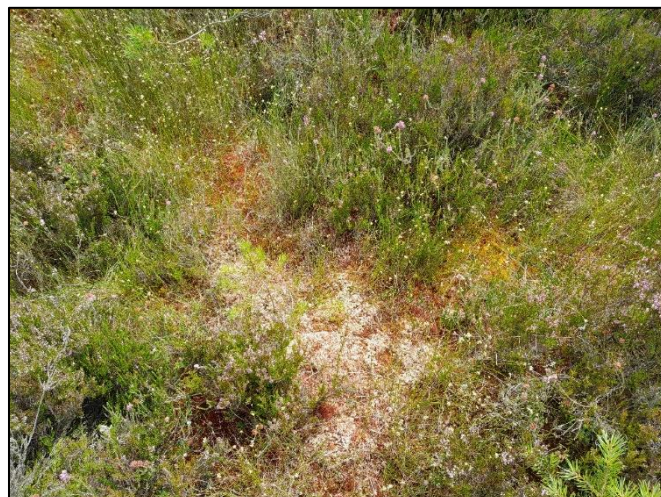
Plate 3.4 Sub-central ecotope located in the active flush in the western section of the bog, formed in the basin of a former lake. (August 2022).

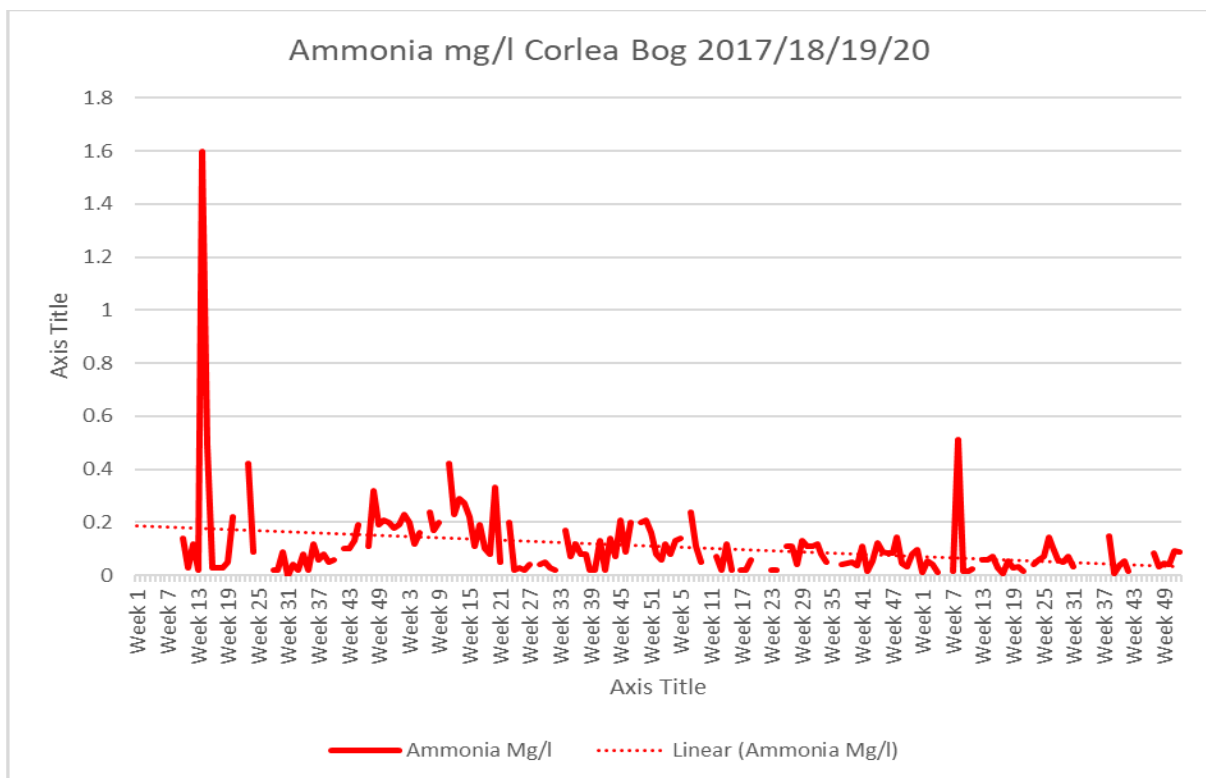
Figure 7.1. Ammonia levels over the period 2015-2019/2020 at Longfordpass and Corlea.

Similarly monitoring of surface water ammonia emissions from a Corlea bog in Mountdillon over the past 3 yrs. post cessation of peat extraction with ongoing rehabilitation, indicate downward trends.

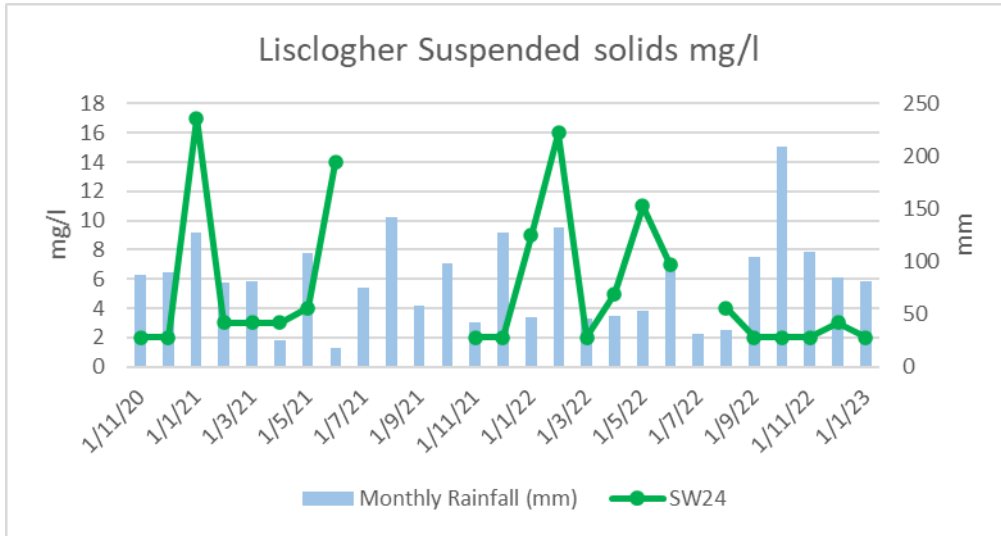
Plate 12-1 Results of suspended solids monitoring at Lislogher West November 2020 - January 2023

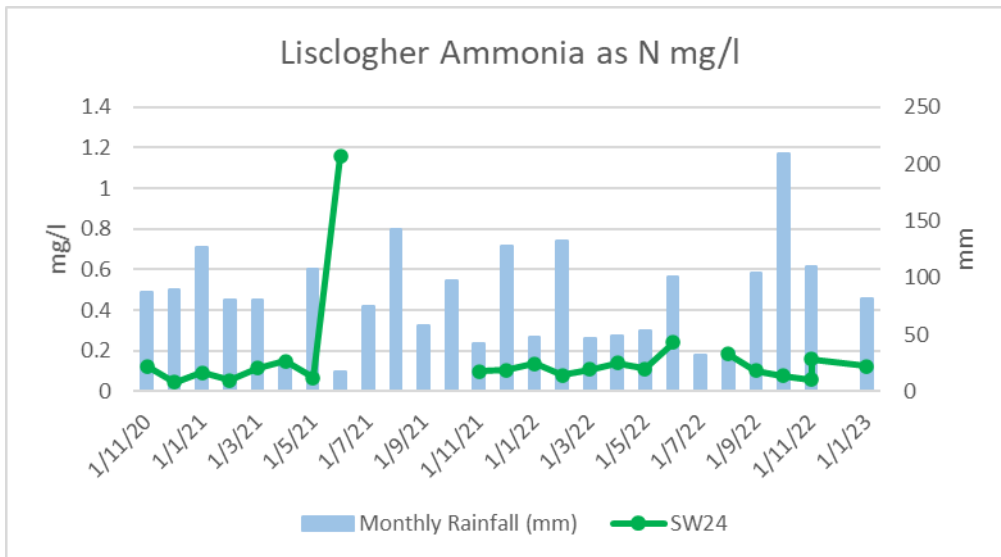
Plate 12-2 Results of Ammonia monitoring at Lislogher West November 2020 - January 2023

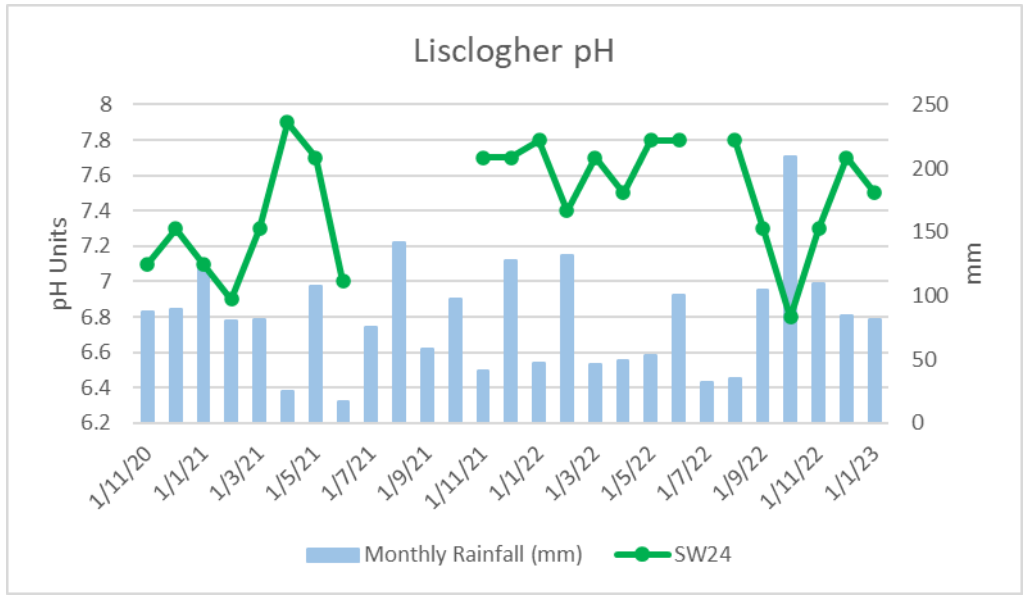
Plate 12-3 Results of pH monitoring at Lislogher West November 2020 - January 2023
