Killeglan Bog Decommissioning and Rehabilitation Plan 2023

SCREENING FOR APPROPRIATE ASSESSMENT | SEPTEMBER 2023

Appropriate Assessment Screening Report

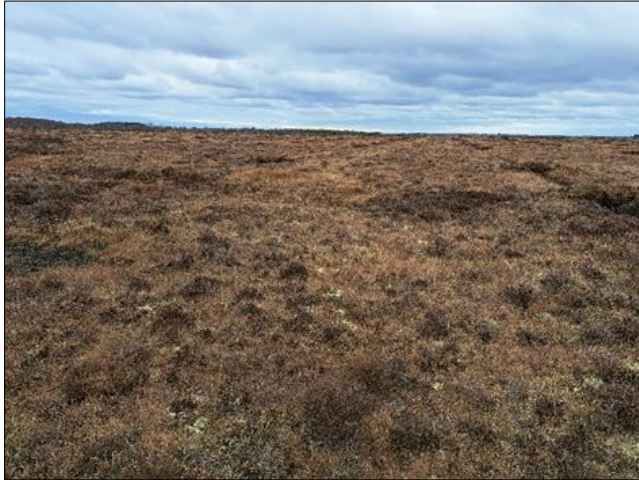
Plate 3.1 Raised bog habitat to the north west of Killeglan Bog showing some former drain blocking.

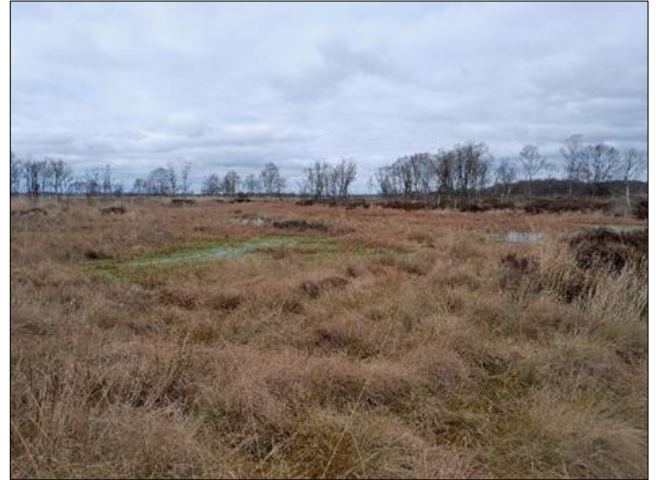
Plate 3.2 Remnant of Goats Lough categorised as Transition mire and quaking bog.

These former lakes are now classified as transition mire and quaking bog (PF3), although they are likely to form a complex soak system. During the ecological surveys carried out in 2016 Goats Lough East was noted as having infilled with a floating mat of *Sphagnum*, and all three lakes were very wet and quaking.

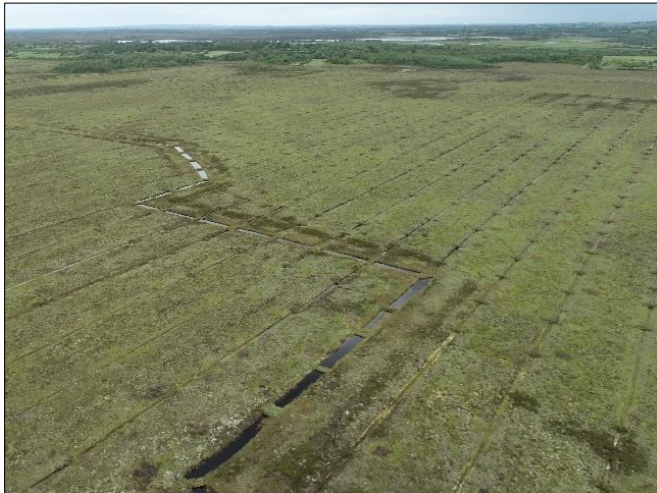
Plate 3.3 Drone photo of Killeglan bog with former drains blocked in this area. Some additional targeted drain blocking has been identified to increase the extent and resilience of former drain blocking.

<p>(c) Killeglan bog with former drains blocked in this area. Some additional targeted drain blocking has been identified to increase the extent and resilience of former drain blocking.</p>	<p>(d) Example of Rich fen and Transition mire occurring within the north central margins of Killeglan bog (West of Cuckoo Hill). This area has been subject to some historic domestic turf cutting. Areas of rich fen have been identified as sensitive habitats and avoided.</p>

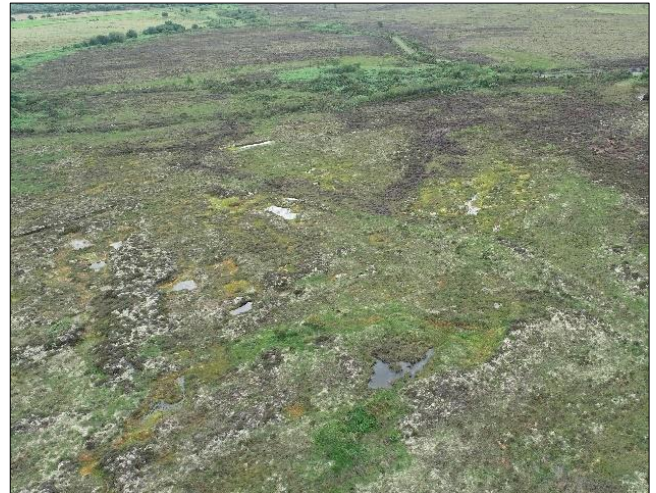
Plate 3.4 Example of Rich fen and Transition mire occurring within the north central margins of Killeglan bog (West of Cuckoo Hill). This area has been subject to some historic domestic turf cutting. Areas of rich fen have been identified as sensitive habitats and avoided.
