# **Bord na Móna**

**Derrymoylin bog**

**Cutaway Bog Decommissioning and  
Rehabilitation Plan**

**2023**

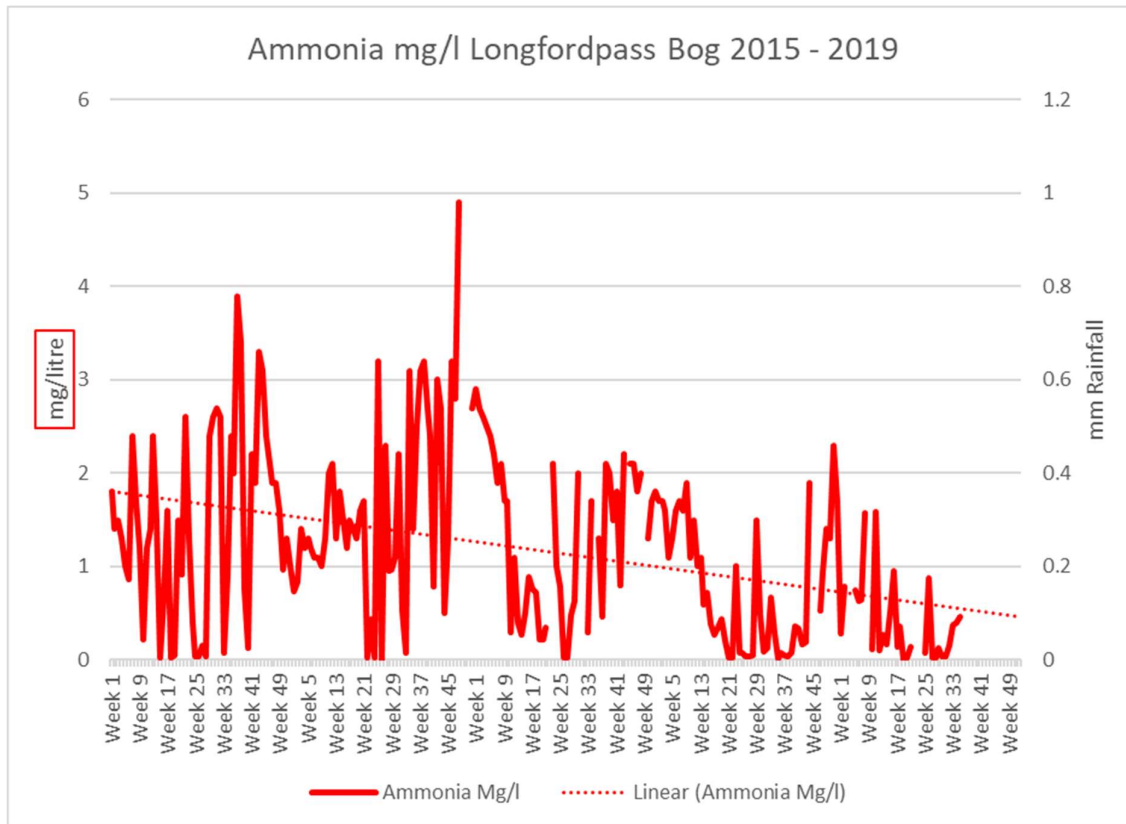
**Figure 7.1.** Ammonia levels over the period 2015-2019 at Longfordpass and the period 2017-2020 at Corlea.

Similarly monitoring of surface water ammonia emissions from a Corlea bog in Mountdillon over the past 4 yrs. post cessation of peat extraction with ongoing rehabilitation, indicate downward trends.

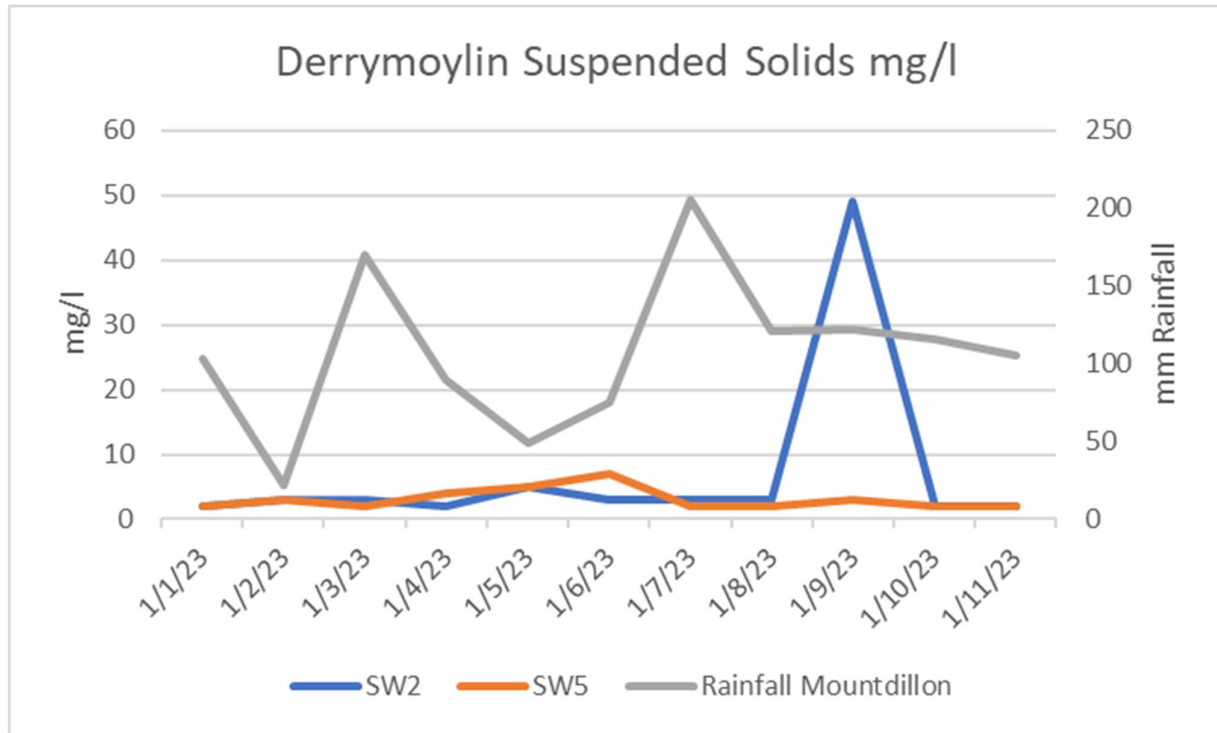
Plate 130-1 Derrymoylin suspended solids sampling results
