**Bord na Móna**

**Newtown-Loughgore Bog**

**Cutaway Bog Decommissioning and  
Rehabilitation Plan**

**2024**

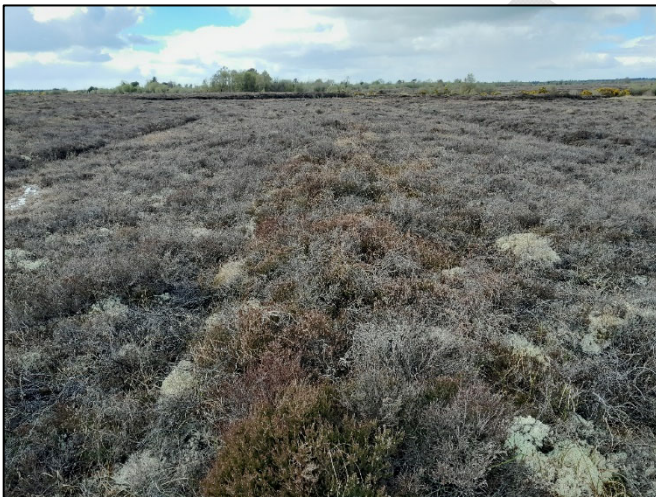
*Plate 3-1 Ditched and degraded raised bog to the north of Newtown Bog.*

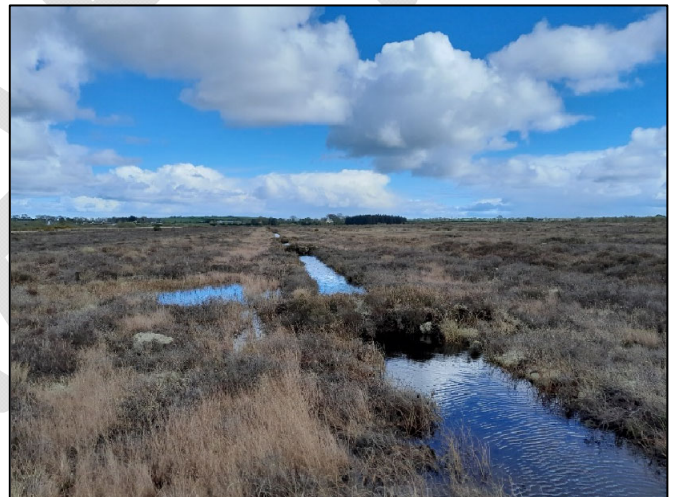
*Plate 3-2 Previously installed drain blocks to the north of Newtown Bog.*

- Rehabilitation was previously carried out on this bog in the form of drain blocking between 2018-2020. However, some of the bog still has functional drainage and targeted measures are required to reinstate identified failed drain blocks, block flow paths and to further maximise the extent of active raised bog conditions. Measures proposed for Newtown-Loughgore Bog include additional targeted drain blocking on high bog and cell bunding on marginal cutover to raise water levels to the surface of the peat.

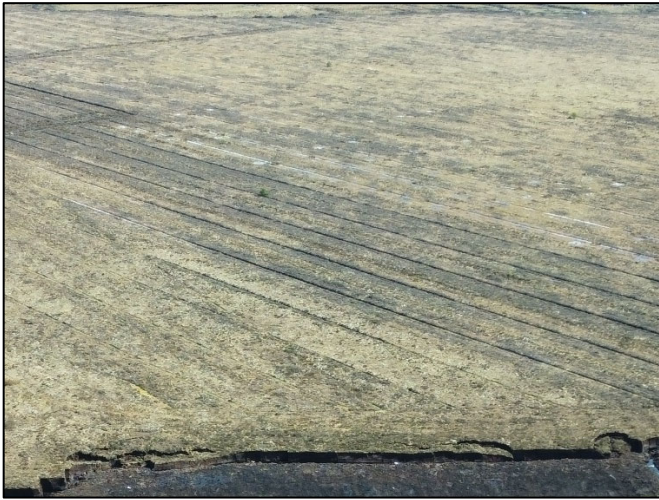
Plate 3-3 Drone image showing cutover bog (foreground, open drainage ditched (middle ground) and previously blocked drains (background).

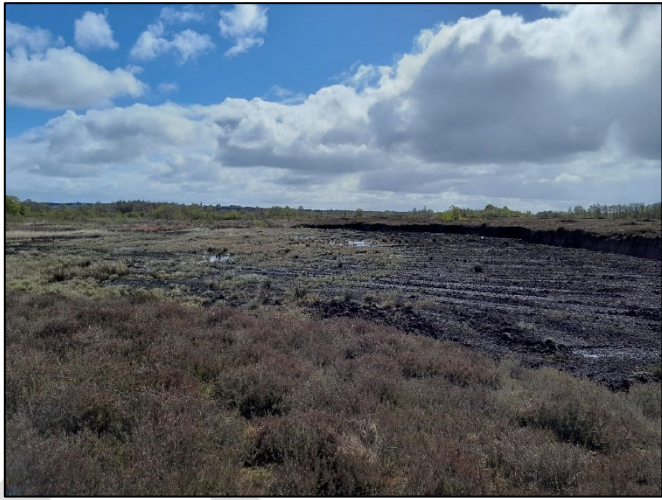
Plate 3-4 Cutover bog to the south of Loughgore
