Bord na Móna

Lemanaghan Bog

**Cutaway Bog Decommissioning and
Rehabilitation Plan**

2024

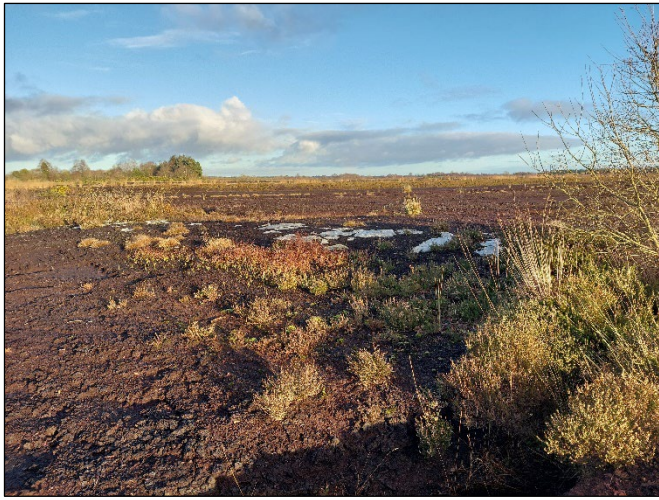
Plate 3-1 Archaeological constraint – ancient trackway running through the NW of Derrynagun Bog. Trackway is developing pioneer vegetation and scrub.

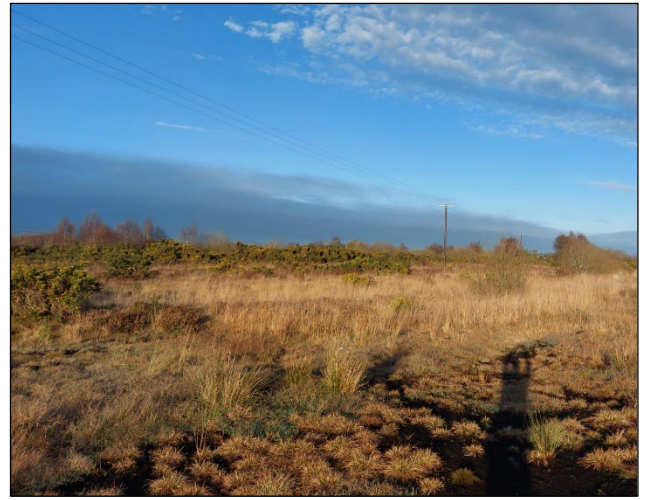
Plate 3-2 Marginal scrub and pioneer vegetation at Derrynagun Bog.

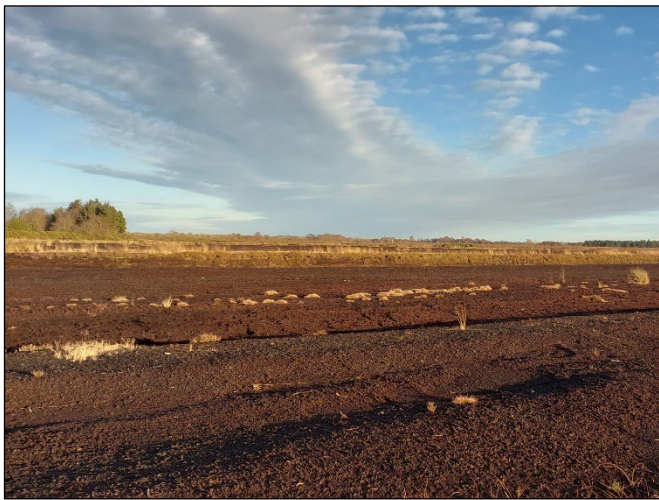
Plate 3-3 Bare peat in the former production area in Derrynagun Bog.

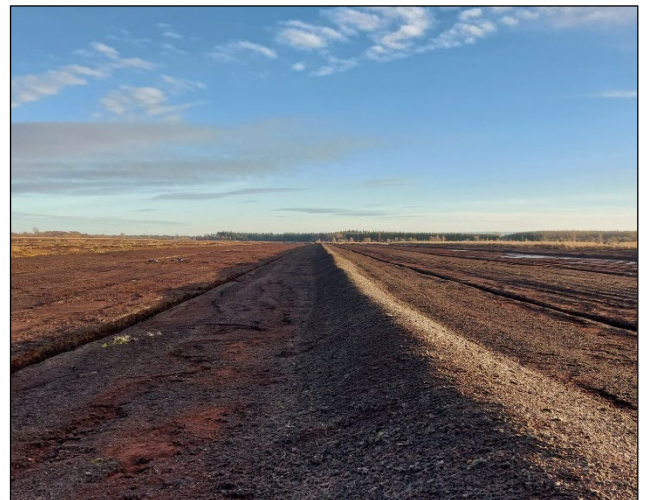
Plate 3-4 Stockpile at Derrynagun Bog.

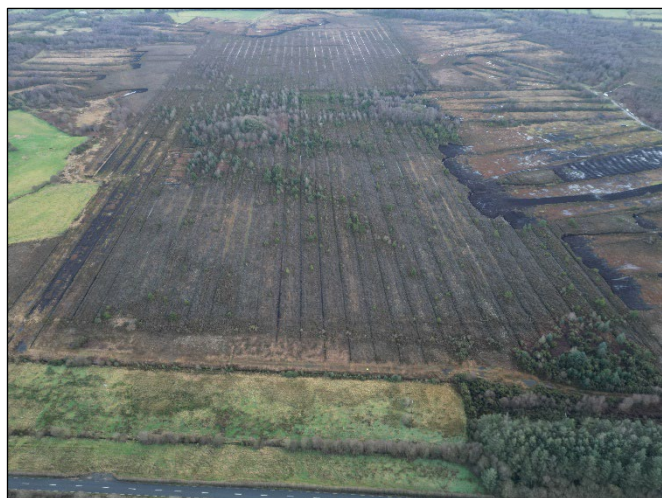
Plate 3-5 Curragalassa Bog a drained raised bog which includes the western PCAS extent, view looking south. Birch scrub and conifers are encroaching in the centre of the bog.

This part of the PCAS extent mainly consists of ditched high bog where (plate 3.5 & Plate 3.6) there has been only limited peat production due to archaeological constraints. It is surrounded by active cutover bog along the south-eastern boundary and there is encroachment from private cutting around other sections (outside of the PCAS extent). Habitats found in this section of bog include; raised bog (PB1), wet grassland (GS4), scrub (WS1), poor fen and flush (PF2), Oak-Ash-Hazel woodland (WN2) and conifer plantation (WD4). There is encroachment of birch scrub and conifers onto the high bog.

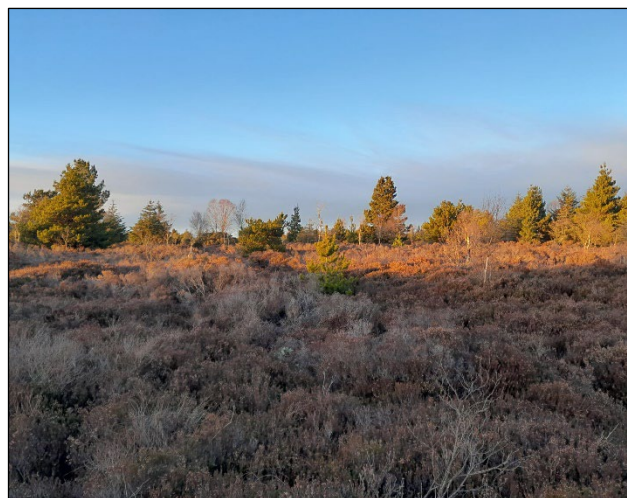
Plate 3-6 Raised bog at Curragalassa with encroaching birch scrub and conifers.
