Bord na Móna

Attymon Bog

**Cutaway Bog Decommissioning and
Rehabilitation Plan
2024**

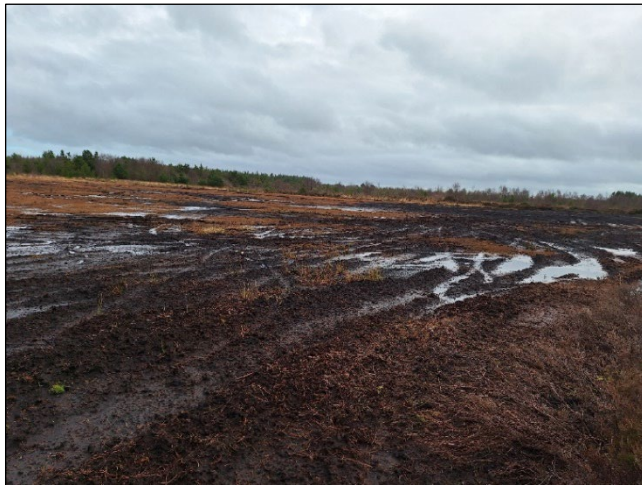
Plate 3-1 Cutover dominated by bare peat and pioneer vegetation to the north-western corner of the site.

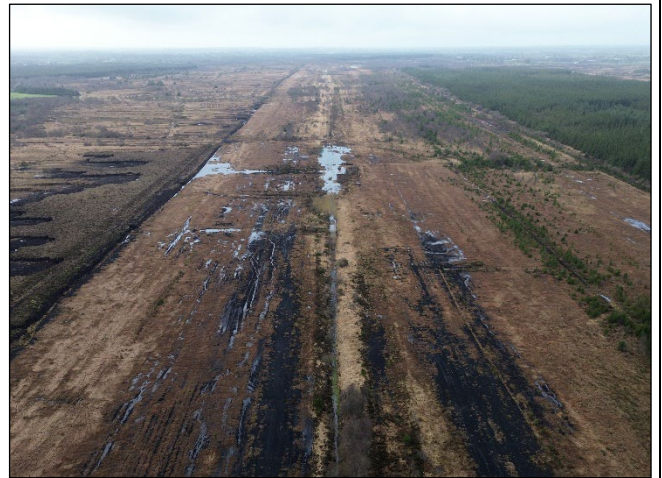
Plate 3-2 Pioneer vegetation and bare peat south of the conifer plantation. Remnant raised bog occurs along the southern border.

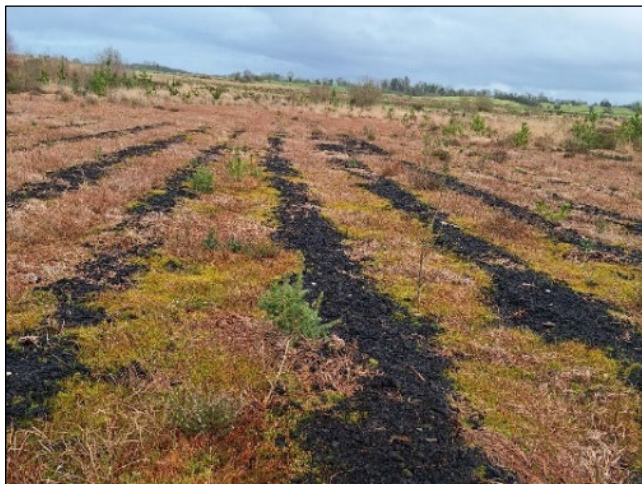
Plate 3-3 Bare peat and pioneer vegetation in the SE of the northern lobe.

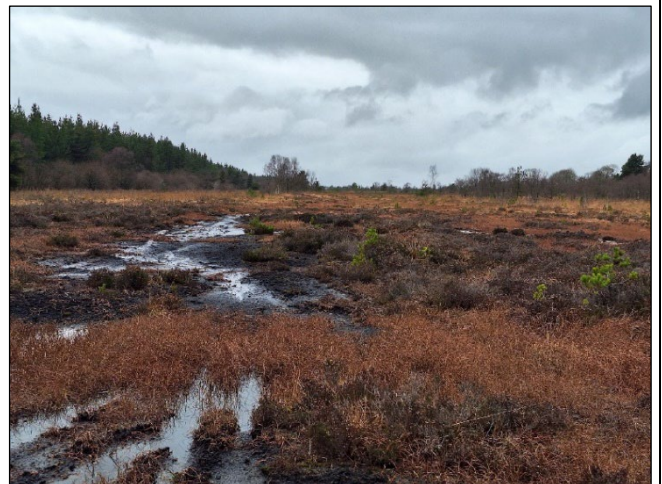
Plate 3-4 Cutover dominated by pioneer vegetation, bare peat and occasional scrub to the north of the conifer plantation within the main lobe.

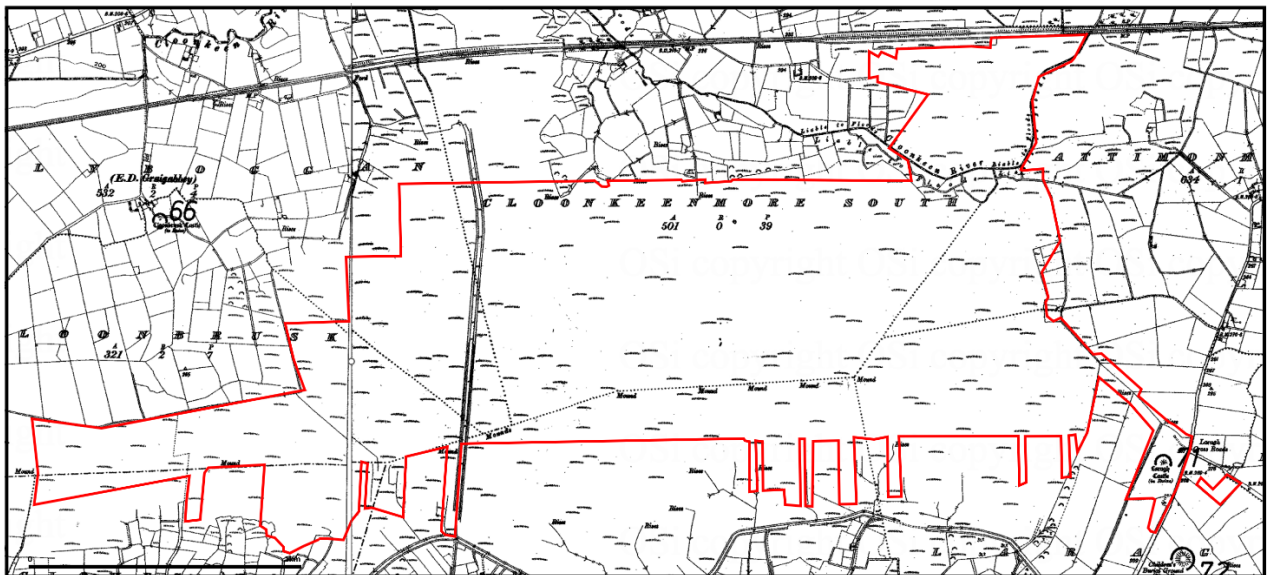
Fig. 2. Attymon bog, Co. Galway, detail of the Record of Monuments and Places map sheet Galway Nos. 84 and 85. The proposed rehabilitation area is outlined with the red line.
