Cloonboley Bog Decommissioning and Rehabilitation Plan 2024

SCREENING FOR APPROPRIATE ASSESSMENT | June 2024

Appropriate Assessment Screening Report

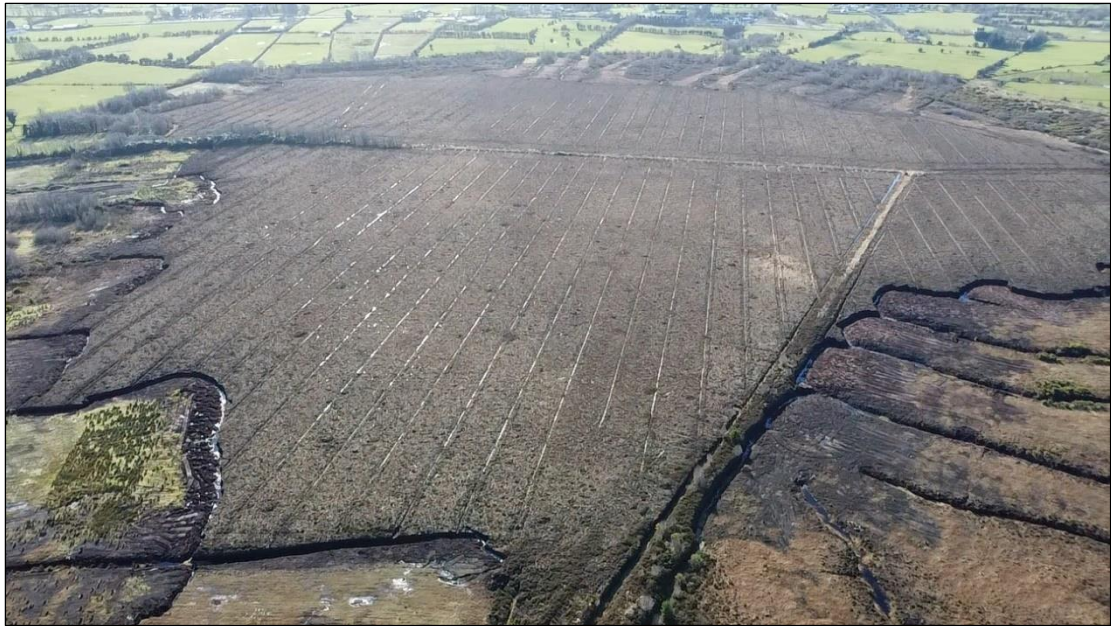
(a) Raised Bog at Tonalig South Bog. Note the cutover bog fringes the high bog.

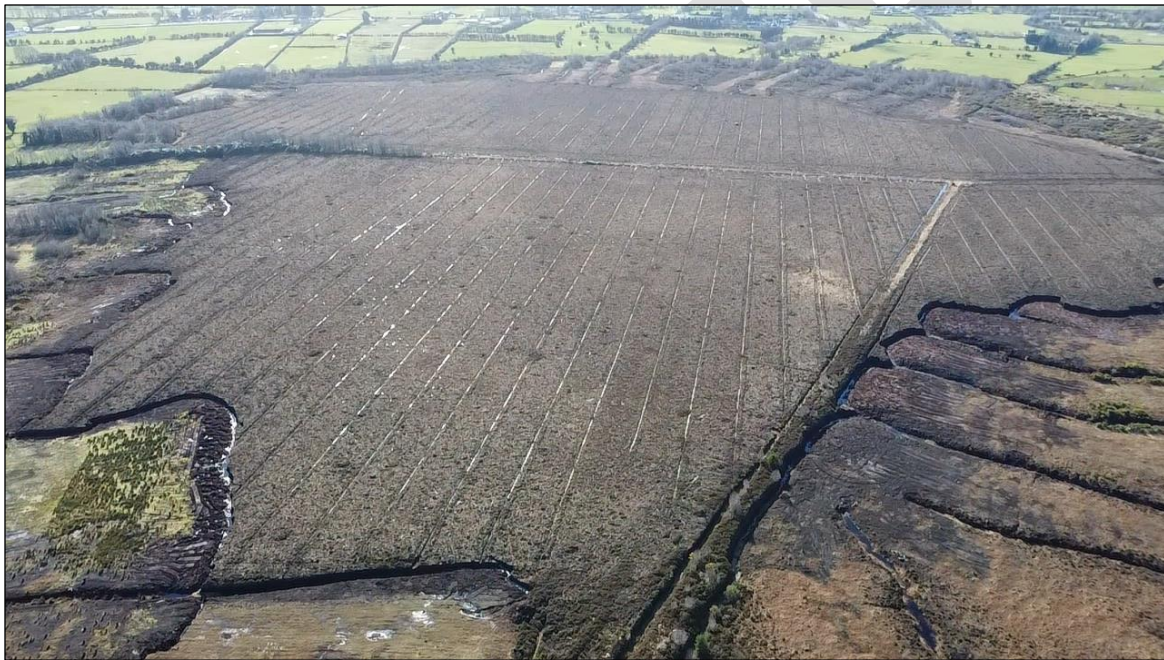
Plate 3.1 Raised bog at Tonalig South Bog. Note the cutover bog fringes the high bog.
