**Bord na Móna**

**Cloontuskert Bog**

**Cutaway Bog Decommissioning and  
Rehabilitation Plan**

**2025**

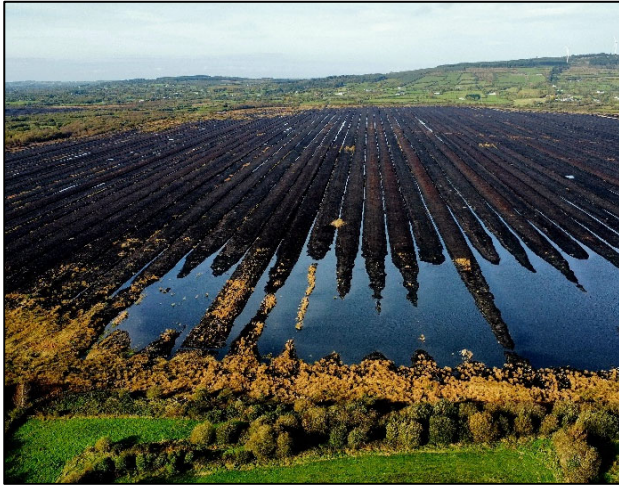
*Plate 3-1 Aerial view of Cloontuskert (view northwest).*

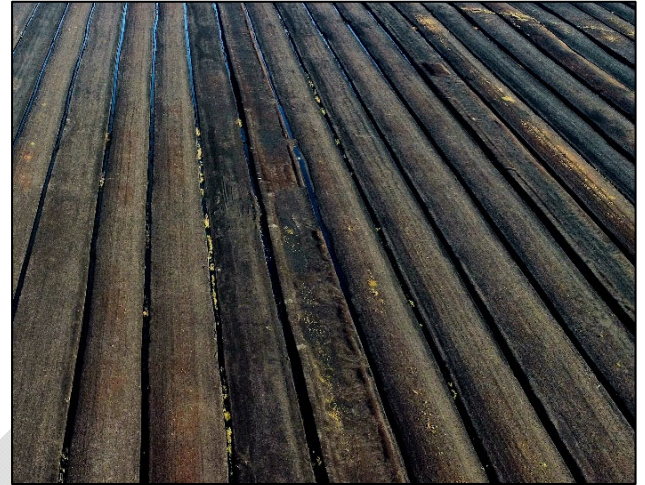
*Plate 3-2 Aerial view of Bare peat.*

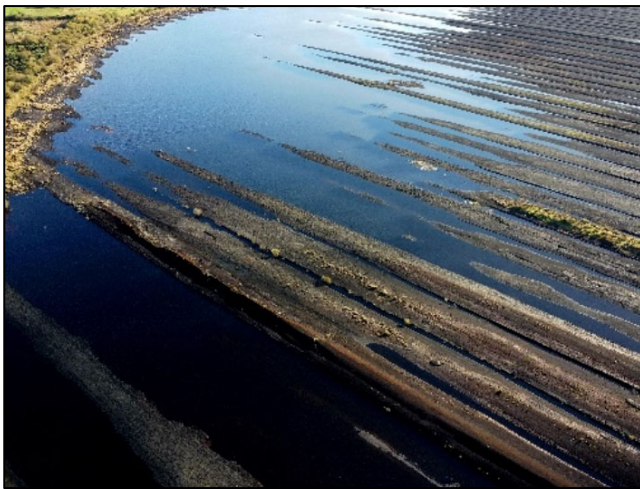
*Plate 3-3 Area of Open water in Cloontuskert bog.*

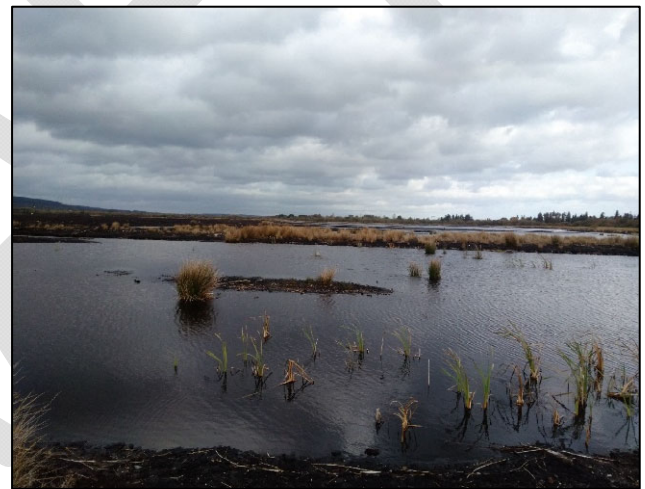
*Plate 3-4 Open water.*

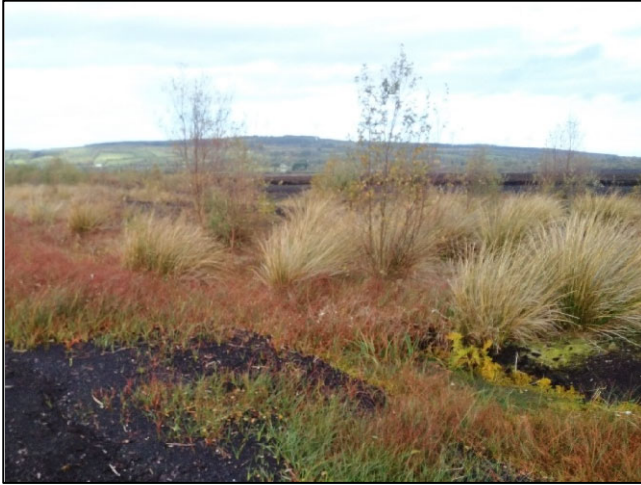
*Plate 3-5 Pioneer open habitats.*

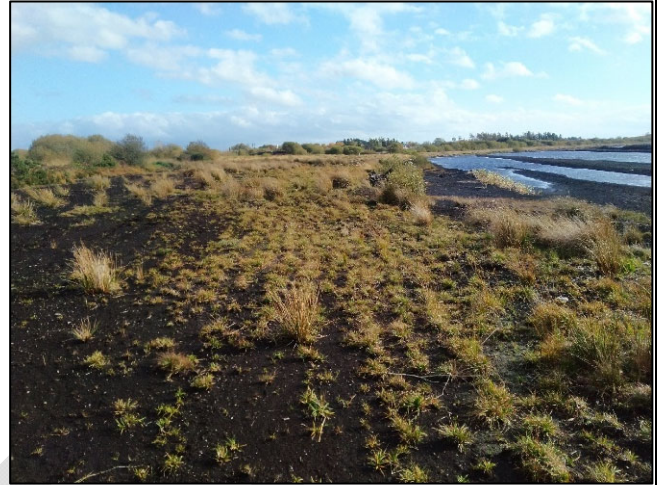
*Plate 3-6 Pioneer open habitats.*

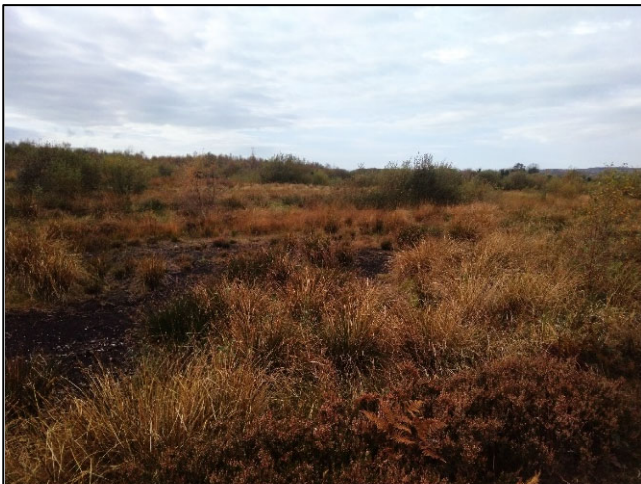
*Plate 3-7 Pioneer open habitats and scrub.*

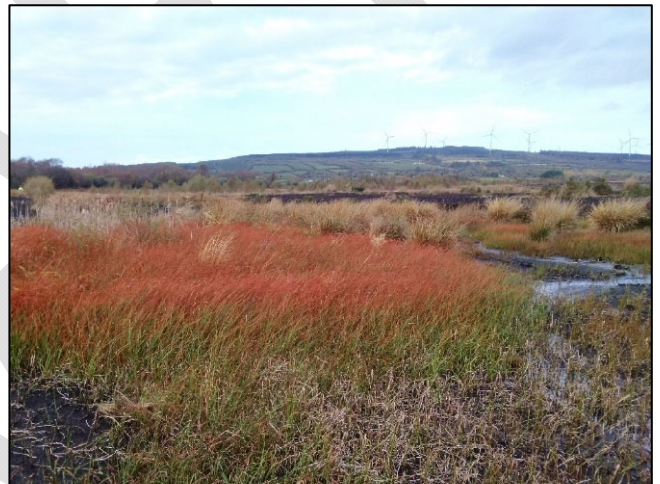
*Plate 3-8 Bog Cotton dominated pioneer open habitats.*
