Bord na Móna

Derryville Bog

**Cutaway Bog Decommissioning and
Rehabilitation Plan
2025**

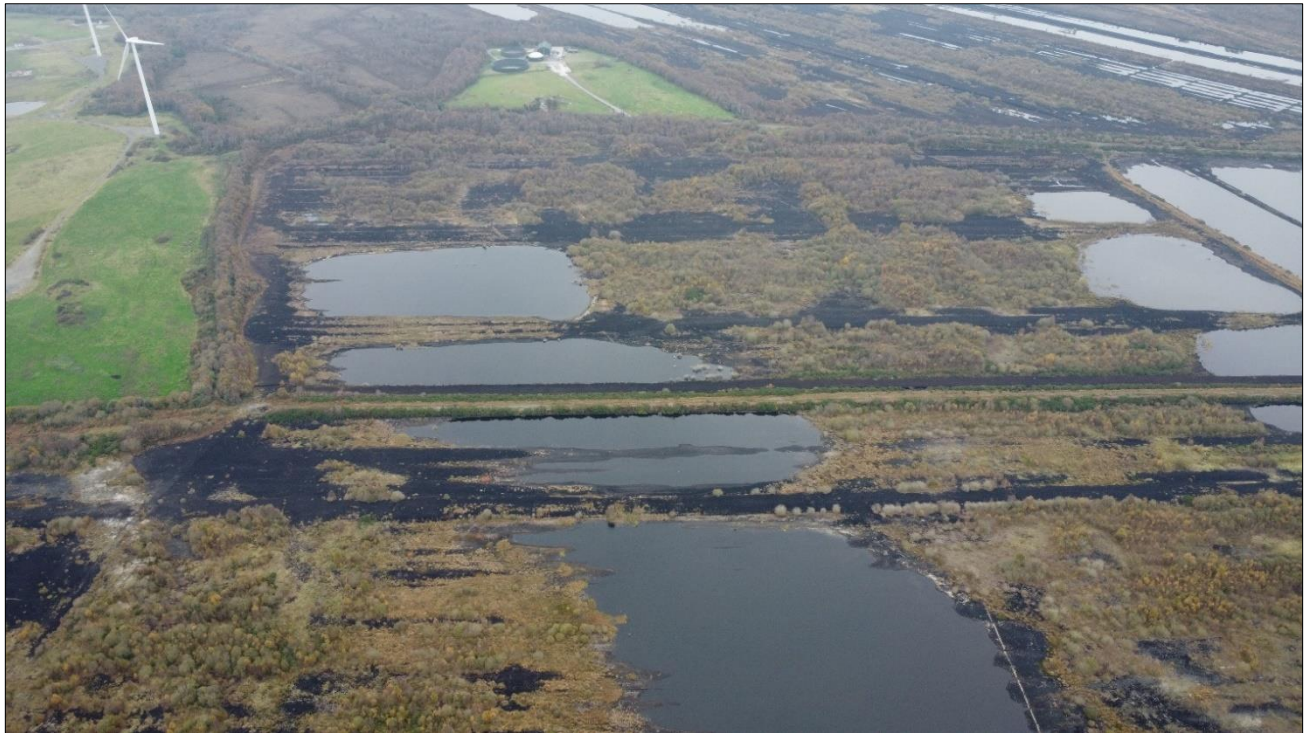
Plate 3-1 Example of dry elevated ridges supporting establishing Birch dominated scrub, with permanent standing water within depressions., in the northwest of Derryville (view looking north).

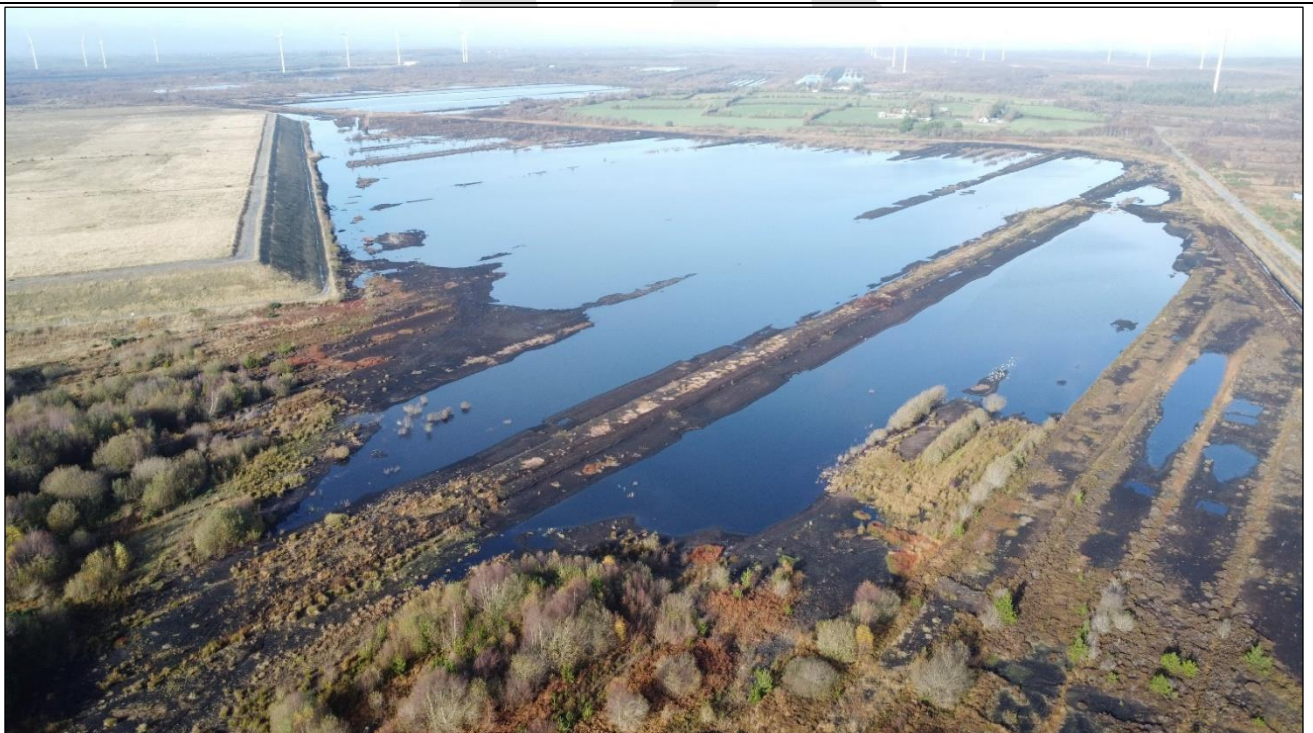
Plate 3-2 Southeastern section of Derryville, looking north. Large wetland has developed in this area.
