# **Bord na Móna**

**Erenagh Bog**

**Cutaway Bog Decommissioning and  
Rehabilitation Plan**

**2025**

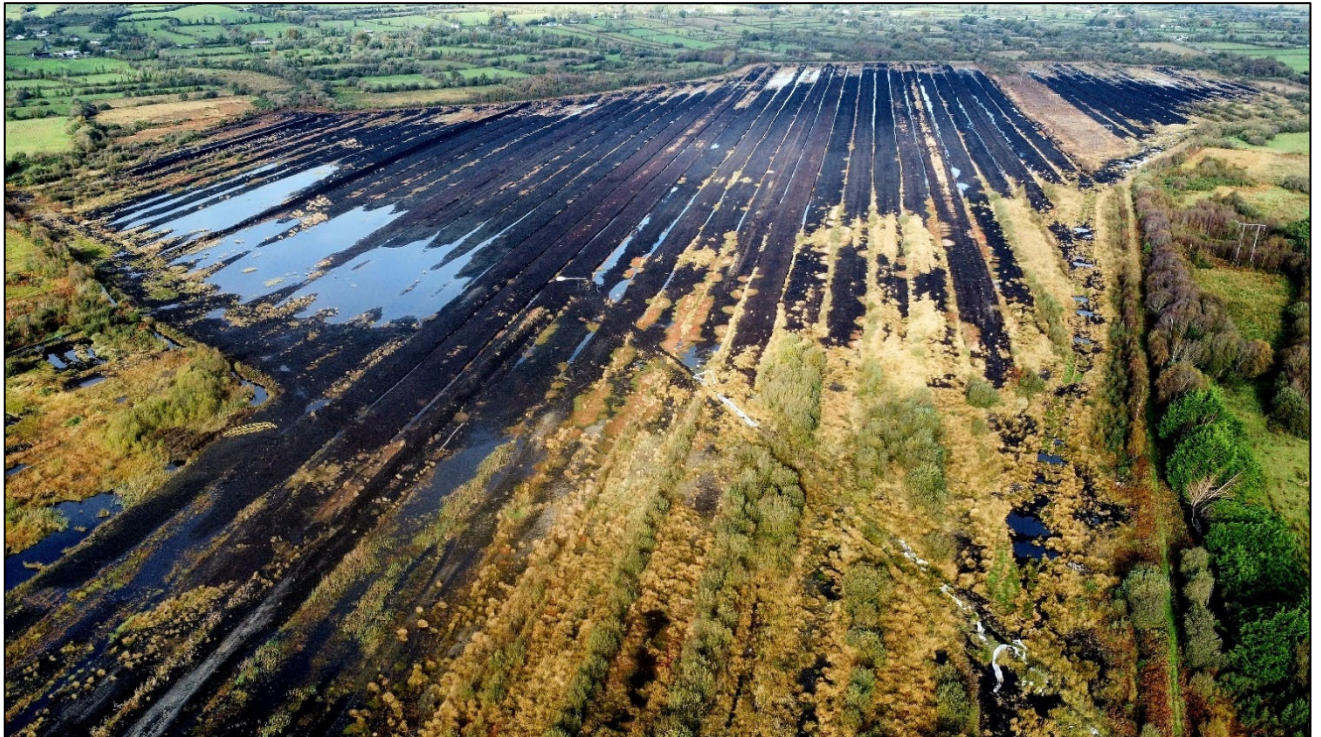
Plate 3-1 Erenagh Bog, looking northwest. The cutover is dominated by bare peat, with developing pioneer communities of *Juncus effusus* and *Eriophorum angustifolium*. Birch scrub (eBir/oBir) and pioneer open habitats are developing in the SW part of the bog.

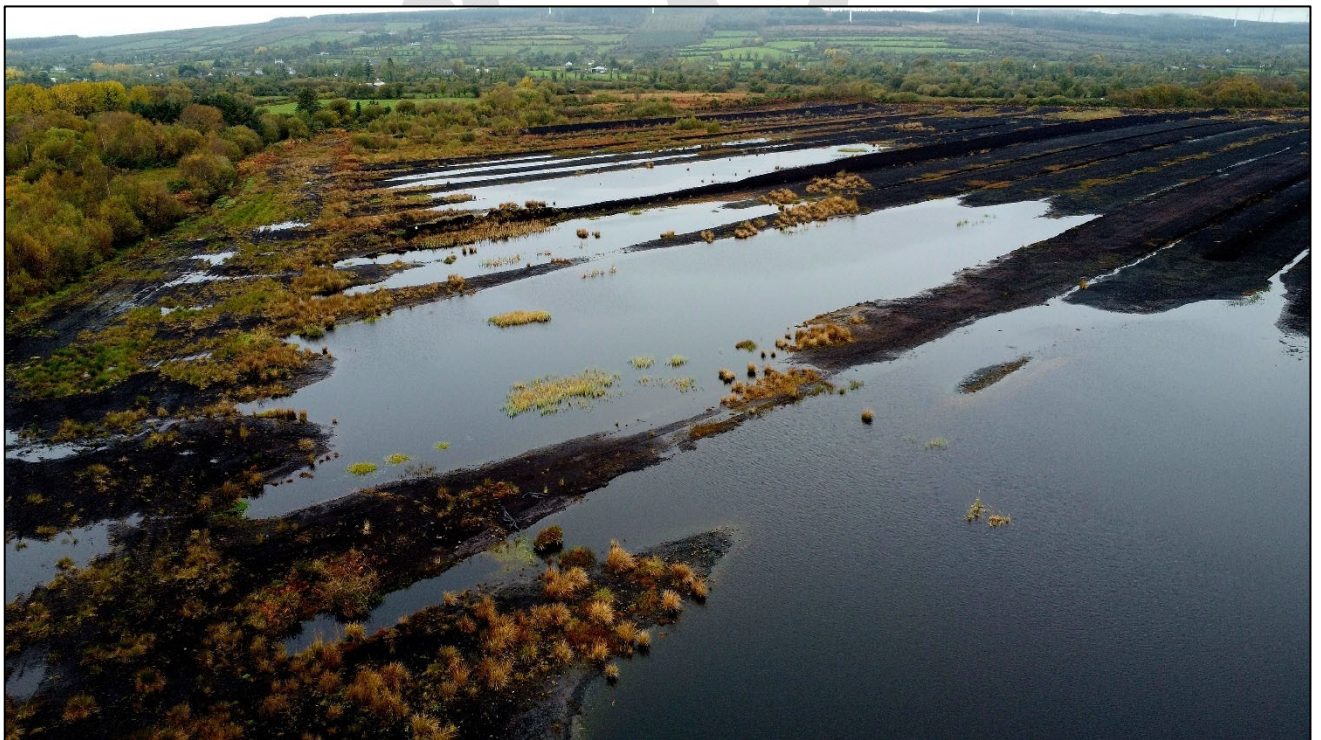
Plate 3-2 Open water (OW) occurs in the south of Erenagh Bog with pioneer *Juncus effusus* (pJeff), *Eriophorum angustifolium* (pEang) and *Carex rostrata* (pRos).

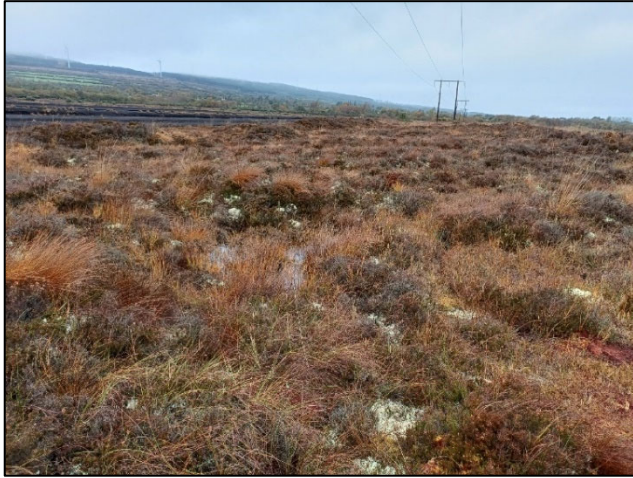
*Plate 3-3 Area of degraded raised bog along the powerline route at Erenagh Bog.*

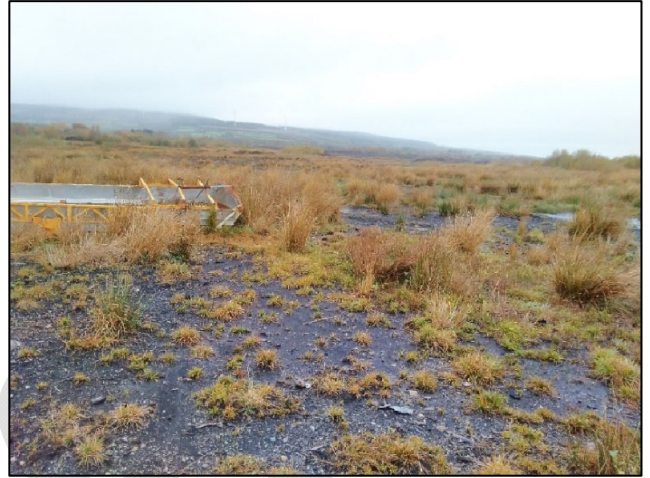
*Plate 3-4 Cutover bog with pioneer vegetation dominated by *Juncus effusus*, *J. bulbosus* and *Carex demissa* in the southeastern part of the Bog.*

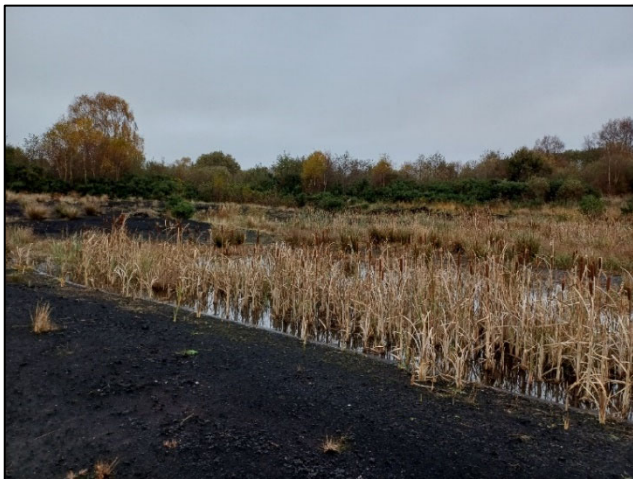
*Plate 3-5 Bare peat cutover in the foreground and pioneer *Typha latifolia* and *Phragmites australis* in ponding areas.*

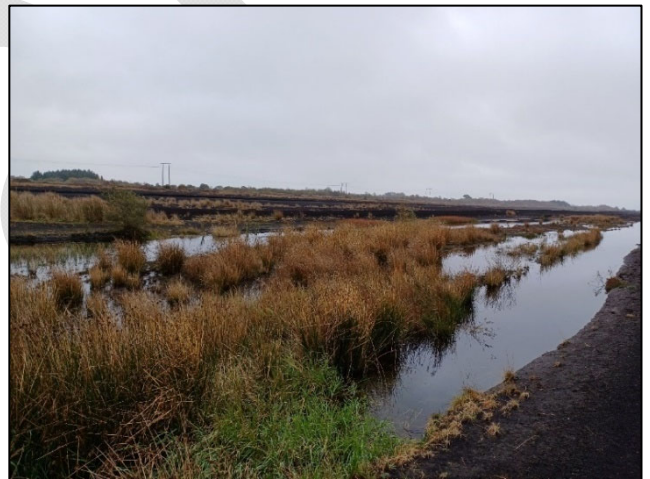
*Plate 3-6 Cutover bog dominated by bare peat with pioneer *Juncus effusus* poor fen (pJeff) in the north of the site.*
