**Templetuohy Bog**

**Cutaway Bog Decommissioning and  
Rehabilitation Plan  
2025**

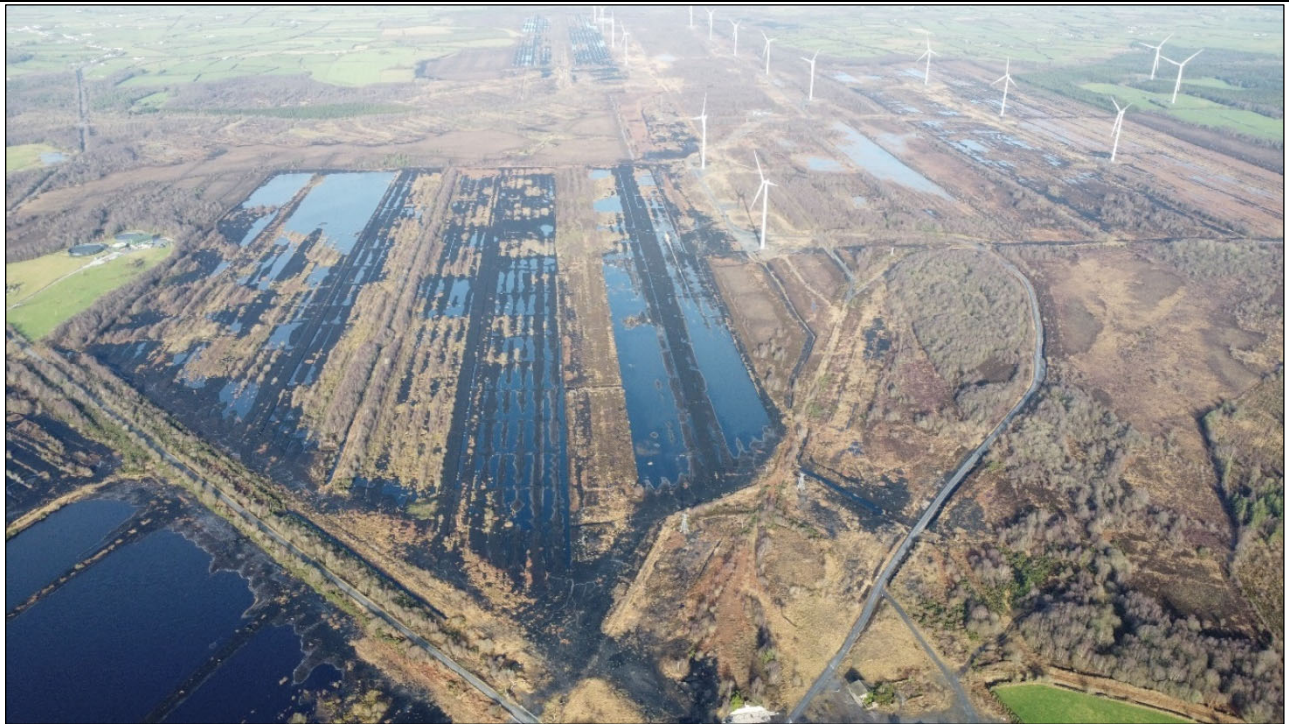
Plate 3-1 Templetuohy Bog, view looking north. Wind farm infrastructure is located in the central section of the bog. The western part of the bog has been rewetted and is a mosaic of bare peat, open water and emergent poor fen communities dominated by Soft Rush (pJef), Bog Cotton (pEang) and Bottle Sedge (pRos).

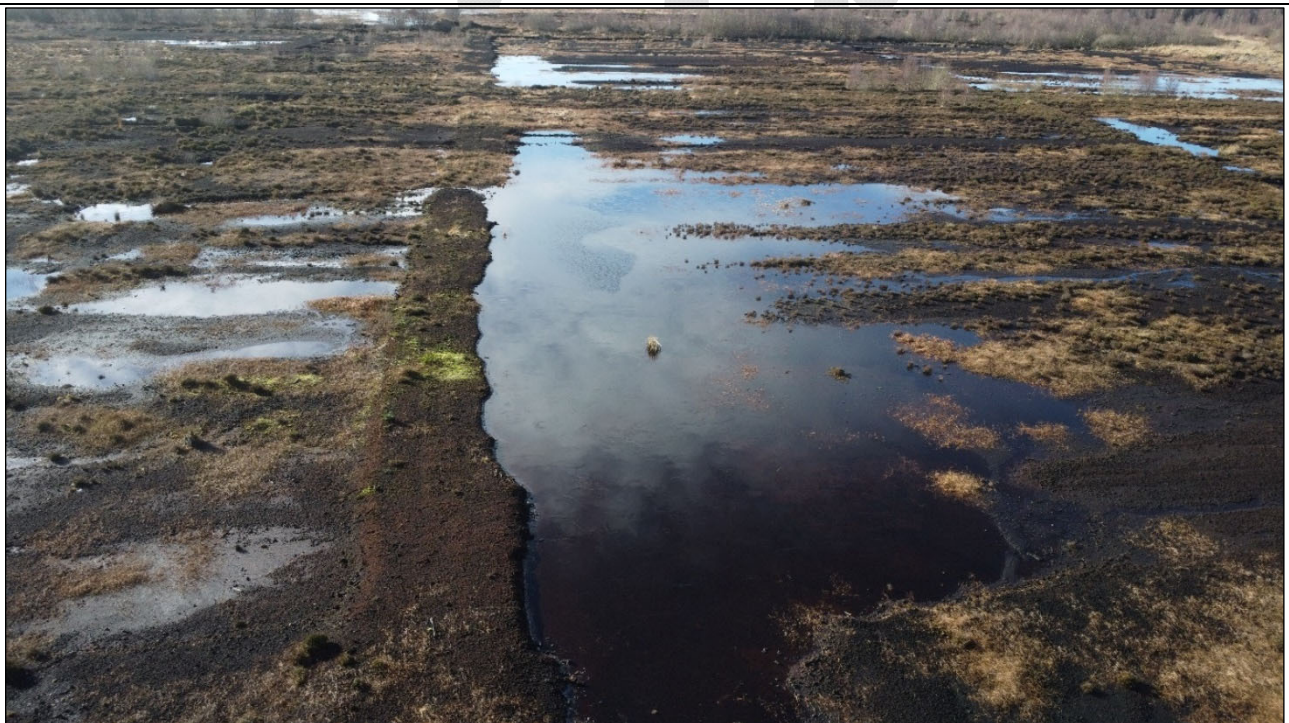
Plate 3-2 Rewetted part of the bog, in the west of the site, of bare peat, open water and emergent poor fen communities.

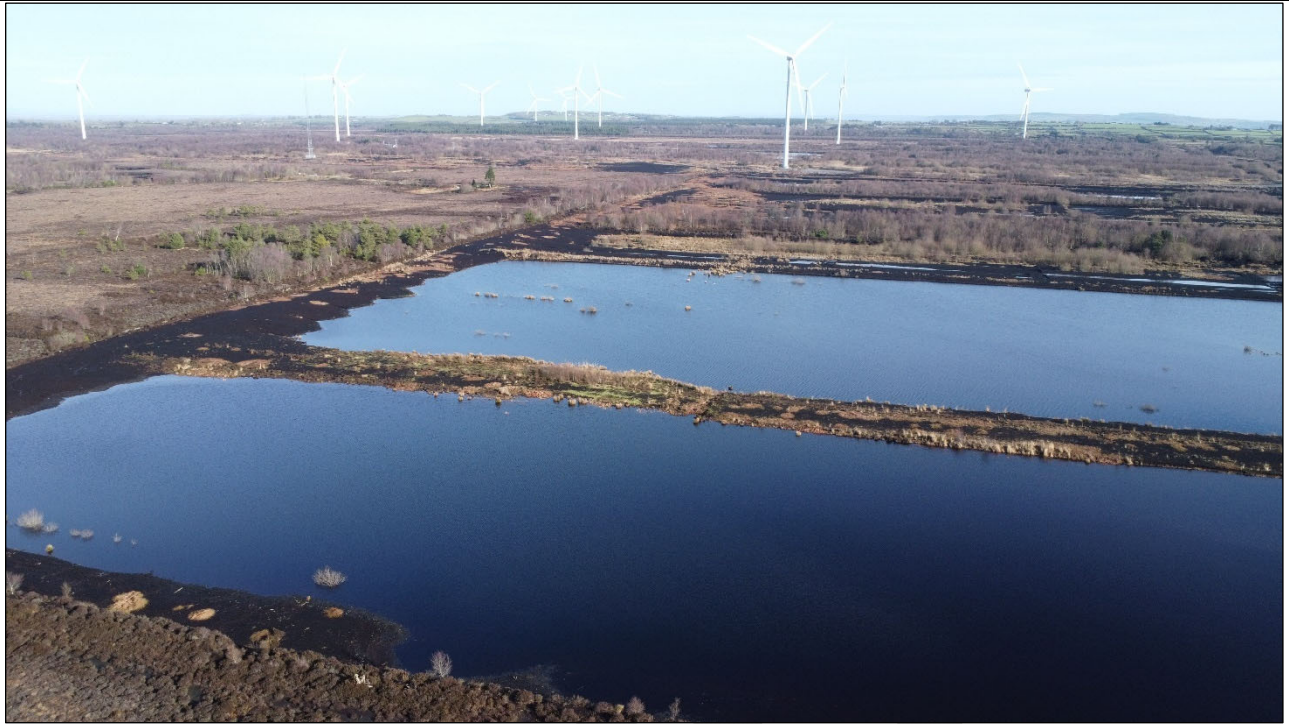
*Plate 3-3 Wetland in the west of the bog (view looking east), with remnant raised bog in the background.*

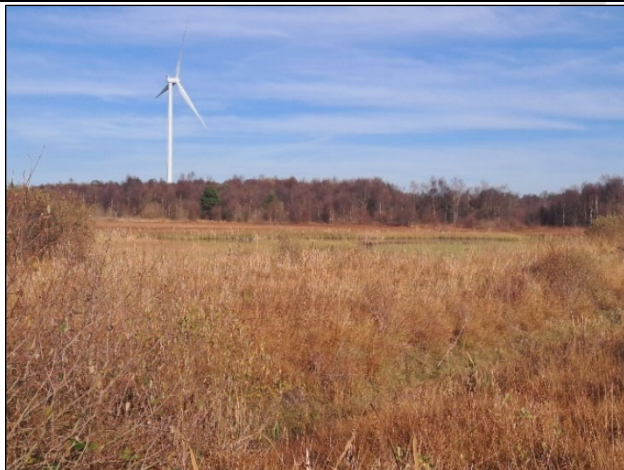
*Plate 3-4 Wetland/poor fen developing in the northern section of the bog, in the central section in between the wind farm infrastructure.*

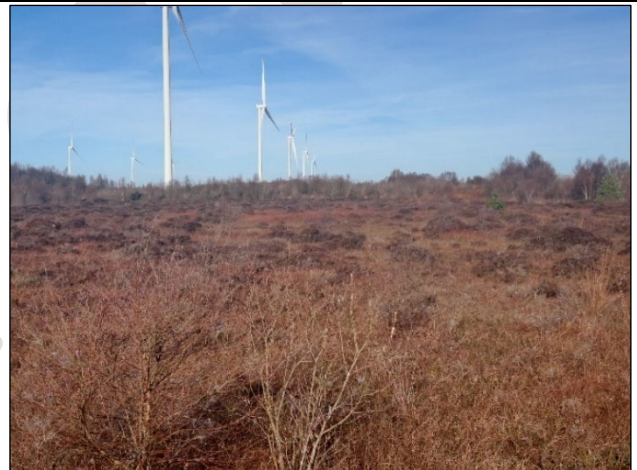
*Plate 3-5 Former rehab (contour bunding) with pioneer vegetation including dry Calluna dominated vegetation (dHeath) and pioneer Eriophorum angustifolium (pEang) in the central, northern section.*

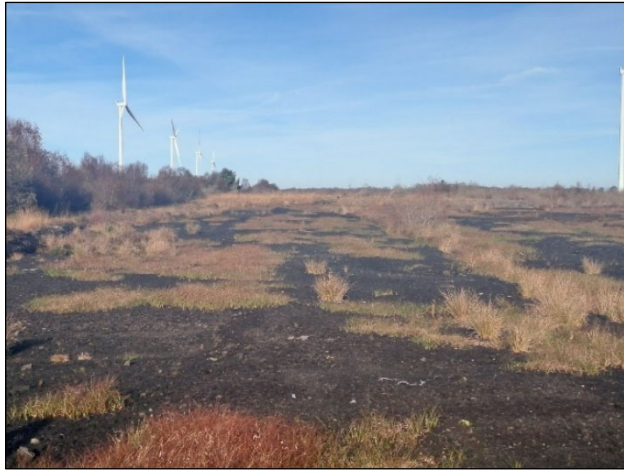
Plate 3-6 Bare peat with pioneer vegetation including pioneer *Eriophorum angustifolium* (pEang) in the central, northern section.

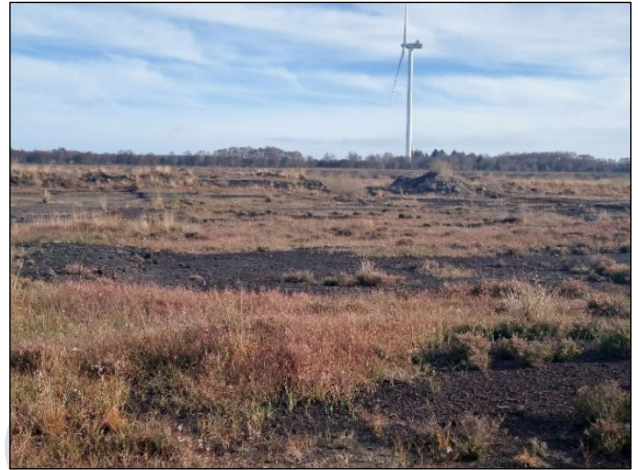
Plate 3-7 Bare peat with pioneer vegetation including pioneer *Eriophorum angustifolium* (pEang) in the central, northern section.

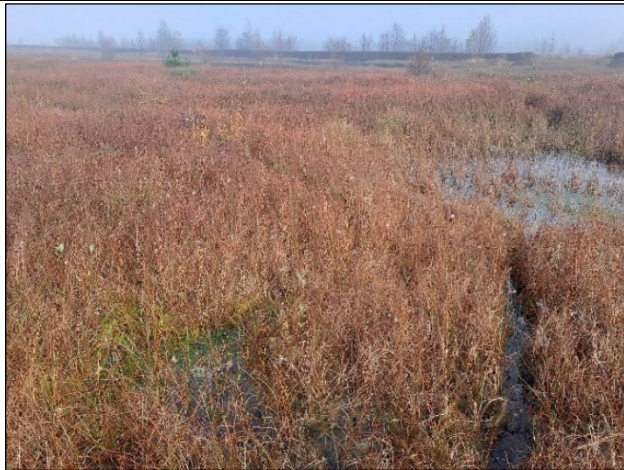
Plate 3-8 Wetland in east of bog.
