Bord na Móna

Bloomhill East Bog

**Cutaway Bog Decommissioning and
Rehabilitation Plan
2025**

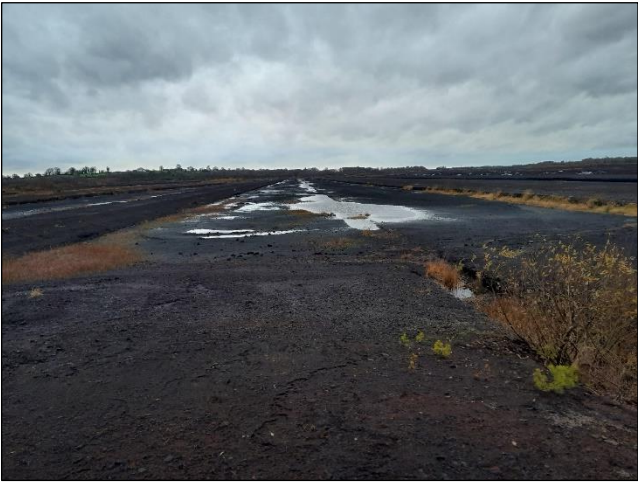
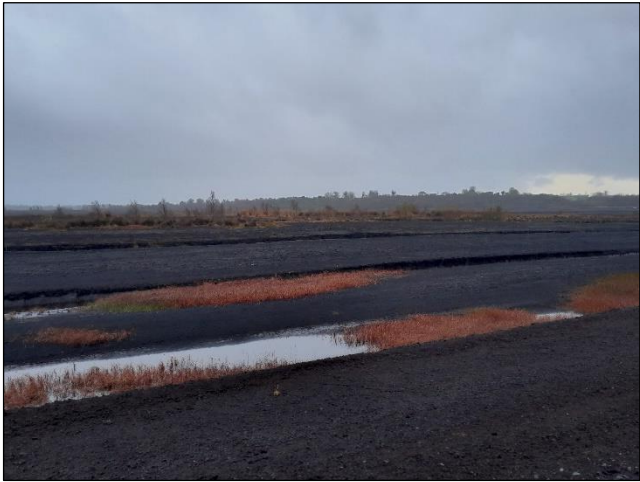
<p>Plate 3-1 Bare peat dominates across the former production area, with some minor development of vegetation along the drains.</p>	<p>Plate 3-2 Bare peat dominates across the former production area, with pioneer <i>Eriophorum angustifolium</i> (pEang) developing along the drains.</p>

Bloomhill East Bog is still dominated by bare peat habitats with some minor development of pioneer vegetation communities. Some small waterbodies have developed in topographical depressions. The margins of the bog are dominated by scrub, immature woodland and some more mature woodland habitats. Silt ponds are present, and riparian vegetation has developed around them. Some small, degraded bog remnants exist in parts of the margins of the bog.

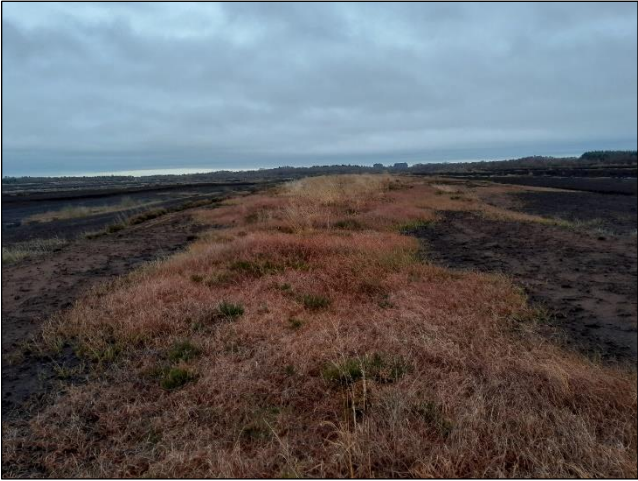
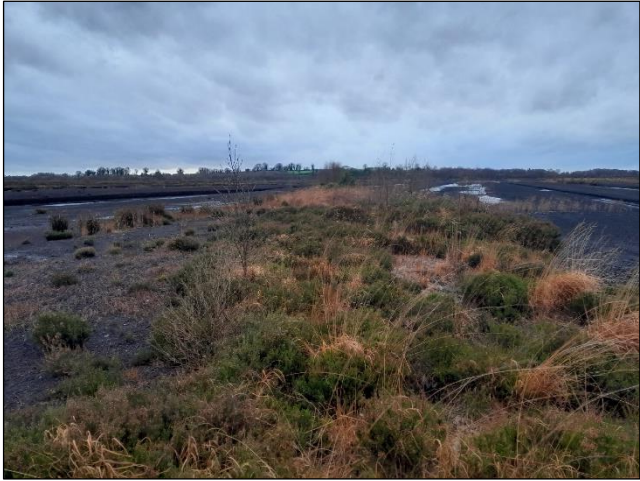
<p>Plate 3-3 Pioneer vegetation including <i>Eriophorum angustifolium</i> (pEang) developing along high fields.</p>	<p>Plate 3-4 Pioneer vegetation including dry <i>Calluna</i> dominated vegetation (dHeath) and <i>Molinia caerulea</i> (gMol) along high fields.</p>

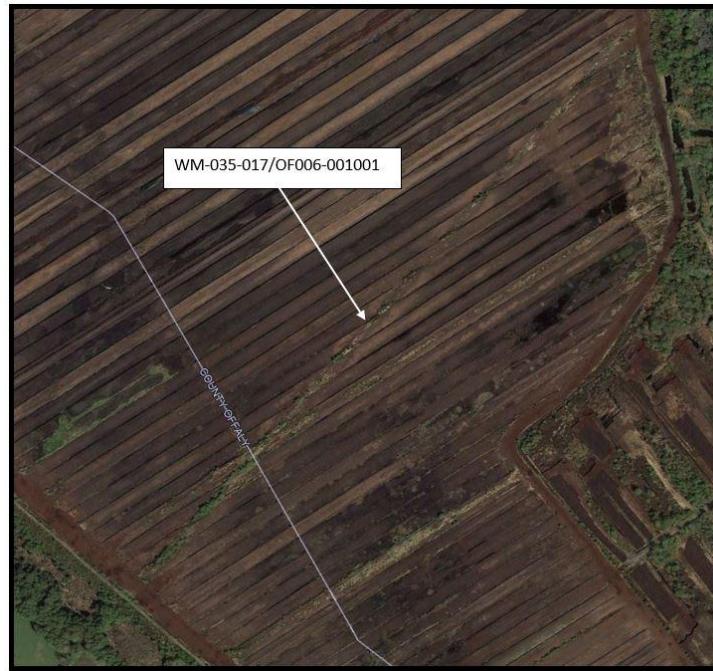
Fig. 3. Bloomhill East Bog, Co. Offaly. Google earth aerial image taken May 2021 indicating the extent of the Road - gravel/stone trackway RMP WM-035-017/OF006-001001 crossing the bog.
