**Bord na Móna**

**Cloontuskert Bog**

**Cutaway Bog Decommissioning and  
Rehabilitation Plan  
2025**

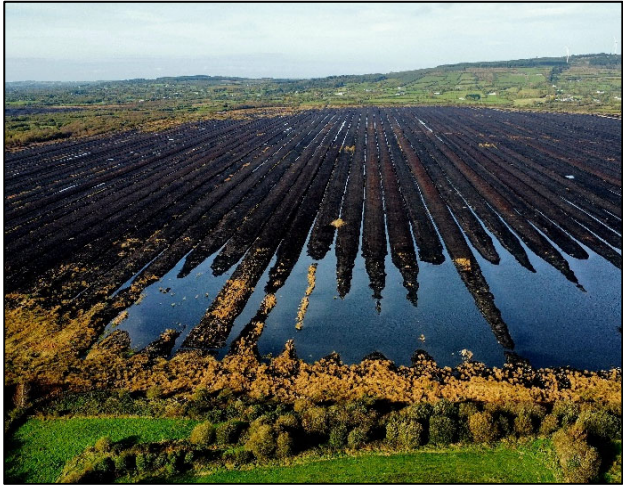
| Photos of Habitats at Cloontuskert (2024) | |
|---|---|
| <i>Plate 3-1 Aerial view of Cloontuskert (view northwest).</i> | <i>Plate 3-2 Aerial view of Bare peat.</i> |

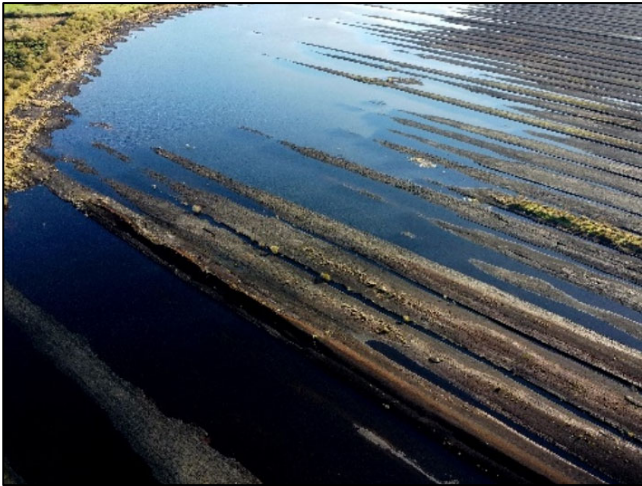
| Photos of Habitats at Cloontuskert (2024) | |
|---|---|
| <i>Plate 3-3 Area of Open water in Cloontuskert bog.</i> | <i>Plate 3-4 Open water.</i> |

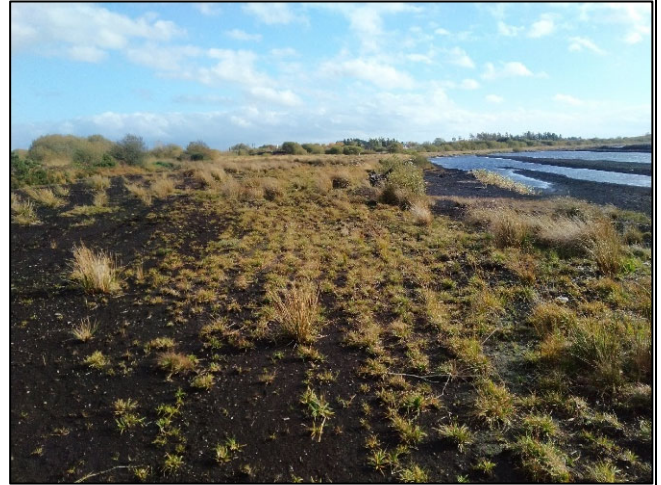
*Plate 3-6 Pioneer open habitats.*

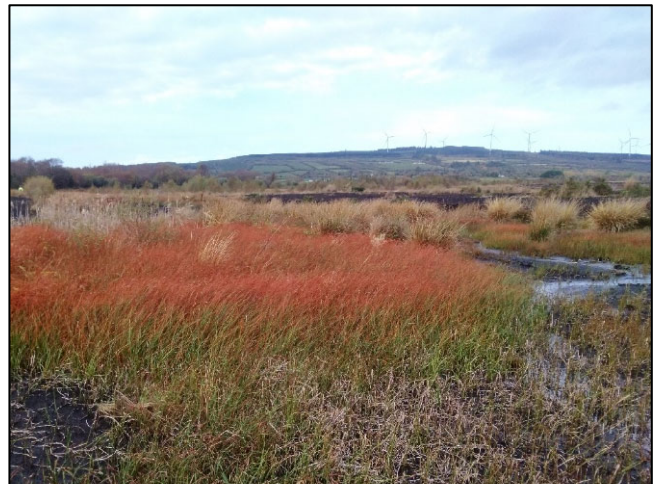
*Plate 3-8 Bog Cotton dominated pioneer open habitats.*

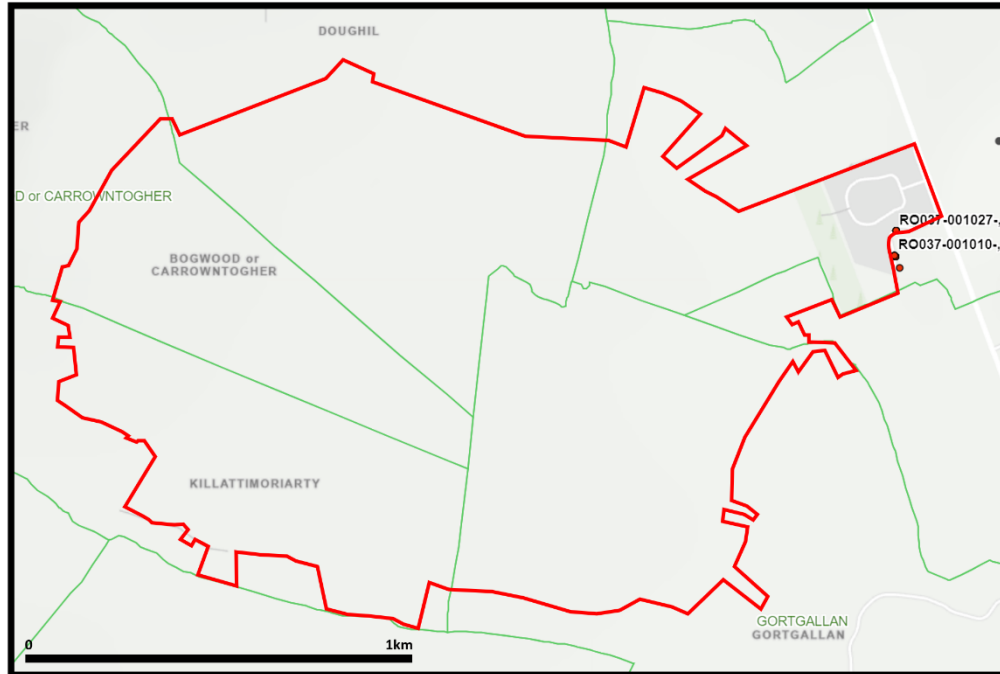
Fig. 2. Cloontuskert Bog, Co. Roscommon, detail of the Sites and Monuments Record with OS Discovery map. The proposed rehabilitation area is outlined with the red line. Note RO017-001027 is indicated north of its actual location.
