Bord na Móna

Moher Bog

**Cutaway Bog Decommissioning and
Rehabilitation Plan
2025**

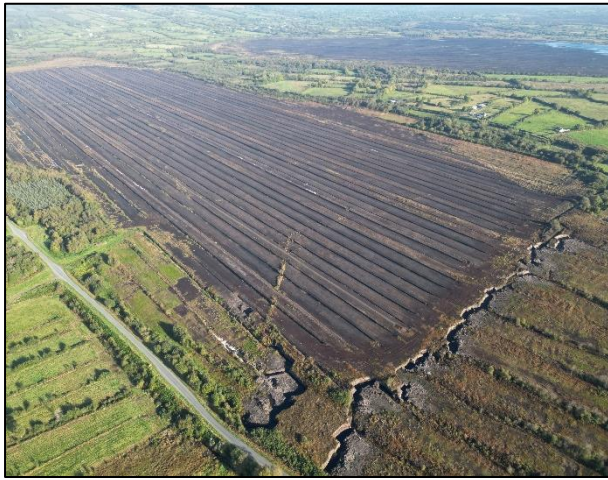
Aerial view of the northern block of Moher bog.

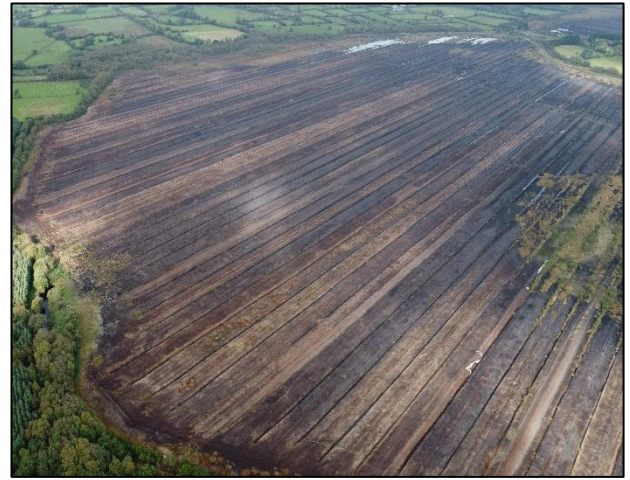
Aerial view of the southern block of Moher bog.

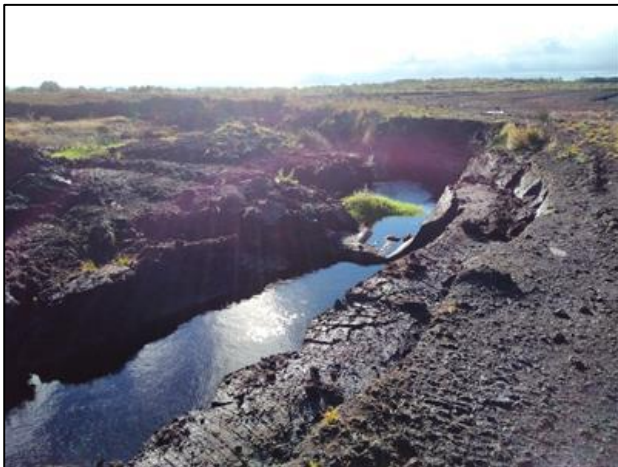
Area of turbary/domestic turf cutting in the northeast of the southern block of Moher bog.

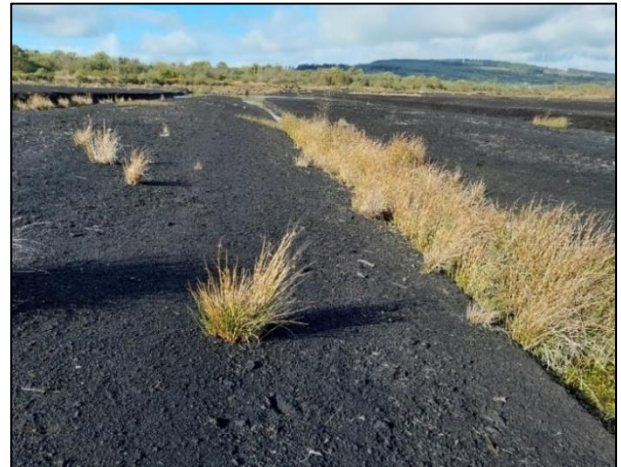
Bare peat present in Moher southern block (dominant habitat).
