Inch Bog

Cutaway Bog Decommissioning and Rehabilitation Plan

2025

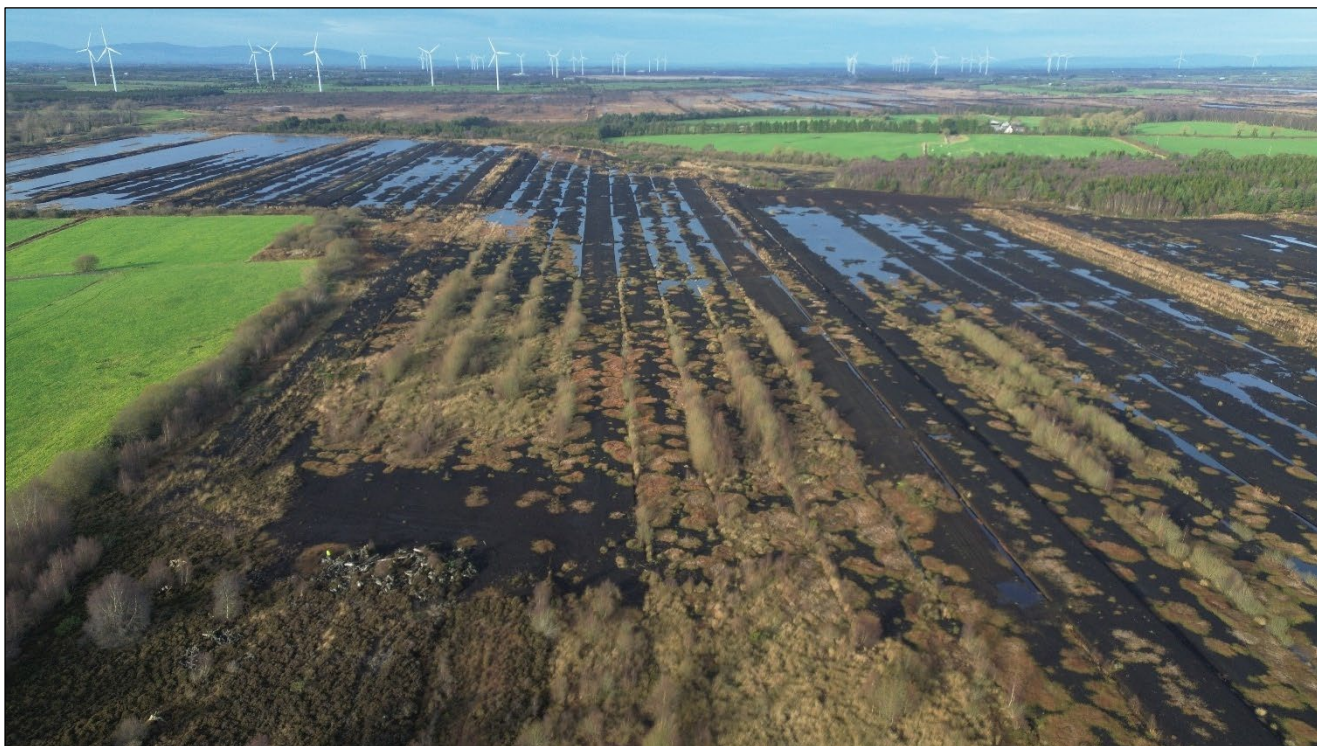
Plate 3-4 Overview of Inch bog looking north-west towards Bawnmore. Cutover dominated by bare peat and with sparse pioneer vegetation of *Juncus effusus* and *Eriophorum angustifolium* along the drains in the centre of Inch Bog.

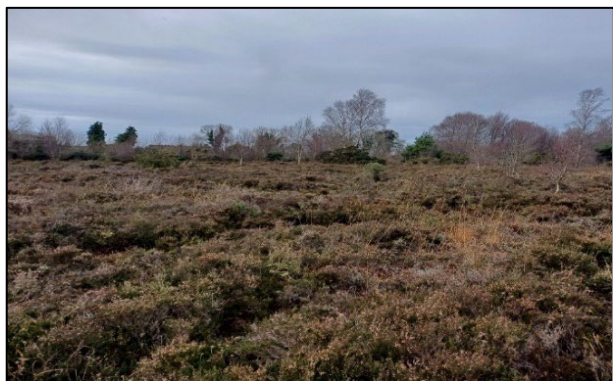
Plate 3-6 Cutover/degraded bog in the foreground dominated by *Calluna vulgaris*/*Erica tetralix* with emerging Birch/Gorse scrub (eBir, eGor), Birch Woodland (BirWD) in the background located in the south of Inch Bog.

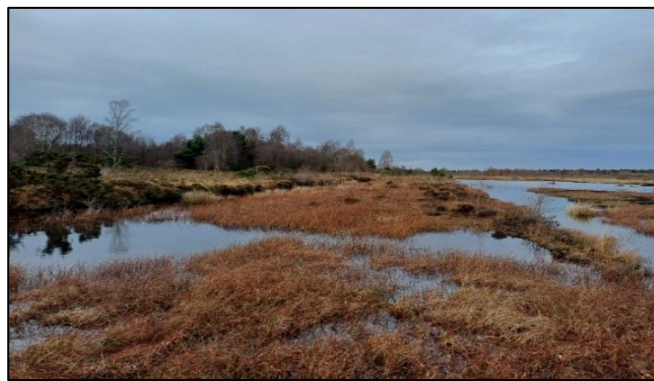
Plate 3-7 Emerging poor fen in foreground on cutaway dominated by *Eriophorum angustifolium* (pEang), wetland in the right background and Birch Woodland (BirWD) left background located in the south of Inch Bog.
