Bord na Móna

Derryville Bog

**Cutaway Bog Decommissioning and
Rehabilitation Plan**

2025

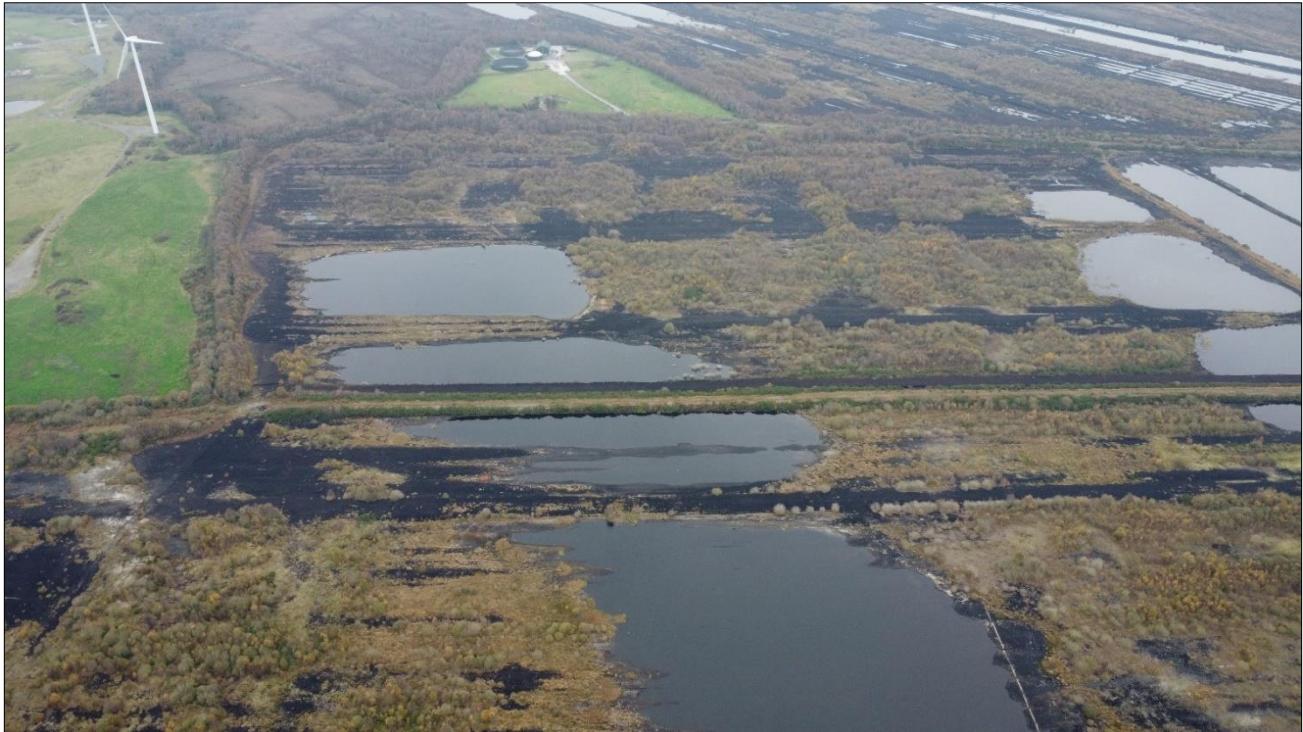
Plate 3-1 Example of dry elevated ridges supporting establishing Birch dominated scrub, with permanent standing water within depressions., in the northwest of Derryville (view looking north).

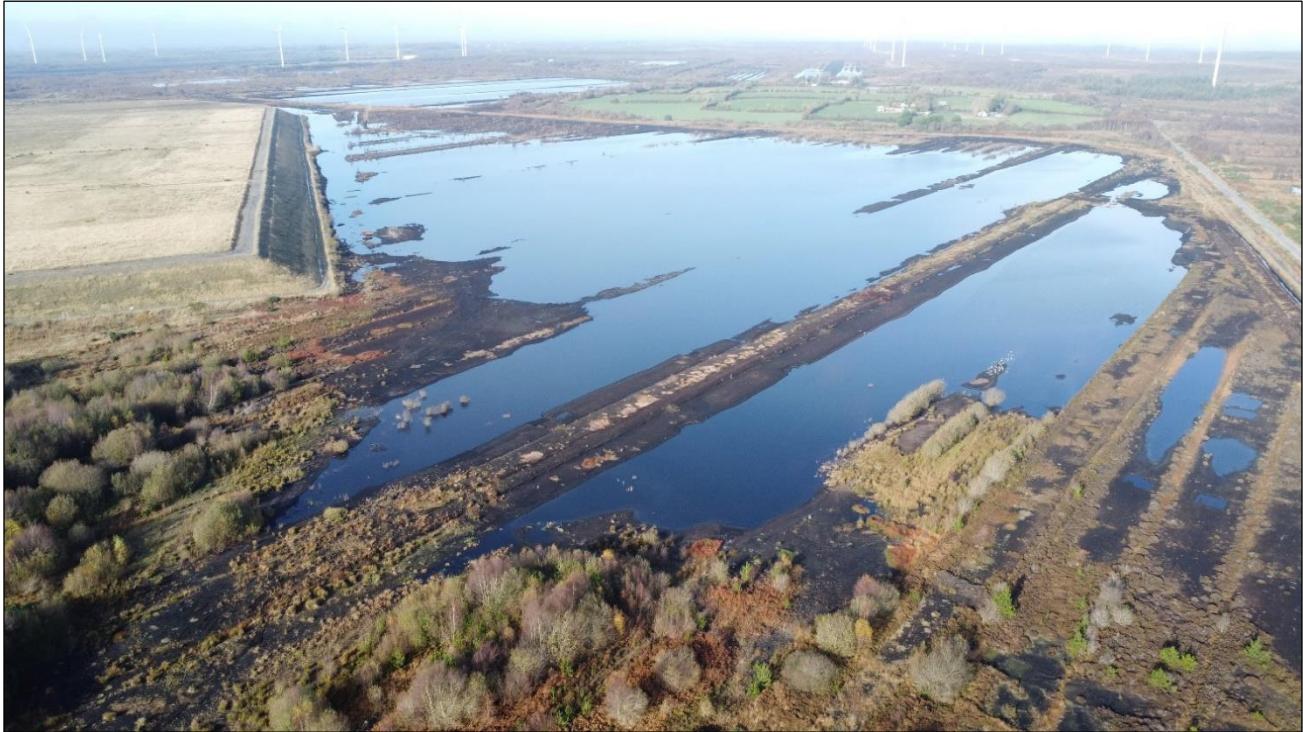
Plate 3-2 Southeastern section of Derryville, looking north. Large wetland has developed in this area.

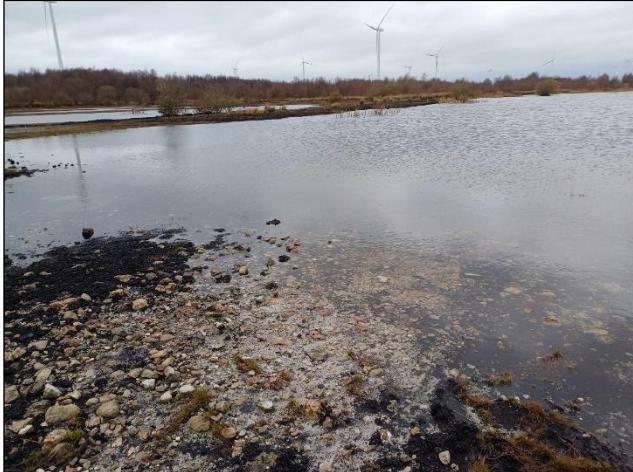
Plate 3-3 Wetlands within the western part of the bog.

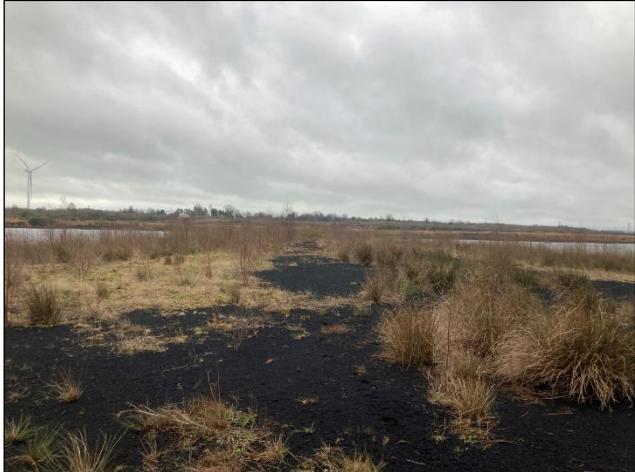
Plate 3-4 Example of revegetating high bare peat between small wetlands within Derryville with pioneer Purple Moorgrass-dominated grassland (gMol) and pioneer Soft Rush-dominated poor fen (pJeff). Establishing Birch dominated scrub in the background.

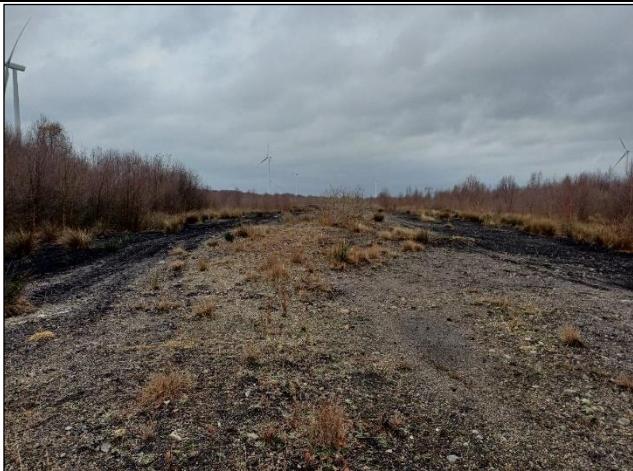
Plate 3-5 Gravel, pioneer disturbed vegetation, pioneer open habitats and Birch scrub forming in the central part of the bog.

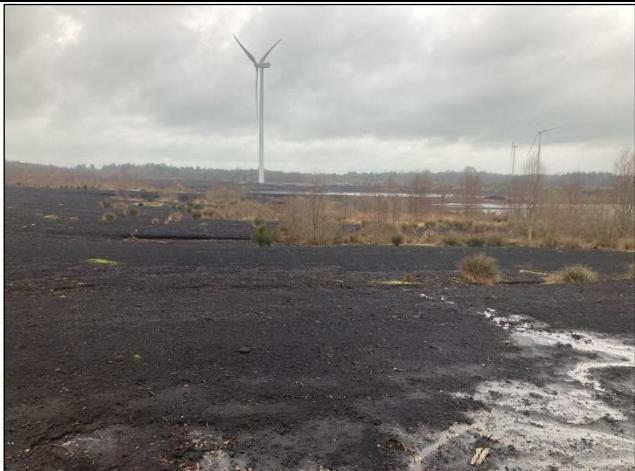
Plate 3-6 Bare peat along the bog headland.

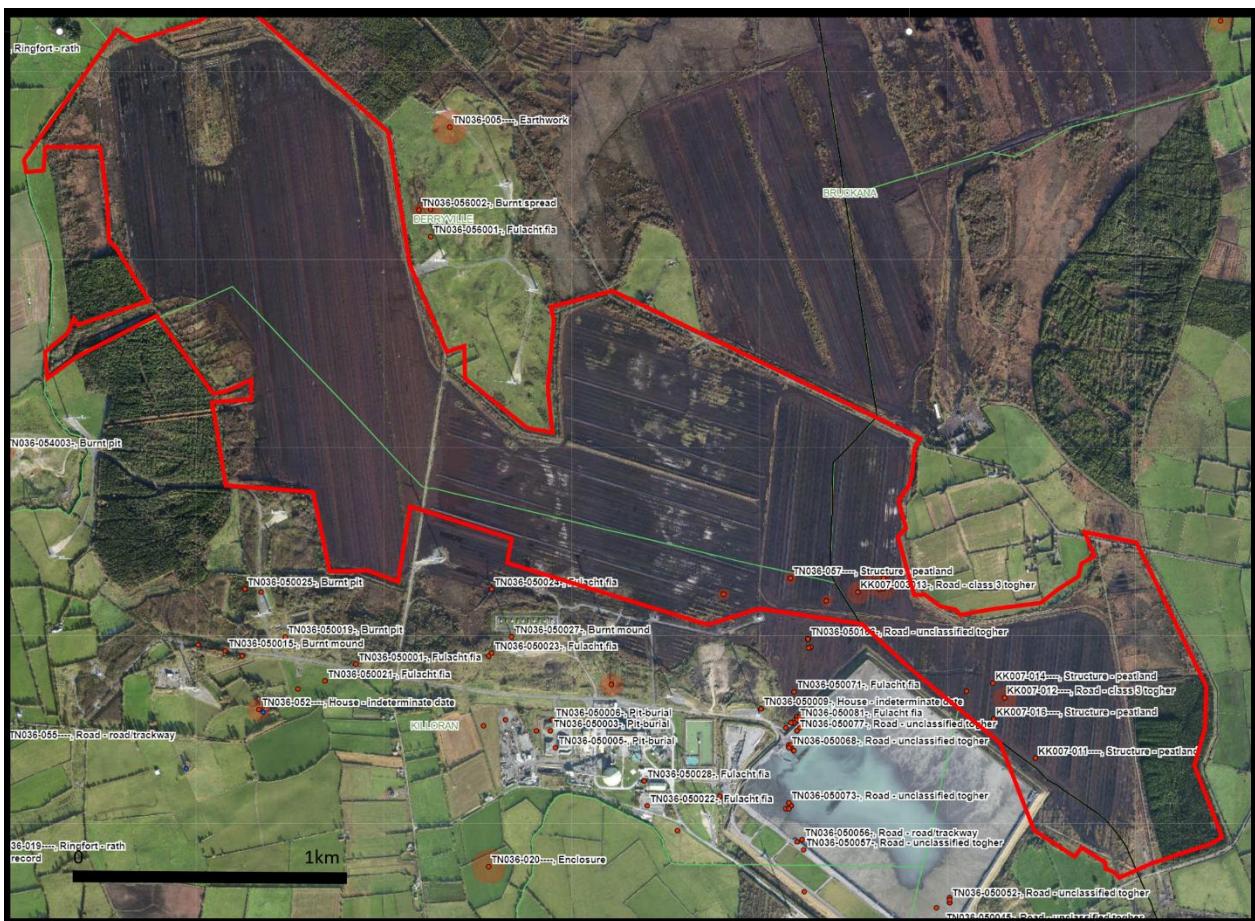
Fig. 2. Carrickhill-Derryville Bog, Co. Offaly, detail of the Sites and Monuments Record. The proposed rehabilitation area is outlined with the red line.

The Sites and Monuments Record (SMR) which is maintained by the Department of Housing, Local Government and Heritage was examined as part of the assessment on the 30th of March 2025. The SMR consists of records included in the RMP and sites and monuments notified to the Dept. since the publication of the RMP. This review established that there are 24 entries in the SMR in the proposed rehabilitation area (see Table 1 and Fig. 2).
