Bord na Móna

Carrickhill Bog

**Cutaway Bog Decommissioning and
Rehabilitation Plan
2025**

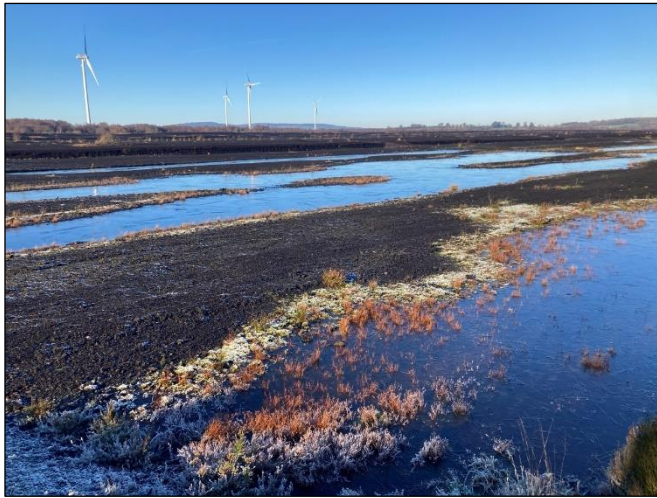
Plate 3-1 Previously rehabilitated area in southeast of Carrickhill Bog, dominated by bare peat, open water and developing vegetation communities including dry heath and pioneer *Eriophorum* vegetation.

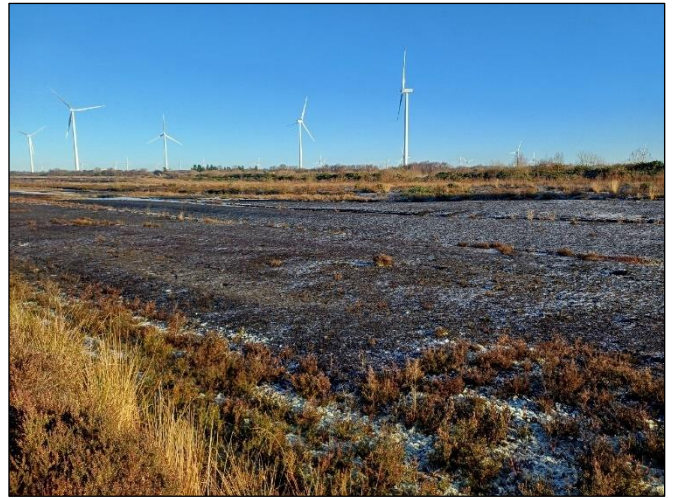
Plate 3-2 Southeast of Carrickhill Bog, dominated by bare peat cutover with developing pioneer vegetation including *Calluna vulgaris* and *Molinia caerulea*.

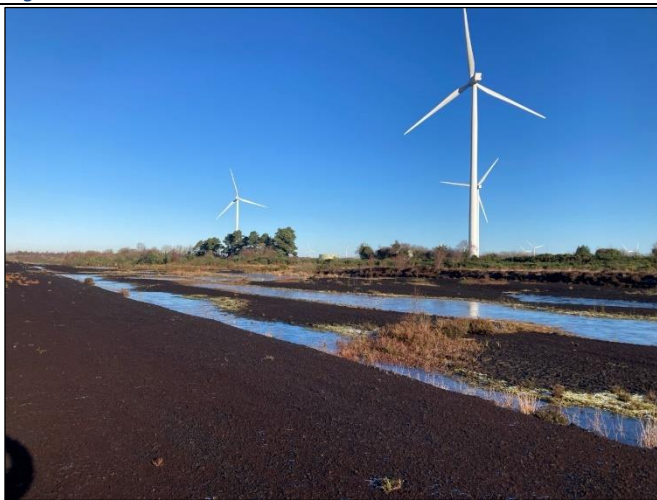
Plate 3-3 Previously rehabilitated area in eastern part of Carrickhill Bog, dominated by bare peat, open water with some developing vegetation.

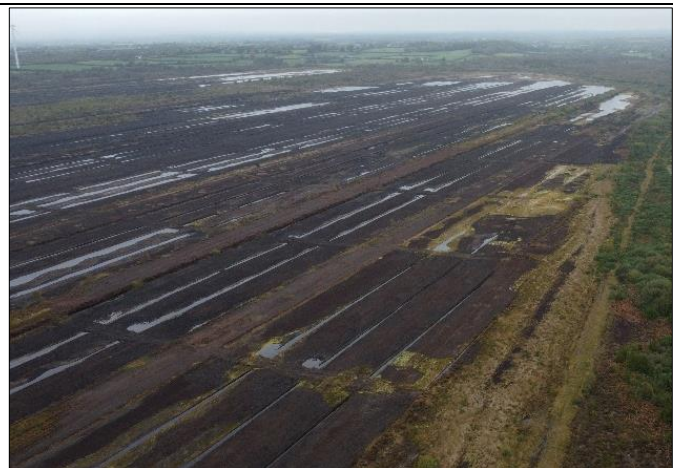
Plate 3-4 Plate 2.7 Bare peat cutover bog within the south east of Carrickhill bog (October 2024).

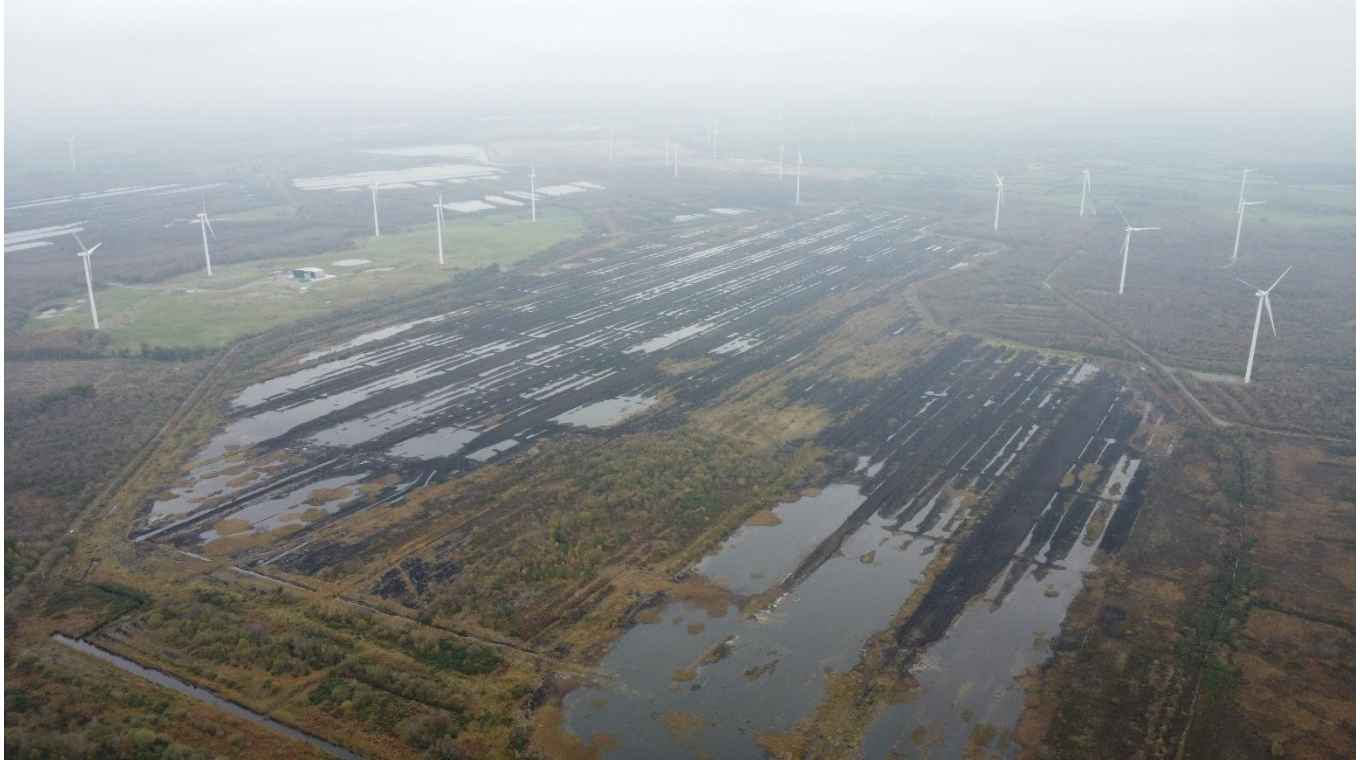
Plate 3-5 Overview of Carrickhill Bog – looking south (Nov 2024)

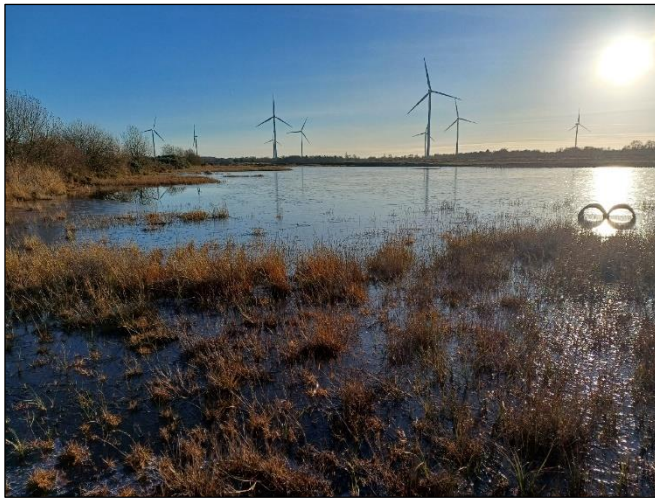
Plate 3-6 Wetland/open water in the northwest of Carrickhill Bog (view looking north).

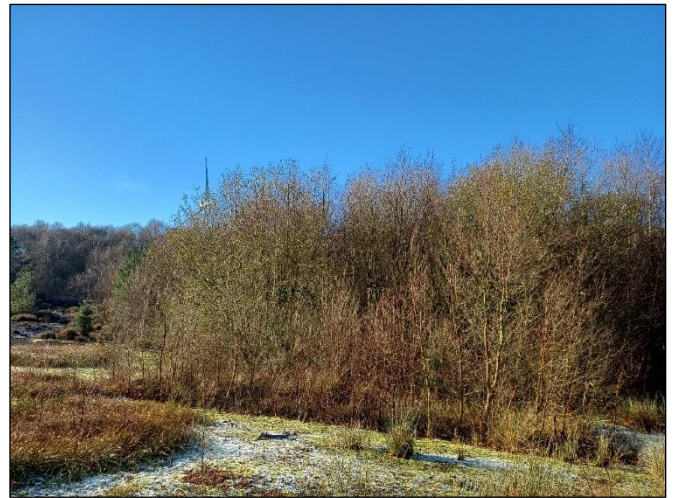
Plate 3-7 Scrub and immature woodland dominated by Willow and Birch occurs along the margins of the bog.
